RECONSTRUCTING CHRISTCHURCH: A Seismic Shift in Building Structural Systems

Reconstructing Christchurch: A Seismic Shift in Building Structural Systems

Michel Bruneau

Greg MacRae

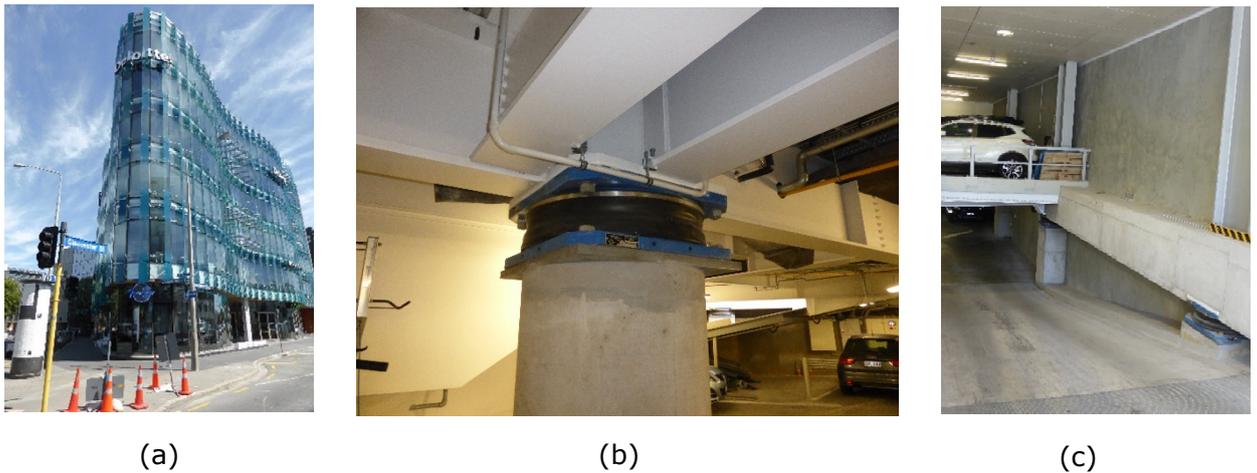
The 151 Cambridge Terrace building (shown in Figure 3-1) was completed at the time of the survey. However, the friction pendulum base-isolation bearings were visible from the underground parking garage. The bearings were supported on concrete columns from the concrete foundation; such elevation accommodated the parking ramp detail. The supported structure was a steel frame throughout, except for the beams framing the parking ramp that provides access to the lower level.

Figure 3-1: 151 Cambridge Terrace. (a) Global view, (b) Base isolator, (c) Details at parking ramp

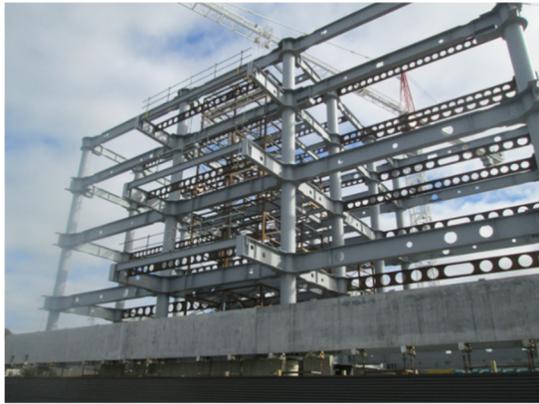
Figure 3-2: Justice Precinct. (a) Global view of steel framing, (b) Special moment-resisting frame with reduced beam section connections, (c) Base-isolation bearing, (d) Slider detail on north-west elevation

Base isolators are lead-rubber bearings, supporting a special ductile moment-resisting steel frame (Figure 3-2a), with circular concrete-filled steel-tube columns. The beams have reduced beam sections (RBS) as shown in Figure 3-2b, and are connected to beams with external diaphragm connections using bolted connections. A bearing above the column is shown in Figure 3-2c, and low-friction supports in Figure 3-2d.

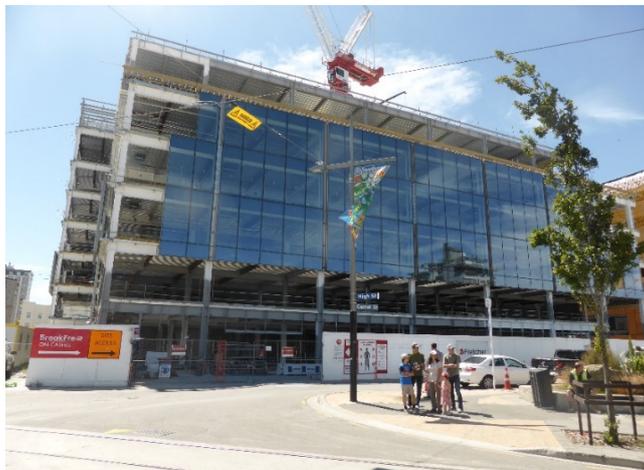
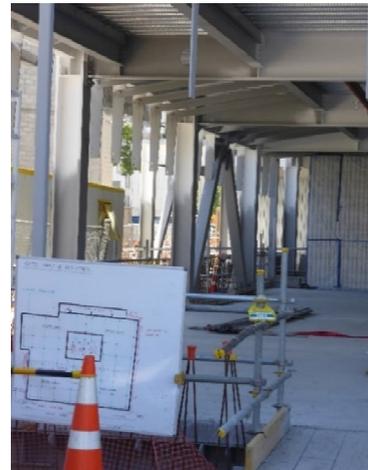
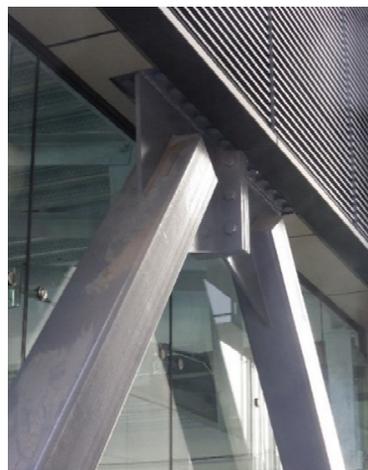
Figure 3-3: Base-isolated Grand Central building. (a) Global view during construction, (b) View of steel-braced frame and MRF inside first floor, (c) Centrally braced frame (CBF) architecturally exposed at ground level after building completion, (d) Brace connection detail

The Grand Central Building consists of CBFs and EBFs supported by base isolators (Figure 3.3). Information on the internet promoting the project and celebrating its completion indicates that the building cost somewhere between \$70 and \$85 million, providing office space to between 1,100 and 1,500 public servants from thirteen different government agencies (per McDonald (2017) and Fletcher Construction (2017)).

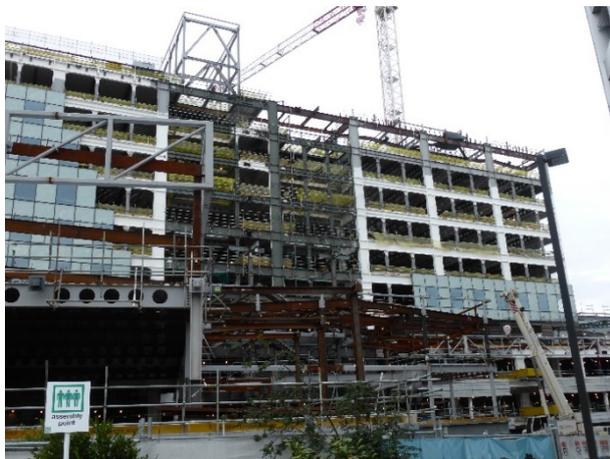
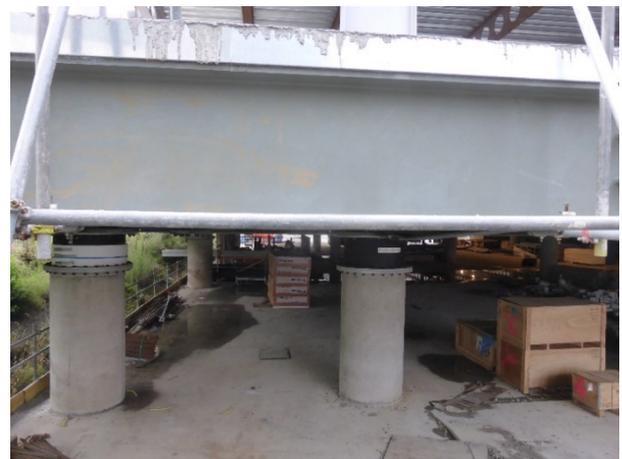
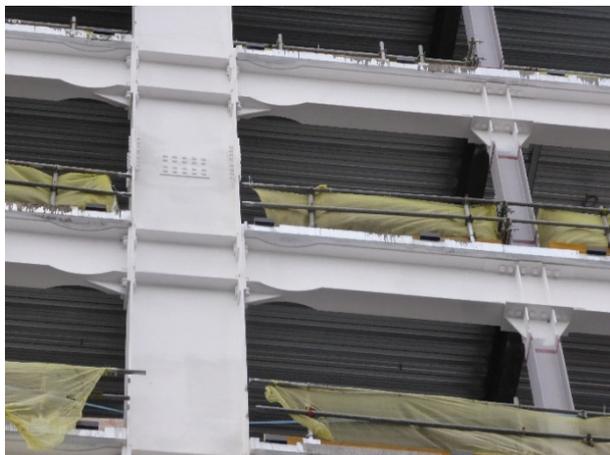
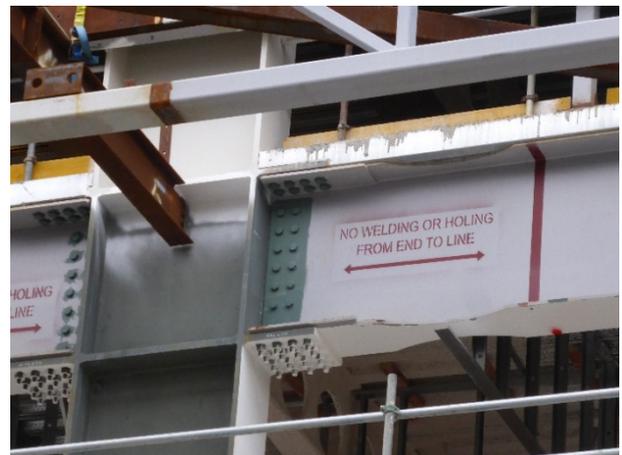
Figure 3-4: Acute Services Building – ductile MRF with RBS connections on top of base isolators and sliders. (a) Global view, (b) Base isolators, (c) Part of ductile MRF, (d) Protected zone at RBS connection

As indicated on the website of the New Zealand Ministry of Health, the Acute Services Building is the largest government project as part of the Canterbury rebuild, with 62,000m² of floor space. As shown in Figure 3-4, the structure consists of a ductile MRF relying on RBS for its moment connections, supported by base isolators and sliders located on top of short columns. Interestingly, the marking on the beams (Figure 3-4d) clearly delineates the zone of potential significant yielding (referred to as the “protected zone” in the US) over which trades cannot weld or drill/punch holes, as these could have detrimental effects on the development of cyclic plastic hinging during seismic response.

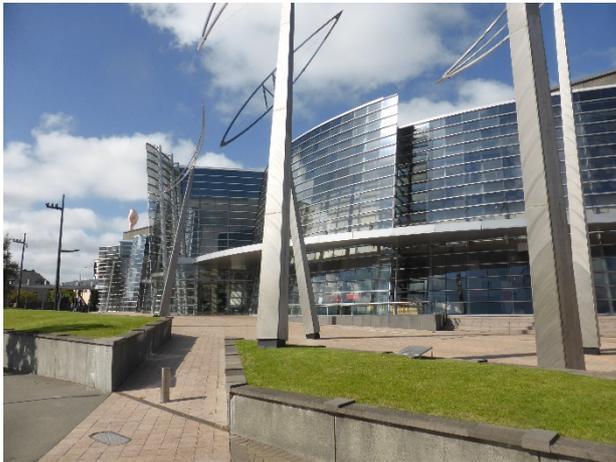
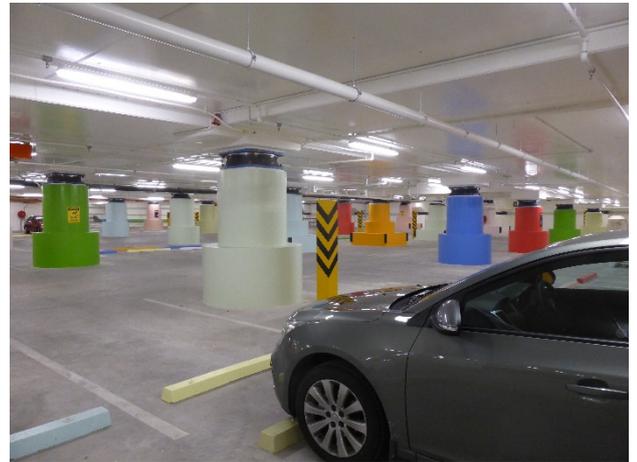
Figure 3-5: Christchurch Art Gallery. (a) Global view, (b) Base isolators in underground parking garage

Although this report is about the Christchurch reconstruction, and thus focused on new construction, an exception is made here with a few words about the Christchurch Art Gallery, because this building served as the Emergency Response Centre during the 2011 earthquake. Interestingly, its glass façade, spanning the width and height of the building, was intact after the earthquake. In the years following the earthquake, extensive retrofitting work was performed, including geotechnical work to relevel the building, and structural work to repair damage to structural and non-structural components, and to base isolate it to better protect its art collections and provide reassurance for travelling collections (Strongman, 2015; Christchurch Art Gallery, 2017). The photos included in Figure 3-5 are provided (as a somewhat “off-topic diversion”) to illustrate how the base-isolator support columns were colourfully integrated in the underground parking garage of the Art Gallery.

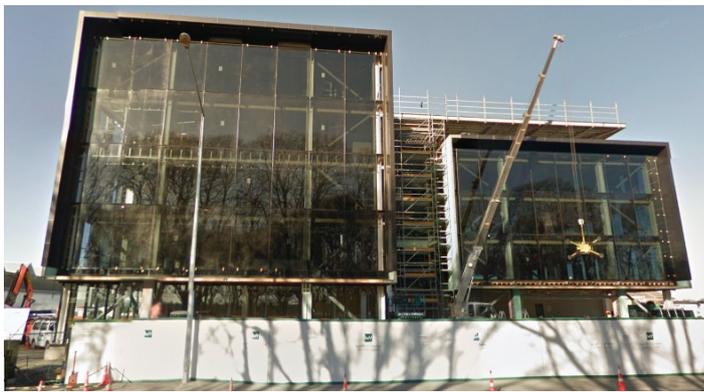
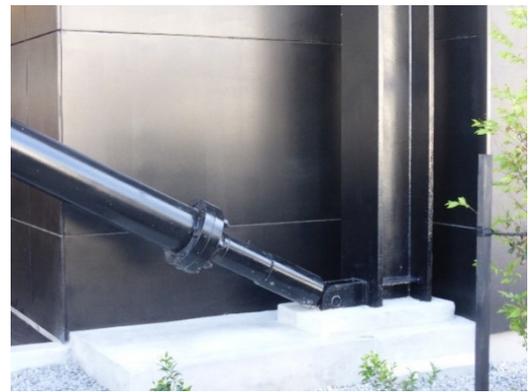
Figure 3-6: Viscous damper implementation in the 12c Moorhouse Avenue building. (a) Global view during construction (from Google Street View, August 2015), (b) Close-up view of damper

The 12c Moorhouse Avenue building is an easily accessible example of this type of application because many of its viscous dampers at the first floor are exposed outside the building, and many others are visible through the glass façade (Figure 3-6).

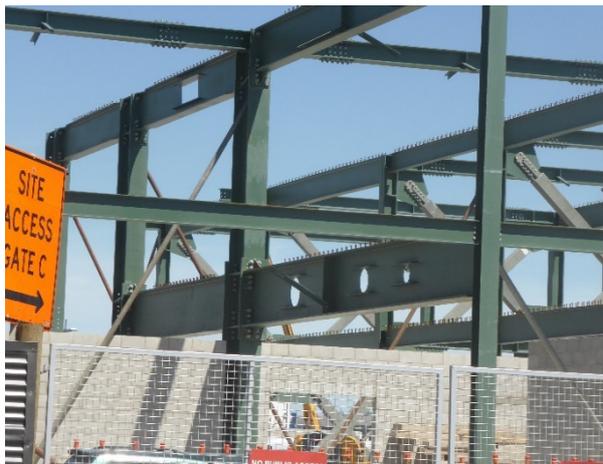
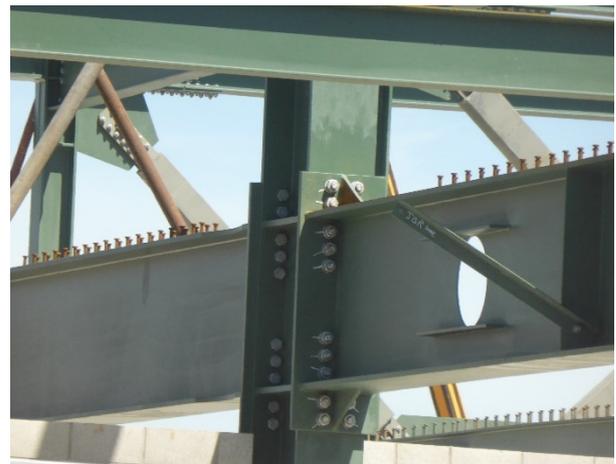
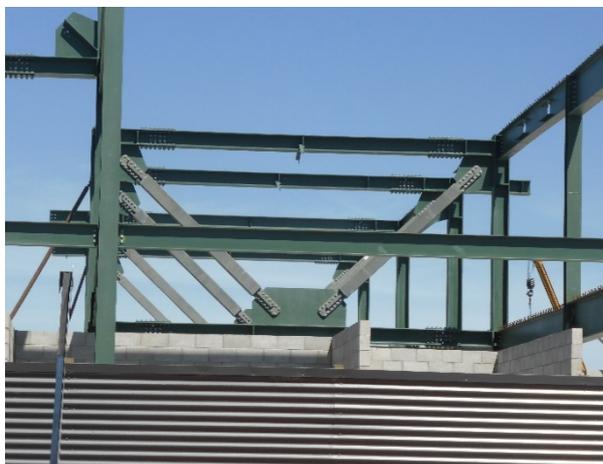
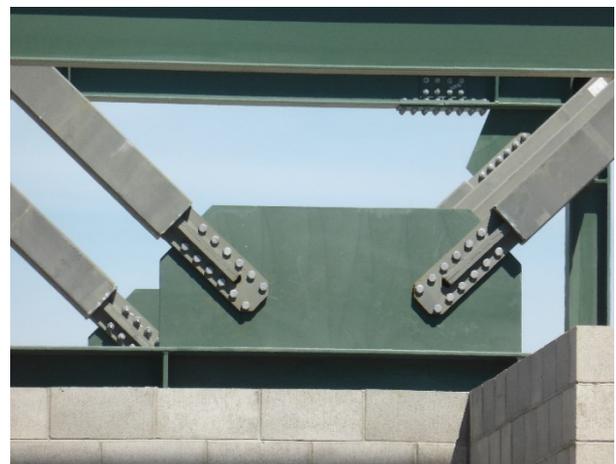
Figure 3-7: MRF and BRB frame, 41 Lichfield Street. (a) Global view of MRF, (b) Close-up of bolted end-plate moment-resisting connection, (c) Global view of BRB frame, (d) Close-up of braced frame connection

In this building located on Lichfield Street (Figure 3-7), adjacent to the Justice Precinct, MRFs with bolted end-plate connections were used in one direction (N-S), while BRB frames were used in the other direction (E-W).

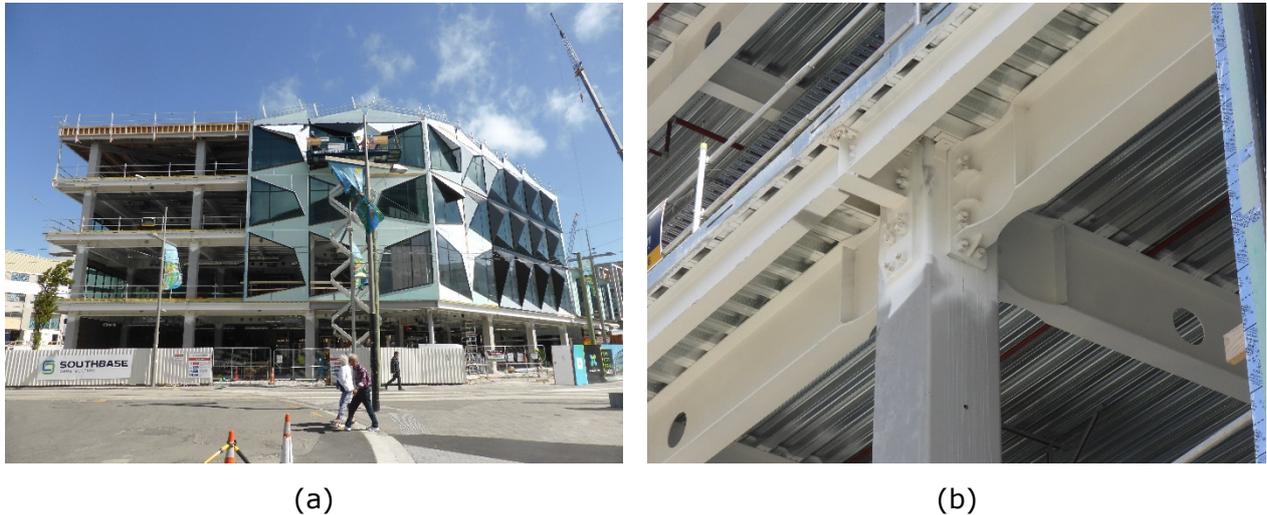
The Crossings is a multi-building retail complex of new and retrofitted heritage buildings, filling the land bordered by Cashel, Colombo, Lichfield and High Streets. The specific building shown in Figure 3-8, with an irregular floor plan, provides a good example of ductile MRF having RBS and square concrete-filled columns.

Figure 3-8: MRF at the Crossings, 71 Lichfield Street. (a) Global view of space moment frame, (b) Close-up of RBS connection with bolted end-plate to moment-resisting connection to square steel section

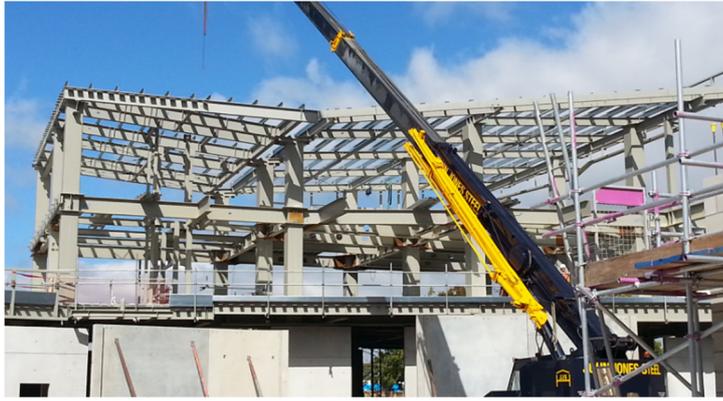
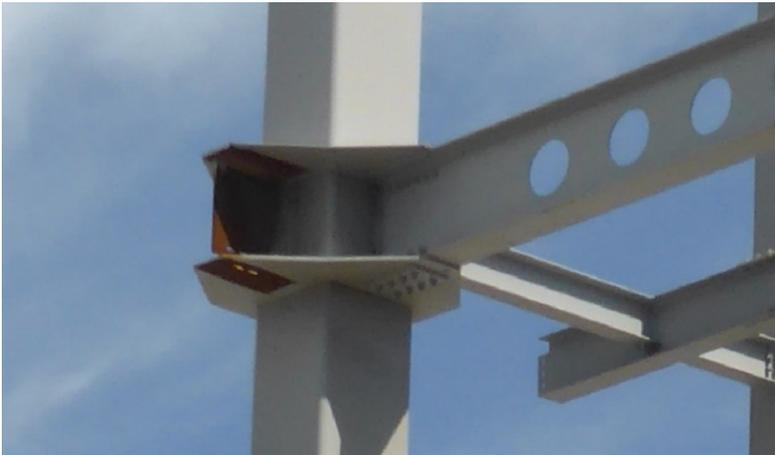
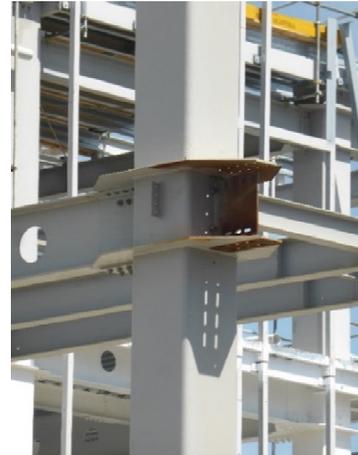
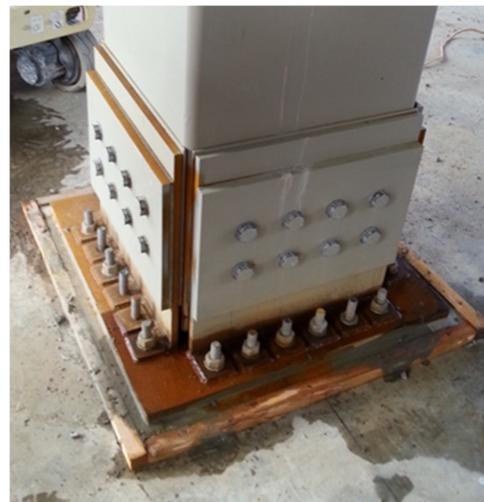
Figure 3-9: Details of the friction connections on the Terrace Project at Oxford Terrace. (a) Global view, (b) Bidirectional moment connection being constructed, (c) Unidirectional moment connection under construction, (d) Completed bidirectional moment connection, (e) Base connection detail

In the Terrace Project on Oxford Terrace (Figure 3-9), MRFs with sliding connections were used in two directions, using external diaphragm connections to the rectangular concrete-filled tube (RCFT) columns, as shown in Figures 3-9b to 3-9d. The base connection was a two-way connection with the column sitting on a central pin and oversized holes placed in the baseplate to allow flexural movement in both directions, as shown in Figure 3-9e.

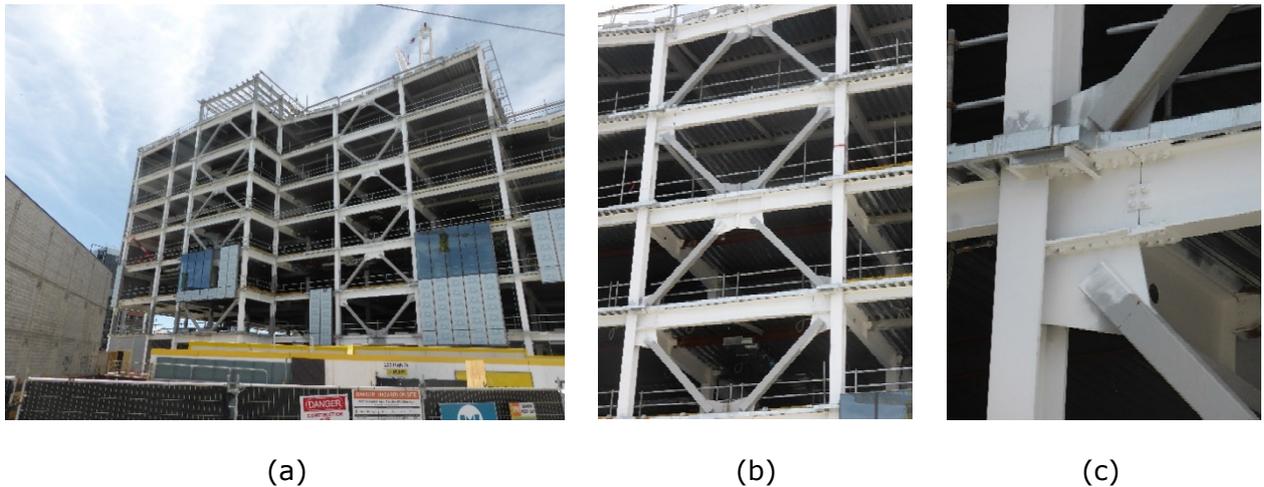
The building at 222 High Street (Figure 3-10) uses CBFs in an X-configuration spanning two storeys. Braces are welded at their ends to gussets made integral with an extended segment of the beam. Braces are rectangular hollow structural shapes. The structure is base isolated.

Figure 3-10: CBF, 222 High Street. (a) Global view, (b) Braced bay elevation, (c) Close-up view of gusset connection brace to beams and columns

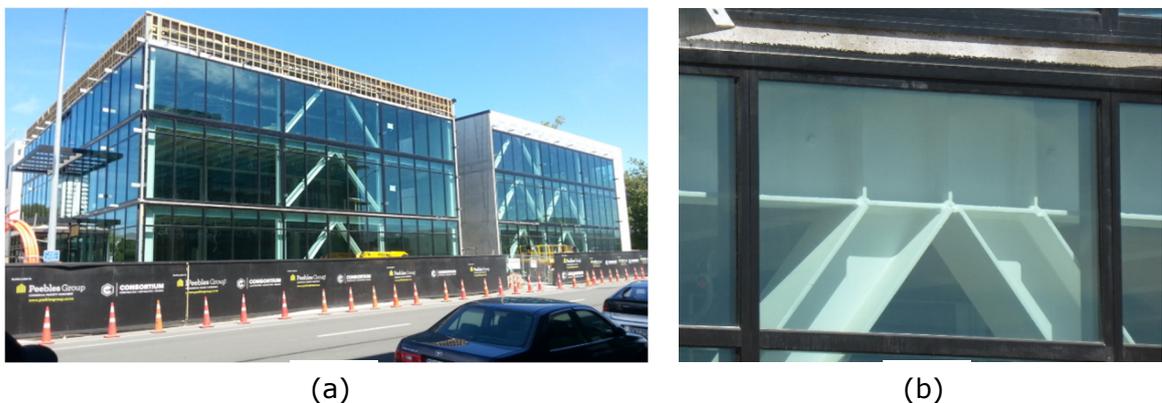
CBFs in an inverted-V configuration have been used in the three-storey 124 Kilmore Street building (Figure 3-11). Braces are directly welded to the beams and columns.

Figure 3-11: Inverted-V CBF at 124 Kilmore Street. (a) Global view, (b) Close-up of brace-to-beam connection detail

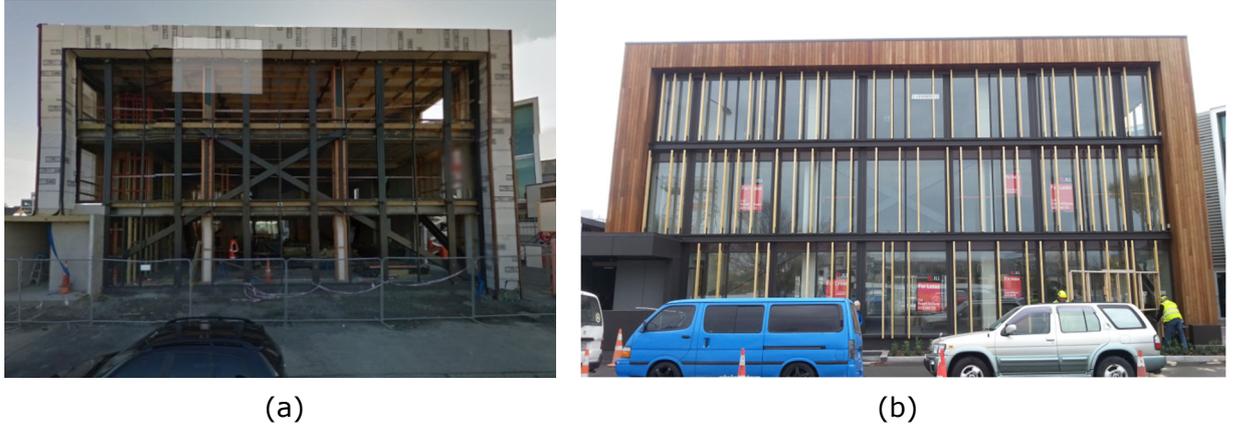
CBFs have been used in the lower two storeys of the 60 Kilmore Street building (Figure 3-12).

Figure 3-12: 60 Kilmore Street. (a) During construction (Google Street View, August 2015), (b) Completed, as seen May 2016

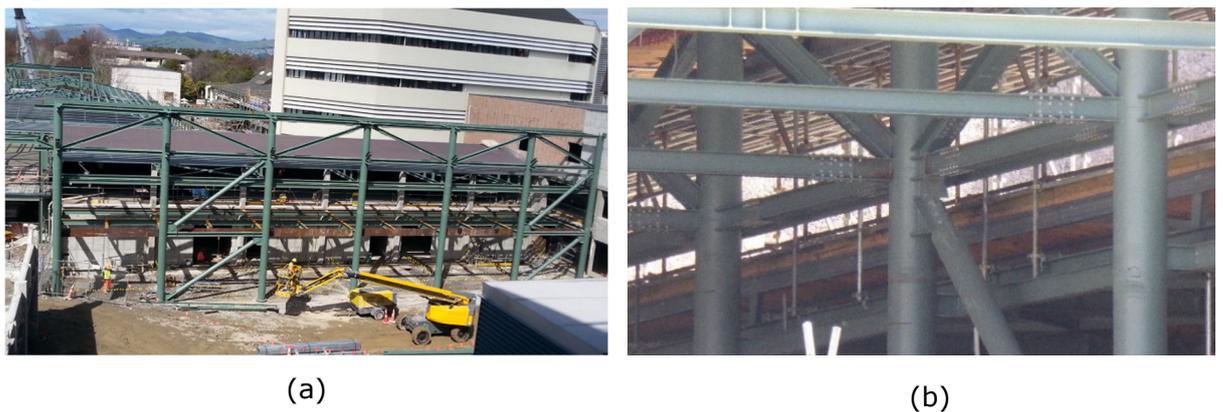
While outside the CBD, these interesting three-storey CBFs have been used for the University of Canterbury engineering hub building (Figure 3-13). It appears that the frames have been laid out such that braces in the first two levels are all oriented in the same direction.

Figure 3-13: CBFs in the Core Engineering building, University of Canterbury. (a) Global view of braced frame, (b) Close-up of brace connection detail

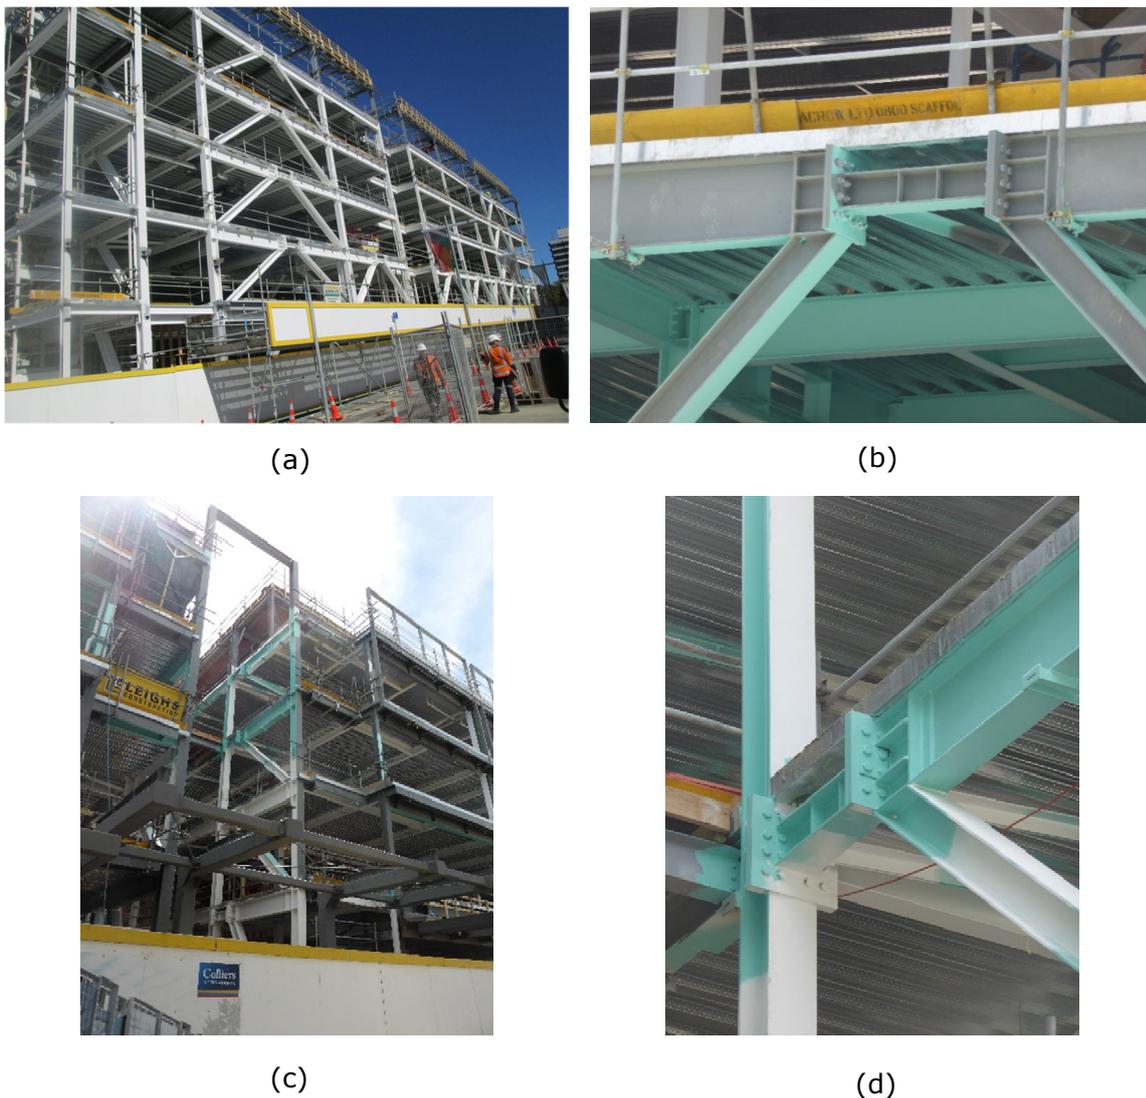
EBFs were used in a number of bays of the 120 Hereford Street building (Figure 3-14). Both the inverted-V configuration and the D-configuration were used. In all cases, bolted replaceable links were used.

Figure 3-14: EBF, 120 Hereford Street. (a) Global view of inverted-V braced frame, (b) Close-up of link in inverted-V braced frame, (c) Global view of D-frame, (d) Close-up of link in D-frame

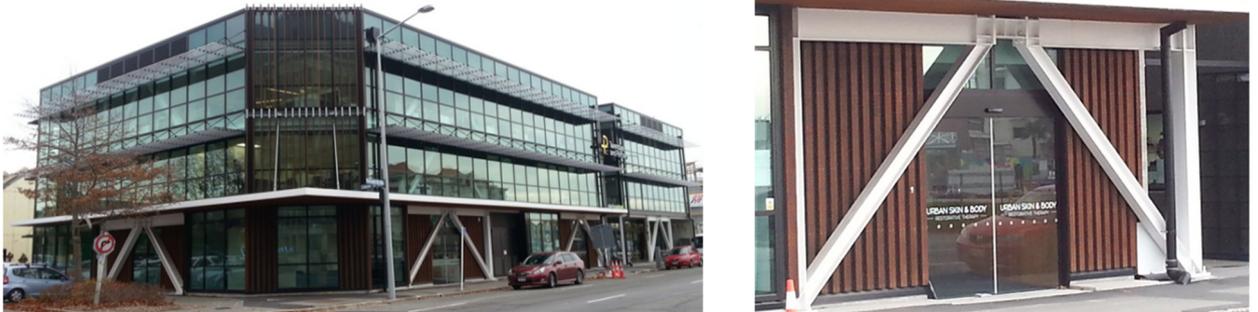
Inverted-V EBFs were used in the three-storey 329 Durham Street building (Figure 3-15). Here again, replaceable bolted links were used. The structural system was left exposed on the first floor as part of the architectural expression.

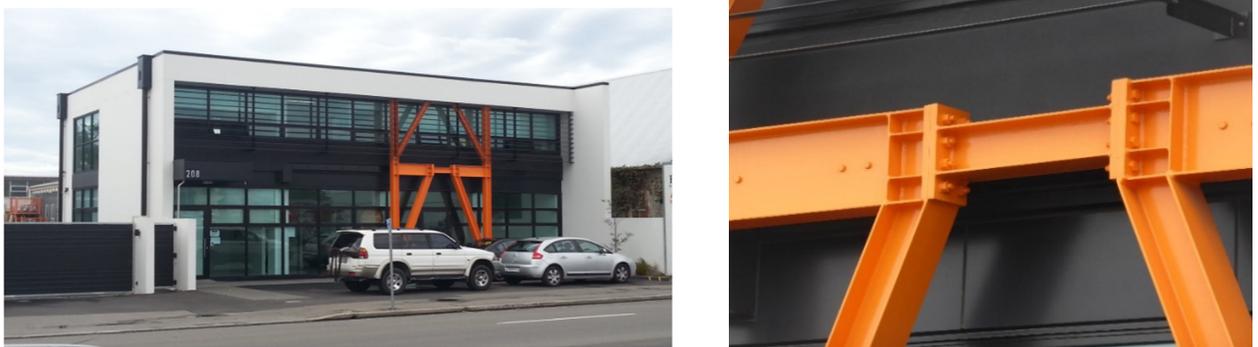
Inverted-V EBFs with bolted replaceable links were also used in the two-storey 208 Barbadoes Street building (Figure 3-16). The structural system was left exposed over the height of the building façade, and distinctively painted orange as part of the architectural expression.

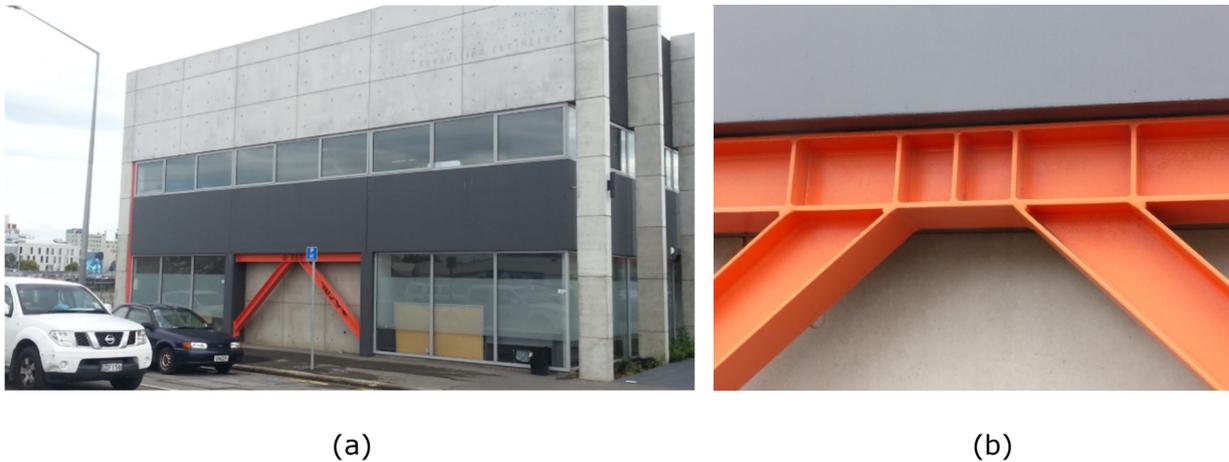
Conventional inverted-V EBFs (meaning without replaceable links) were also used in the building on the northwest corner of Lichfield and Barbadoes Streets (Figure 3-17). In the first-storey façade, the braces and beams of the braced frame were left exposed and painted orange.

Figure 3-17: EBF, building on northwest corner of Lichfield and Barbadoes Streets. (a) Global view of inverted-V braced frame, (b) Close-up of link in inverted-V braced frame

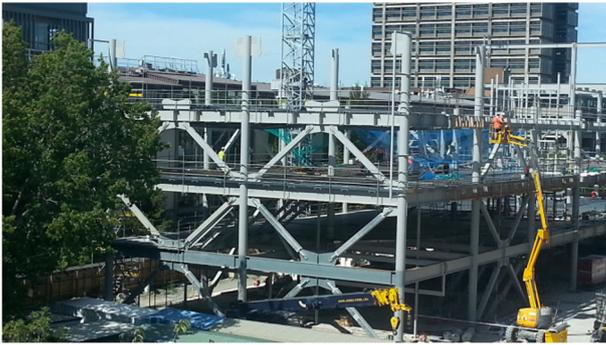
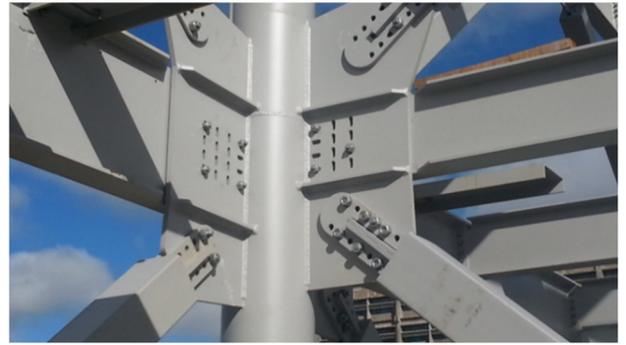
Figure 3-18: BRB frame, University of Canterbury Science Annex. (a) Global view, (b) Close-up view of gusset connection of BRB to beams and columns

The new Science Annex building constructed at the University of Canterbury (not in the CBD) uses BRBs in multiple bays (Figure 3-18), and different types of braces and brace connections at different locations in the structure. Plates at the ends of the braces are stiffened and bolted to large gussets, having beam flange extenders to which the beams are connected. Columns are circular steel tube.

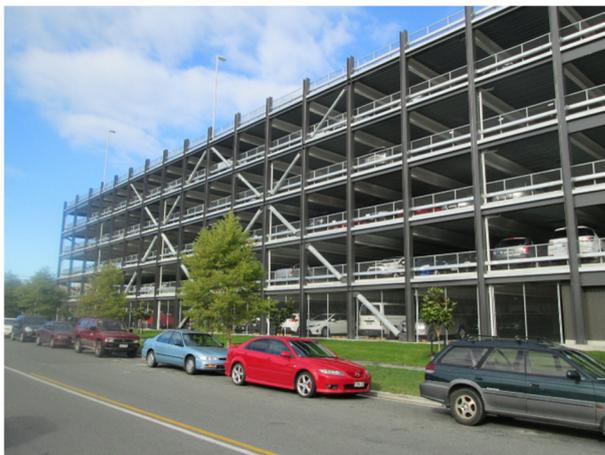
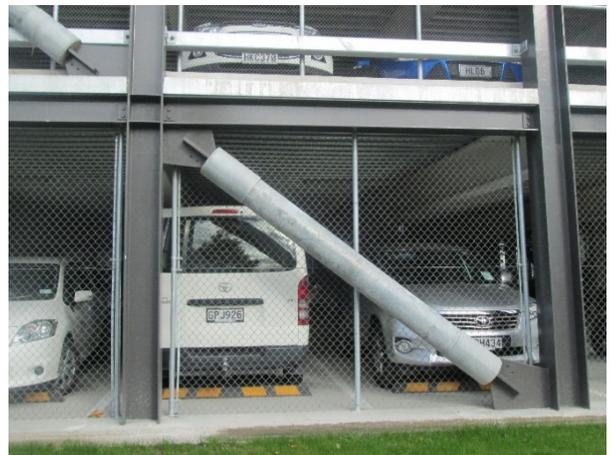
Figure 3-19: BRB frame, 14 Hazeldean Road. (a) Global view, (b) Close-up view of gusset connection of BRB to beams and columns

The five-storey building at 14 Hazeldean Road uses BRBs in a super-X configuration, spanning up to ten bays (Figure 3-19).

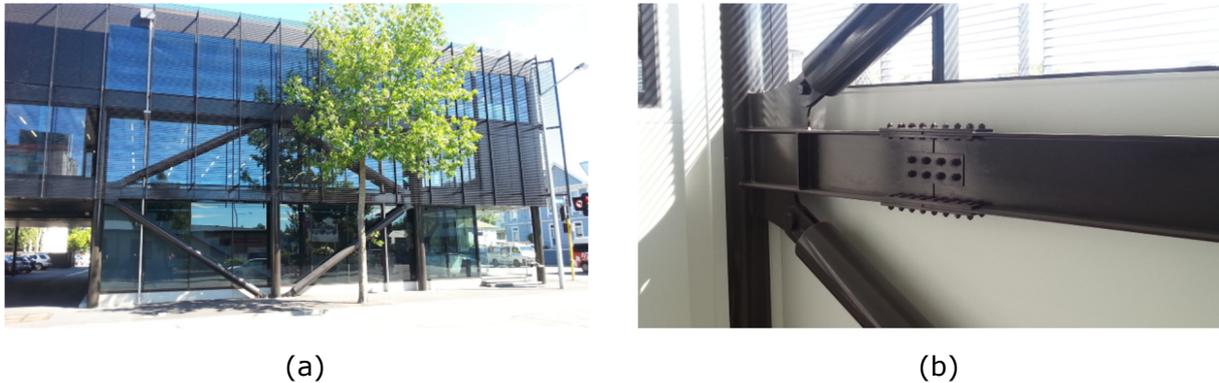
The three-storey building at 254 Montreal Street uses BRBs in multiple bays of the structure, with braces pin-connected at their ends to gussets made integral with an extended segment of the beam (Figure 3-20). Some of the frames, both inside and outside, have been painted dark bronze and used for architectural purposes.

Figure 3-20: BRB frame, 254 Montreal Road. (a) Global view, (b) Close-up view of gusset connection of BRB to beams and columns

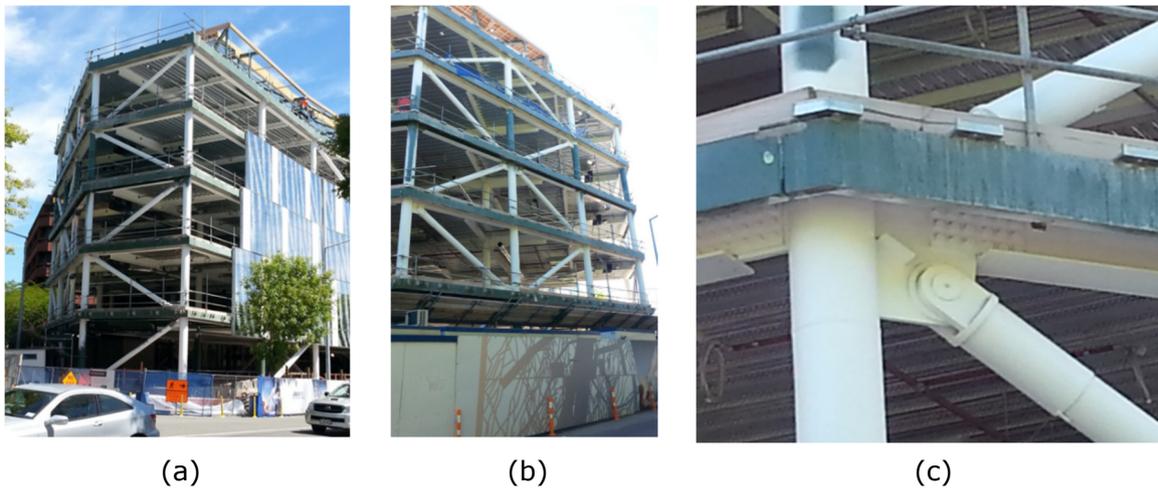
The five-storey PwC Centre building on Cambridge Terrace has an irregular floor plan. It uses BRBs in multiple bays on the periphery of the structure, with braces pin-connected at their ends. Columns are circular steel tubes (Figure 3-21).

Figure 3-21: BRB frame, PwC Centre. (a) Global view, (b) Alternative brace configuration on other façade, (c) Close-up view of gusset connection of BRB to beams and columns

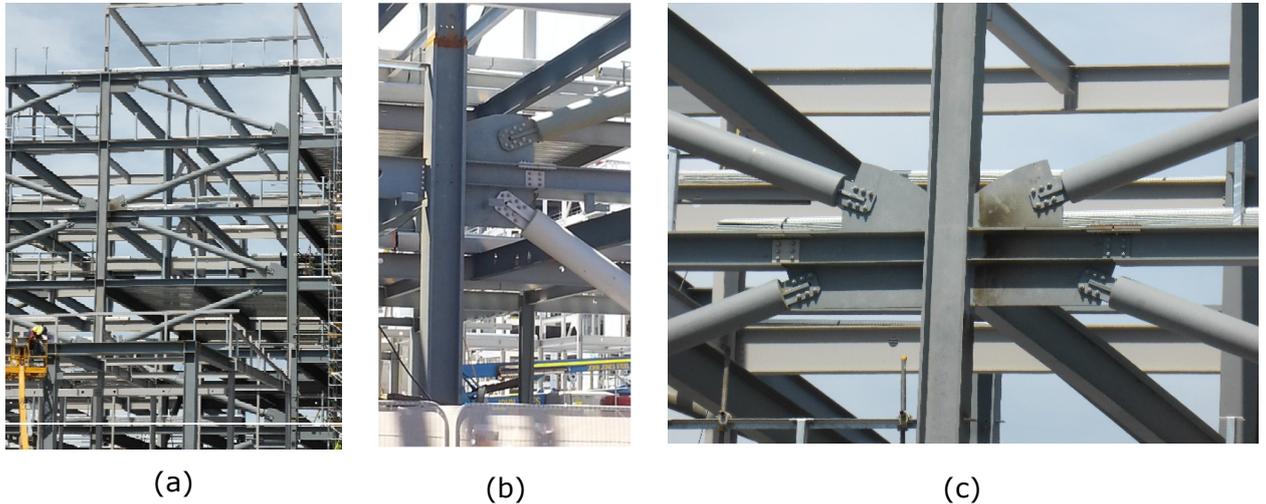
The building constructed on the northeast corner of Lichfield and Colombo Streets used BRBs in a super-X configuration (Figure 3-22). Each super-X spans two-storeys/bays. Plates at the ends of the braces are stiffened and bolted to large gussets. The beams are spliced at the edge of the gussets.

Figure 3-22: BRB frame, building on northeast corner of Lichfield and Colombo Streets. (a) Global view, (b) Connection to column at edge of braced frame, (c) Connection to column at mid-bay of braced frame

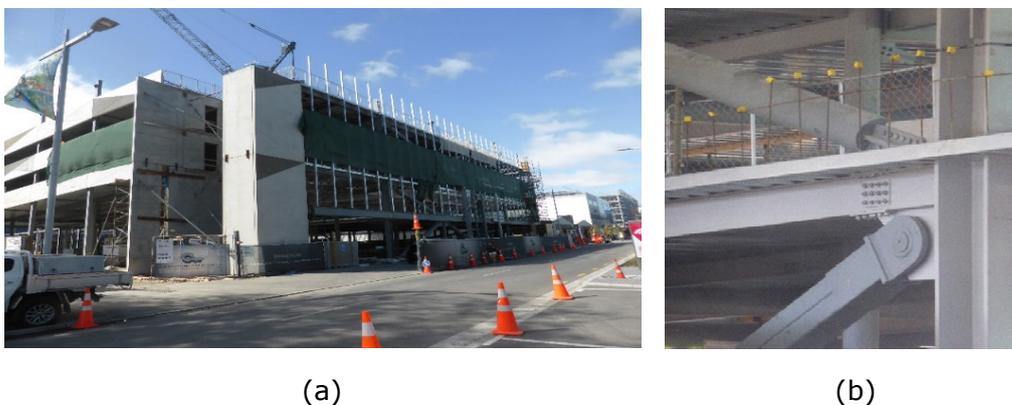
The carpark being constructed on Lichfield Street, across the street from the Justice Precinct, was an example of BRB construction mixing two different types of BRBs and BRB connections in the same building. Figure 3-23 shows pin-ended BRB connections used for the BRBs at the ground floor, and bolted BRB connections on the floor above.

Figure 3-23: Lichfield carpark building, with BRB frame. (a) Global view, (b) Close-up view of BRB connections to column

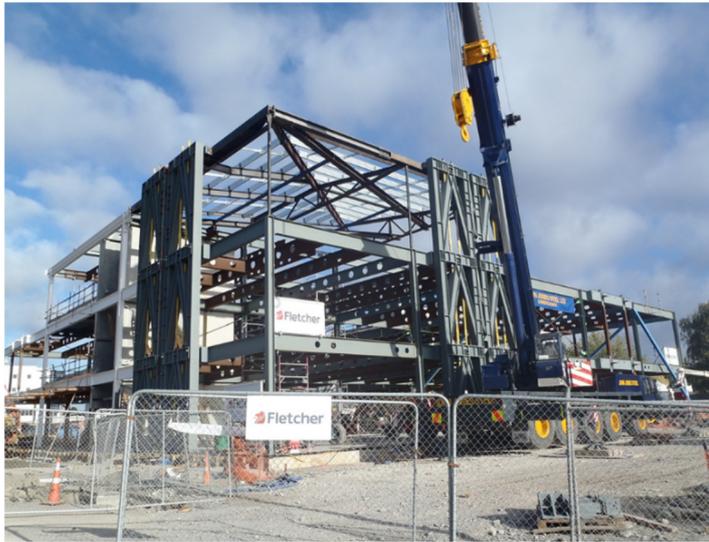
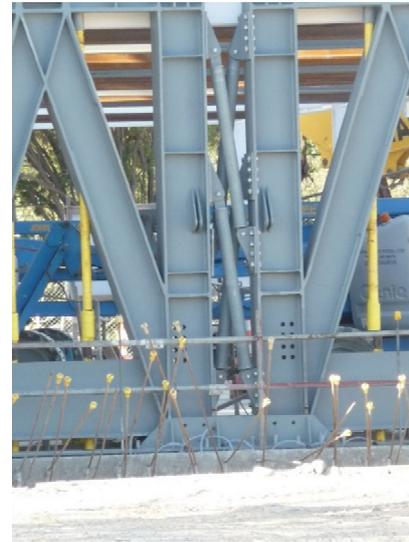
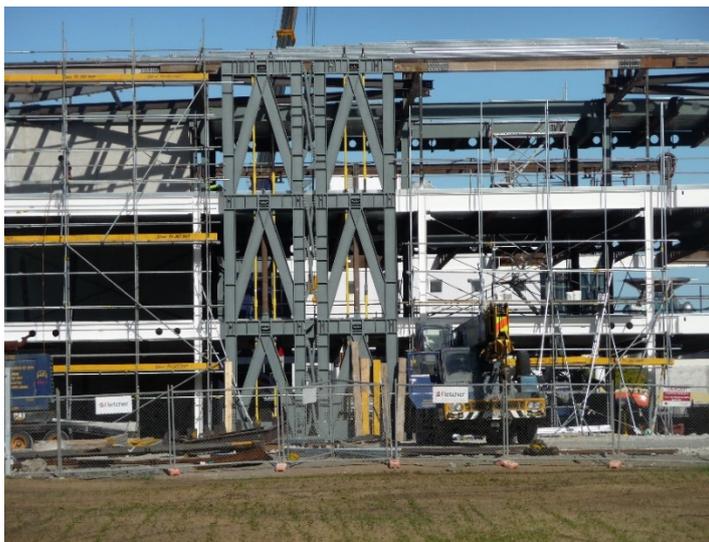
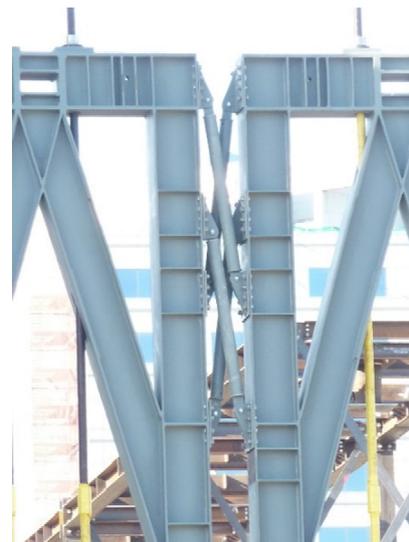
Figure 3-24: Rocking frame system implemented in Forte Health building. (a) Global building view, (b) Guides at base of rocking frame, (c) Coupled rocking frames, (d) Energy-dissipating couplers between rocking frames

The first new rocking steel frame building constructed in Christchurch after the earthquakes was the Forté Health building, 132 Peterborough Street, which integrated a few different systems for seismic energy dissipation, including friction dissipators (Figure 3-24). Pairs of rocking walls were coupled in a manner such that seismic energy is dissipated during relative movement between the walls by lead extrusion dissipators. The rocking frames are also held down by tendons extending over their height. Vertical deformations of the rocking frame are also decoupled from the slab of the building while allowing horizontal force transfer.

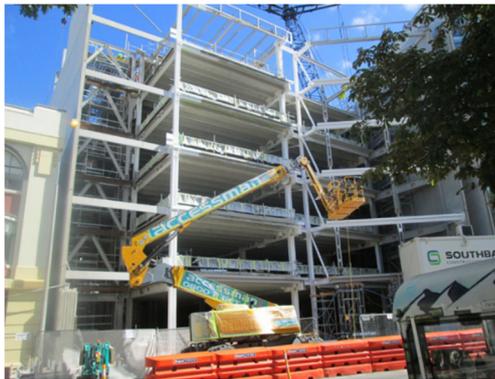
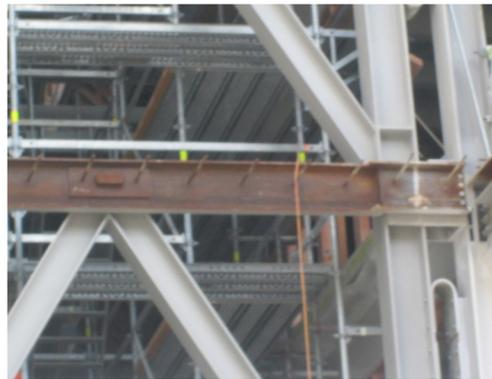
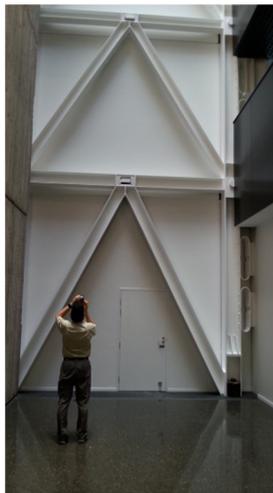
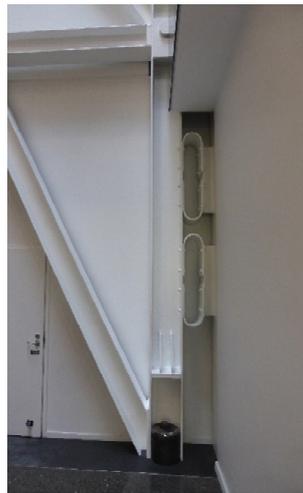
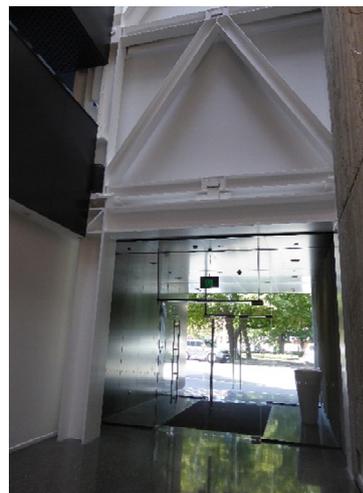
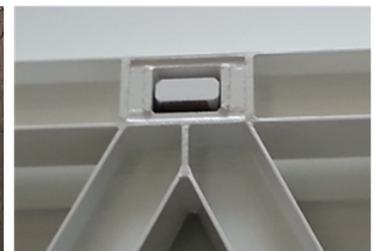
Figure 3-25: Rocking frame system implemented in 141 Cambridge Terrace building. (a) Global view, (b) Close-up view during construction, (c) Interior view after completion, (d) Detail at uplifting corner, (e) Portal on front side of building, (f) Sliding detail

The rocking frames used at 141 Cambridge Terrace (Figure 3-25) are tied down at their base using large springs designed to limit the onset of rocking. Flexural yielding U-shape energy dissipators are placed between the columns of the rocking frame and the adjacent gravity columns. On the side of the façade, to ensure access to the building (i.e., without braces), rocking is designed to take place above a portal frame. The rocking frames have been left exposed after the completion of construction and are visible in the entrance hall of the building.

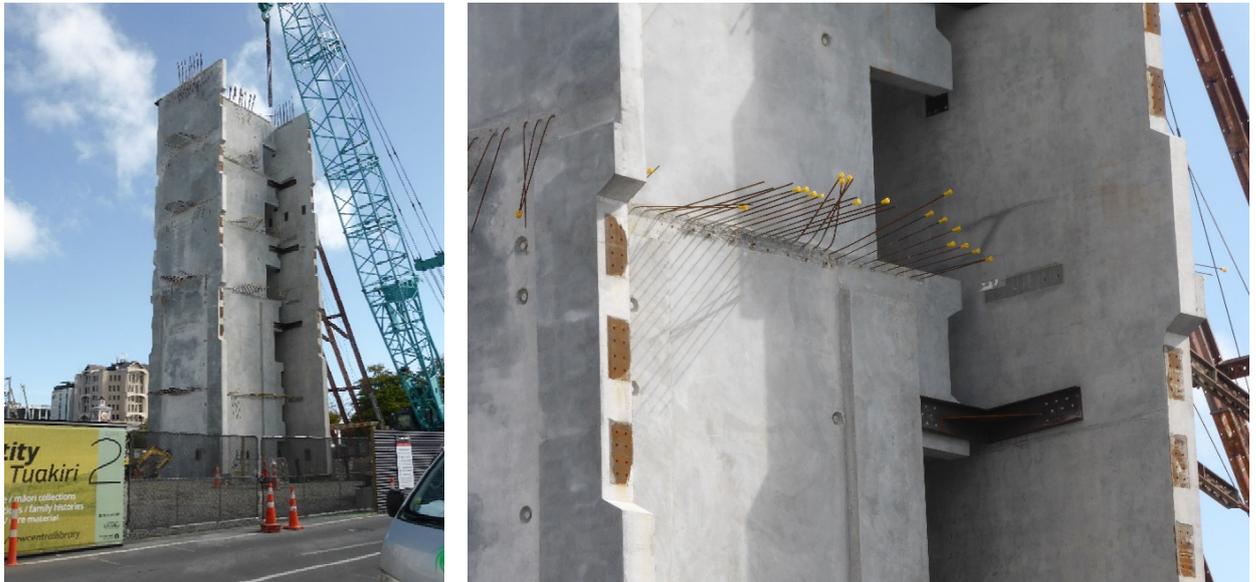
Christchurch's new Central Library, being built on the corner of Gloucester Street and Cathedral Square, is heavily promoted on-site and online (<https://my.christchurchcitylibraries.com/central-library>). This information shows that its tall rocking precast concrete core walls will be surrounded by a steel frame (Figure 3-26).

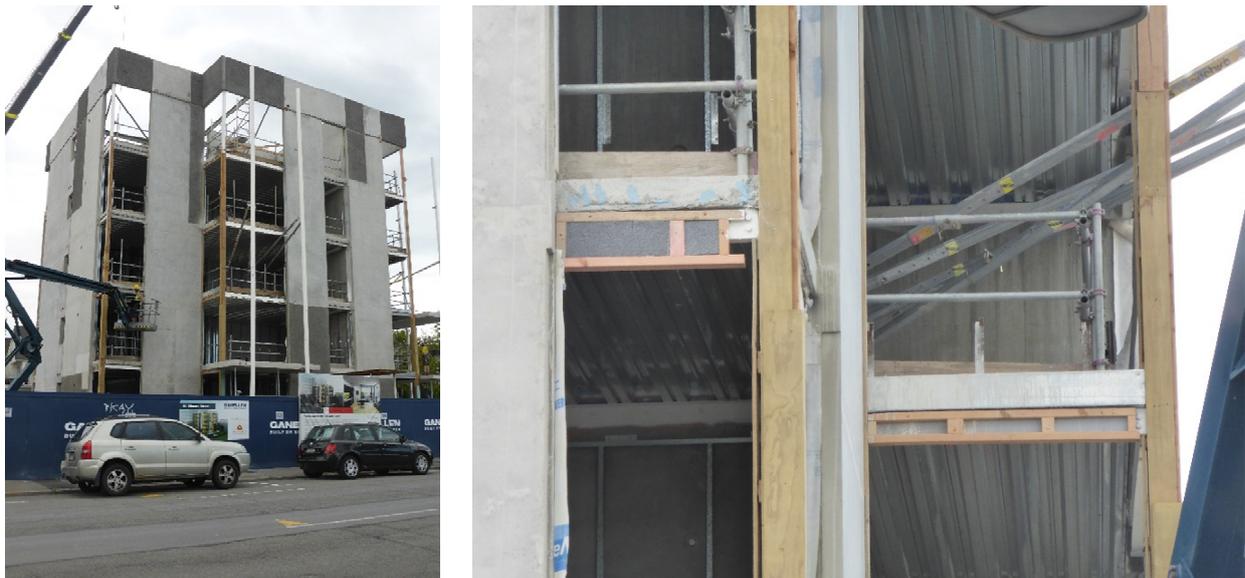
Figure 3-27: Precast concrete walls, 50 Kilmore Street. (a) Global view, (b) Close-up view of floor system

The five-storey apartment building being constructed at 50 Kilmore Street (Figure 3-27) consists of a steel floor frame with large precast concrete panels that serve as shear walls (supplemented by a few steel columns). A sign on the construction site advertised this building to be the first of a multi-building project; the architectural rendering on that sign depicted an adjacent similar-looking 11-storey building to be built later.

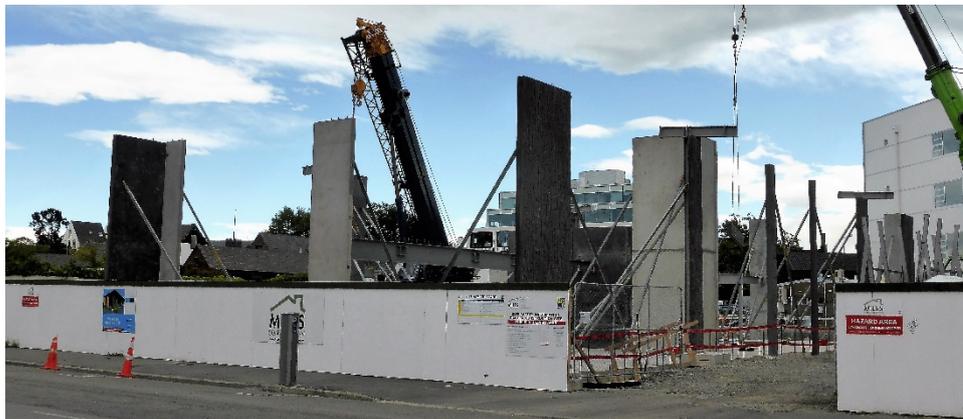
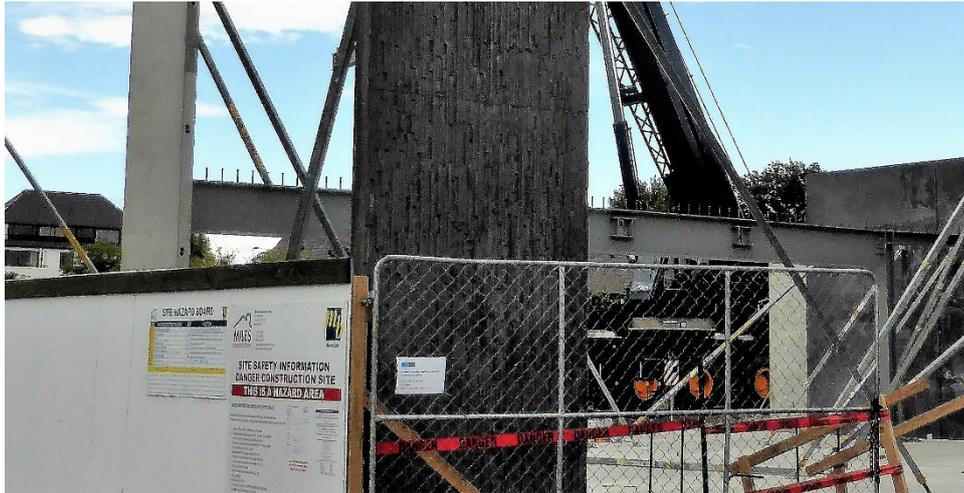
The two-storey office building constructed at 57 Kilmore Street for the Canterbury Employers' Chamber of Commerce (Figure 3-28) consists of a steel floor frame with large precast concrete panels that serve as shear walls.

Figure 3-28: Precast concrete walls and steel floor system, 57 Kilmore Street. (a) Global view, (b) Close-up of steel beam
