RECONSTRUCTING CHRISTCHURCH: A Seismic Shift in Building Structural Systems

Reconstructing Christchurch: A Seismic Shift in Building Structural Systems

Michel Bruneau

Greg MacRae

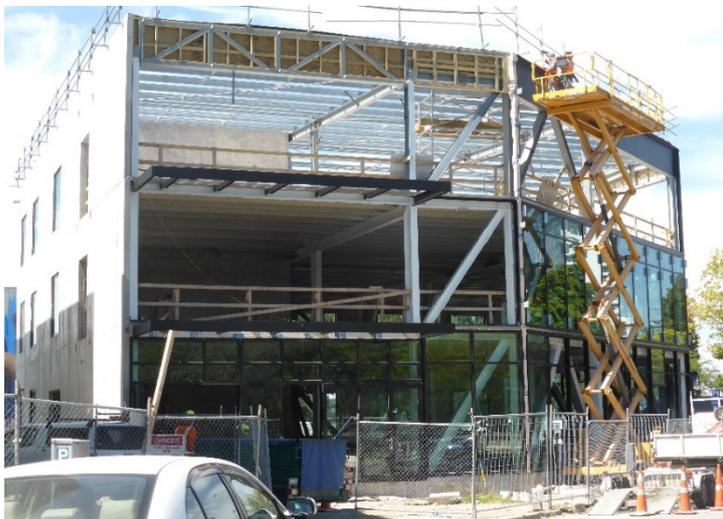
The three-storey building constructed on the corner of Colombo and Cambridge Streets shows precast panels along the alley-side of the building and CBFs along its main glass façades (Figure 3-29).

Figure 3-29: Combination of concrete walls and braced frames, building on the corner of Colombo and Cambridge Streets. (a) Global view, (b) Close-up view of CBFs

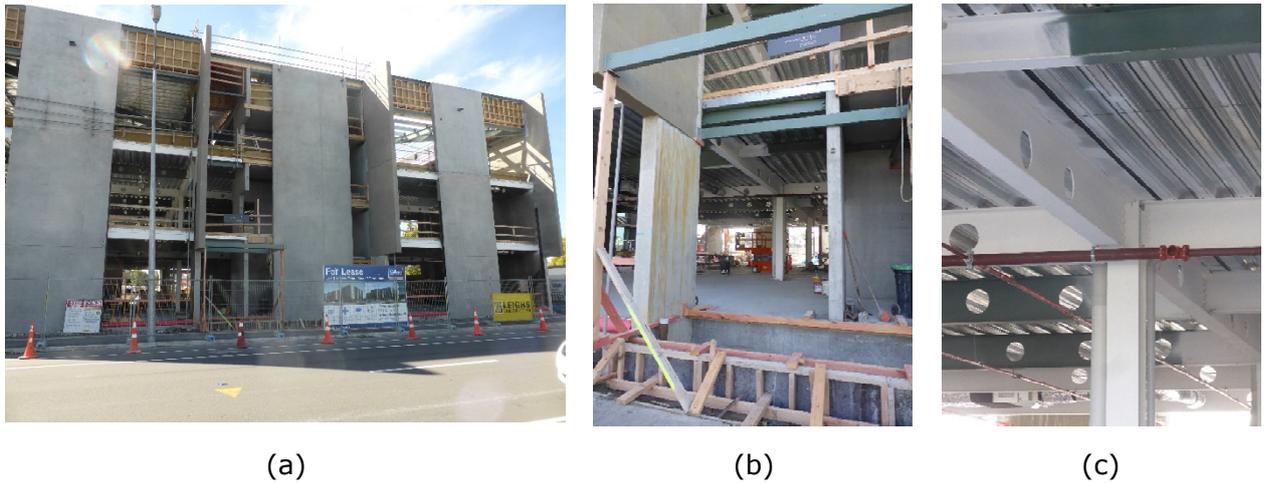
The three-storey building on the corner of Kilmore and Peterborough Streets (Figure 3-30) has precast walls in both principal directions to resist lateral loads, and a complete gravity steel framing system (beams, columns, and steel decking). Documentation on-site and online indicate that this building is intended to offer a mix of medical/dentistry and office space.

Figure 3-30: Precast concrete walls and gravity steel structure in the Forté Health building. (a) Global view, (b) Closer view of walls and gravity system, (c) Close-up of steel beams, columns, and decking

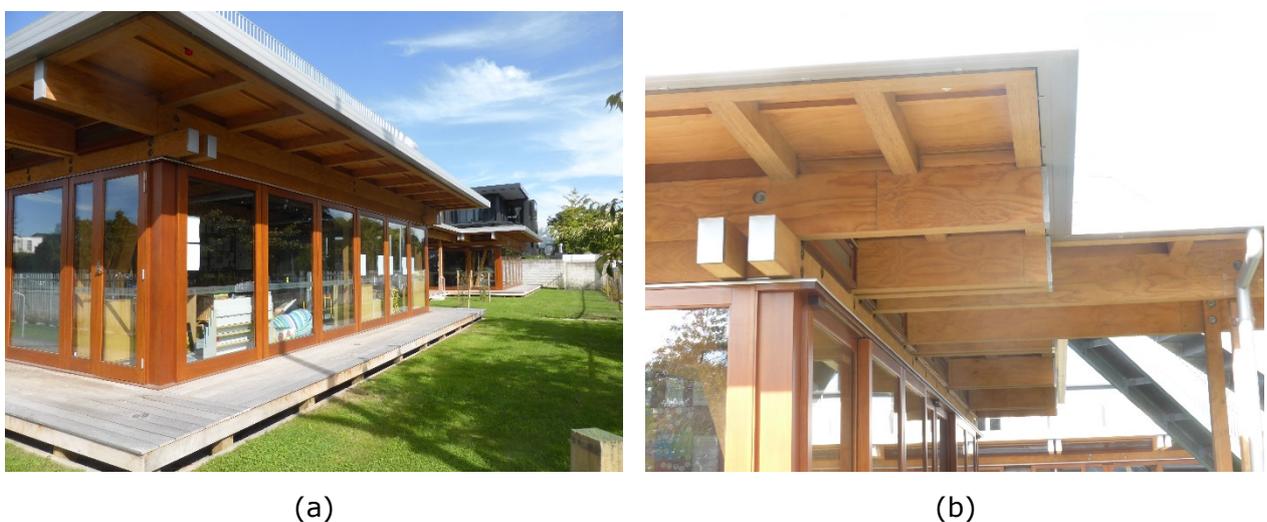
The authors did not notice any multistorey buildings having timber structural systems under construction in the Christchurch CBD during their visits. However, some completed projects have exposed timber structures, such as the Cathedral Grammar School buildings on Kilmore Street, shown in Figure 3-31.

Figure 3-31: Low-rise, open floor-plan timber structure used for the Cathedral Grammar School buildings. (a) Global view, (b) Close-up view of structural detail of timber beam and columns

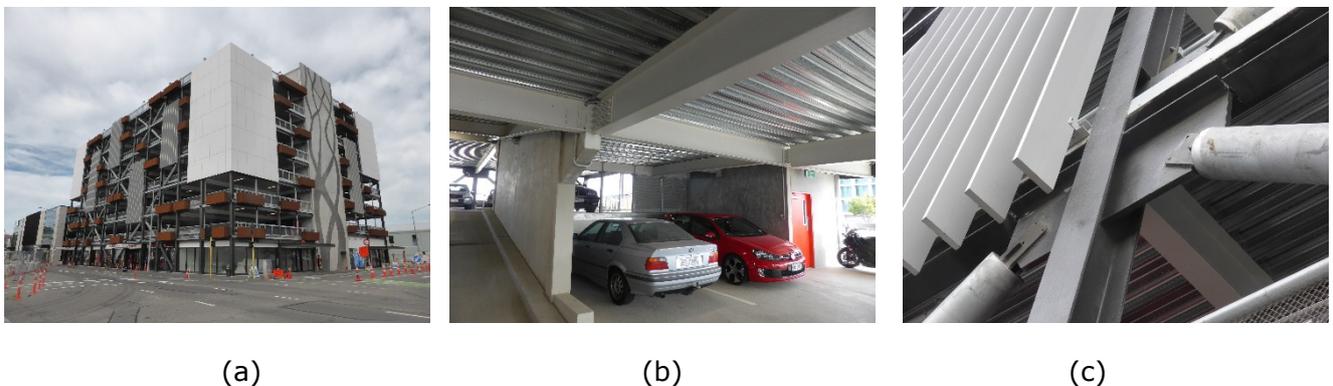
BRBs were used in the north–south direction of the parking garage located on the southwest corner of Lichfield and Madras Streets (Figure 3-32). Core walls (around the staircases) as well as planar ones (along the parking ramps) are visible in the east–west framing direction.

Figure 3-32: Building at 160 Lichfield Street with BRBs in one direction and structural walls in the other. (a) Global view, (b) Wall view, (c) BRB connections

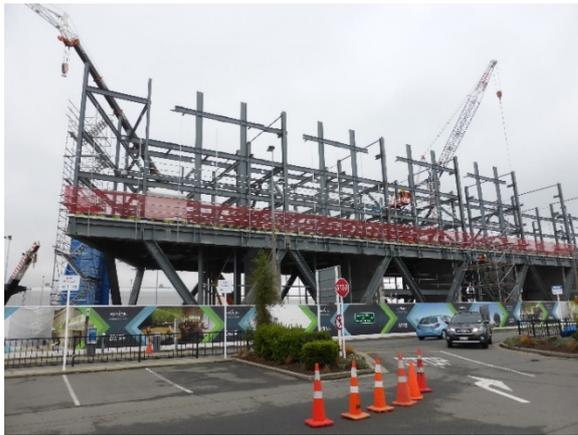
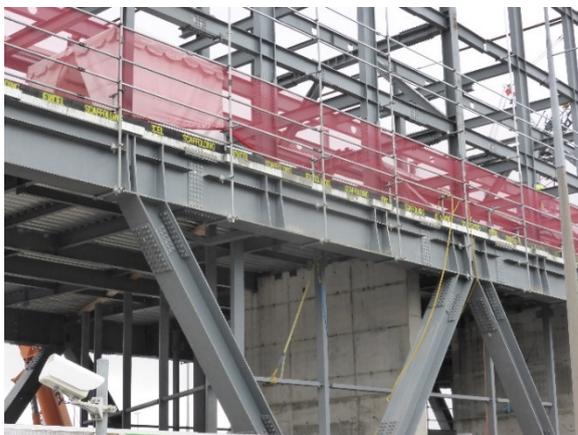
Not located in the CBD, but rather a stone’s throw from the Christchurch International Airport terminal, the hybrid structure shown in Figure 3-33 has concrete walls in the transverse direction and open braces in the longitudinal direction at ground level. At the other levels, EBFs are used in the transverse direction, and MRFs in the longitudinal direction.

Figure 3-33: Hybrid structure, Airport Hotel. (a) Global view, (b) View of concentric diagonals at ground level in longitudinal direction, (c) View of EBF in transverse direction and MRF in longitudinal direction about ground level

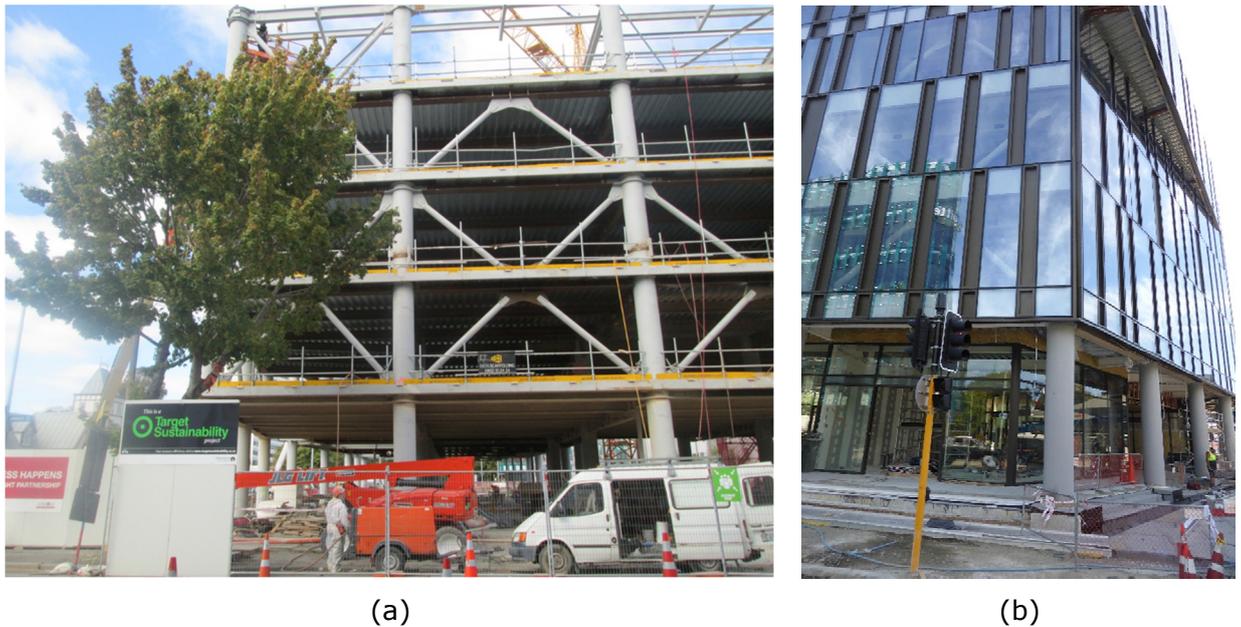
Interestingly, the base-isolated building located on the southwest corner of Durham Street North and Armagh Street (known as the Awly Building) could be considered a hybrid building, relying on MRFs at ground level and CBFs in the other floors above. Figure 3-34 shows the steel moment frames and braced frames. Figure 3-34b shows the same, somewhat hidden behind cladding, as well as the trench to accommodate base-isolation movements at the sidewalk level of the building.

Figure 3-34: Hybrid structure example during construction, Awly Building. (a) In March 2016, (b) In March 2017

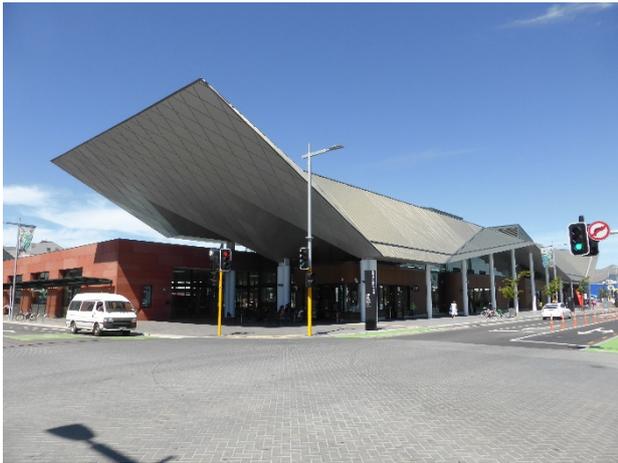
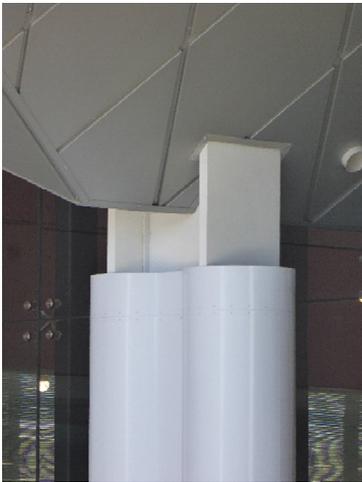
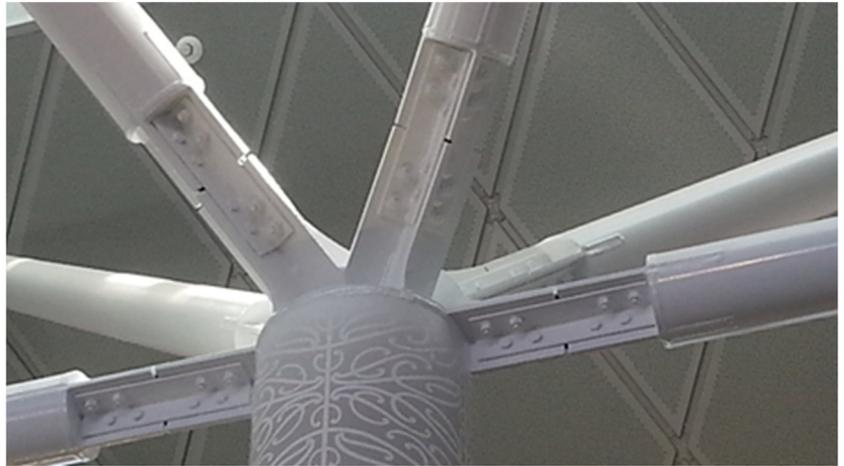
The new Christchurch bus terminal building consists of a freeform space-truss supported on either steel pipe columns or encased wide-flange columns. Select nodes of the space truss are rigidly welded to the top of the columns, as shown in Figure 3-35. Note that, as interesting as this structure might be, this is also a good example of a building that falls outside of the scope of this study, because single-storey buildings were not included in the data collected (as described in Section 4).

Figure 3-35: Christchurch new bus terminal. (a) Global exterior view, (b) Global interior view, (c) Encased steel column, (d) Connection detail at steel pipe column

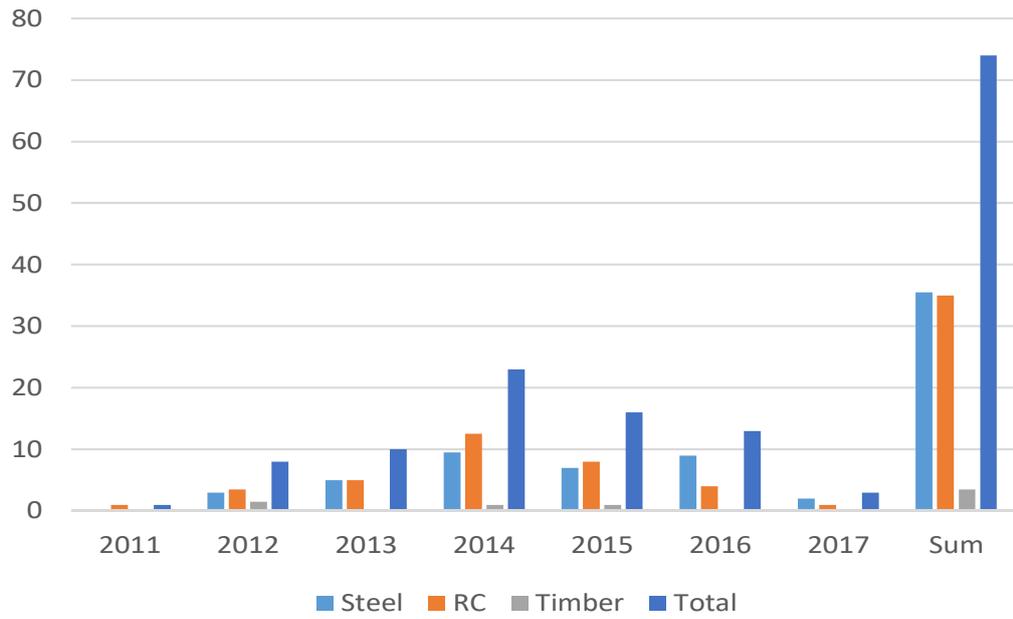
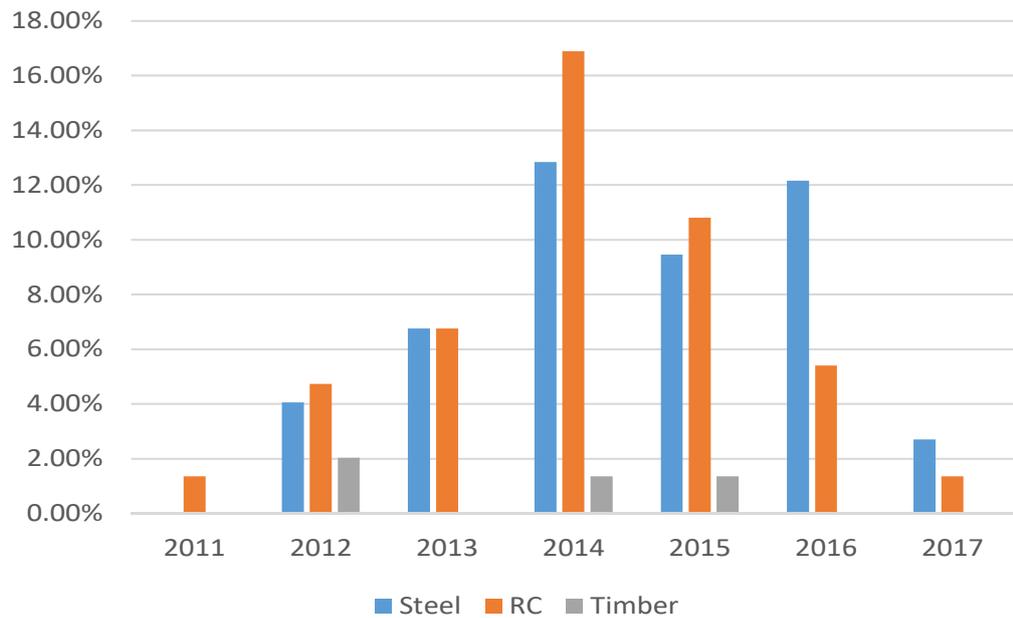
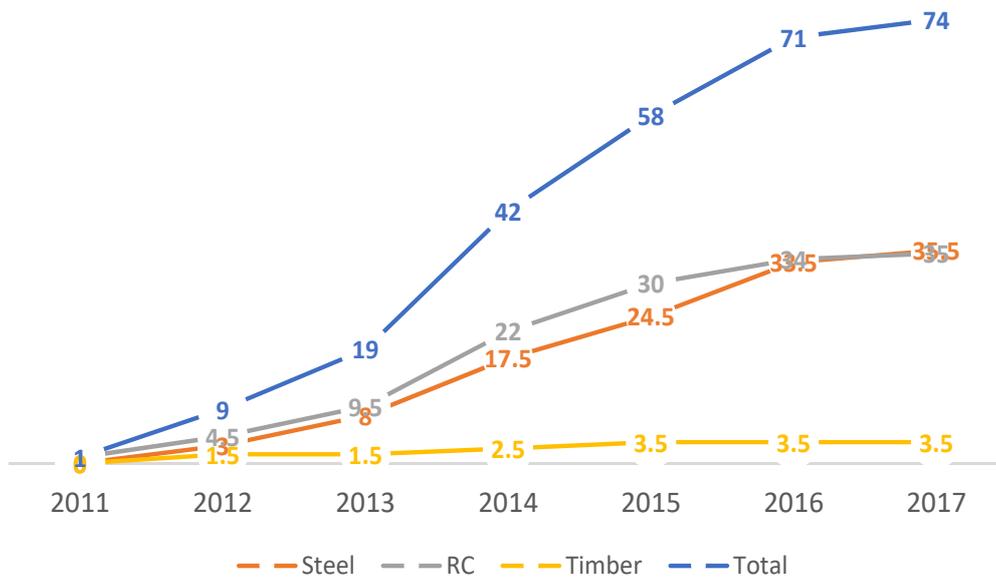
Figure 5-1: Number of new buildings having lateral-load-resisting systems of each material type. (a) Absolute numbers, (b) Percentages, (c) Cumulative numbers

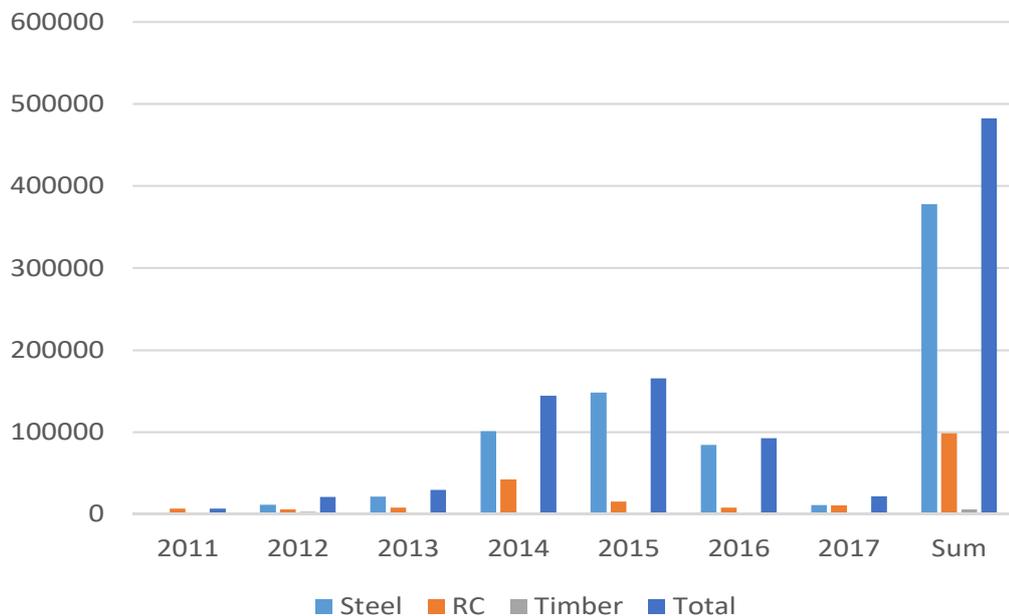
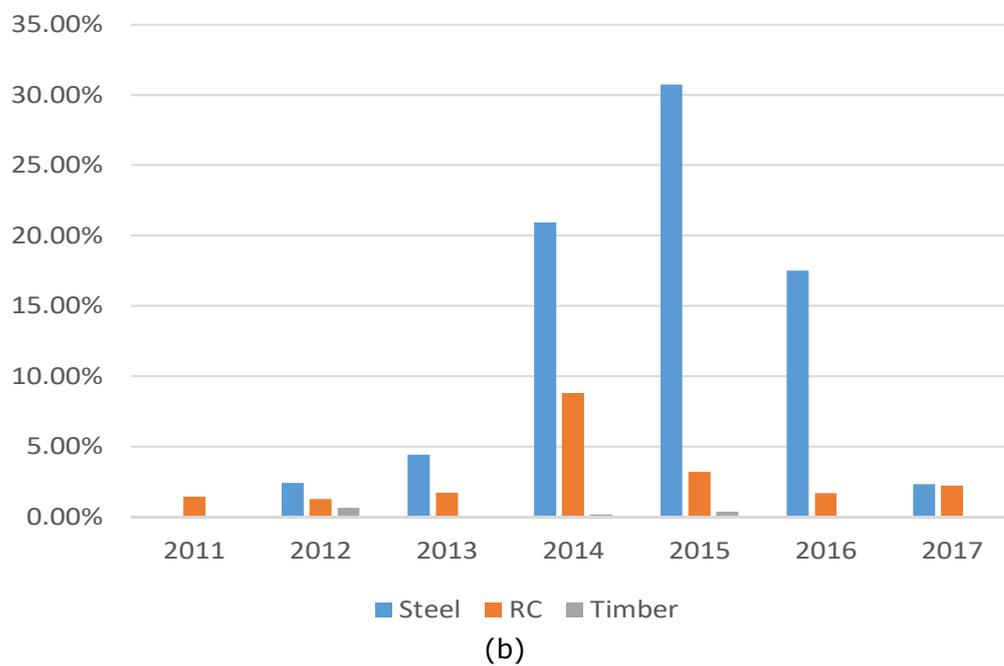
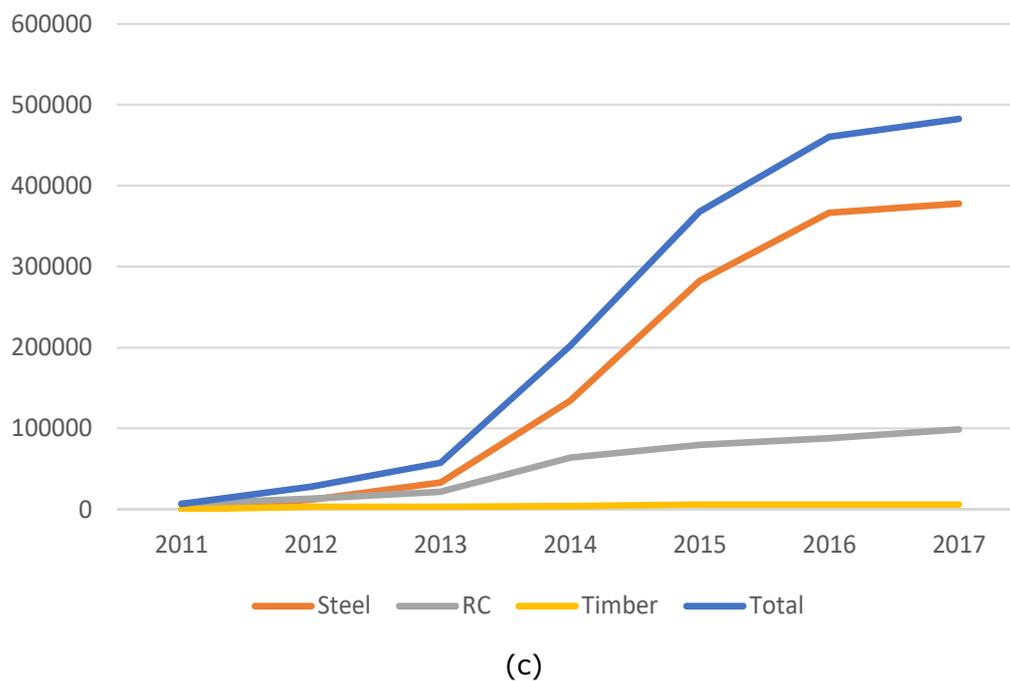
Figure 5-2c shows that, in terms of floor area, the rate at which RC was built peaked in 2014 and decreased by more than half afterward (from floor areas of 42,500m² in 2014 to 15,500m² in 2015). For steel, rates peaked in 2015, with a decrease in the subsequent year (from floor areas of 148,000m² in 2015, to 84,500m² in 2016).

Figure 5-2: Floor area of new buildings having lateral-load-resisting systems of each material type. (a) Absolute numbers, (b) Percentages, (c) Cumulative numbers

Figure 5-2 (continued): Floor area of new buildings having lateral-load-resisting systems of each material type. (a) Absolute numbers, (b) Percentages, (c) Cumulative numbers

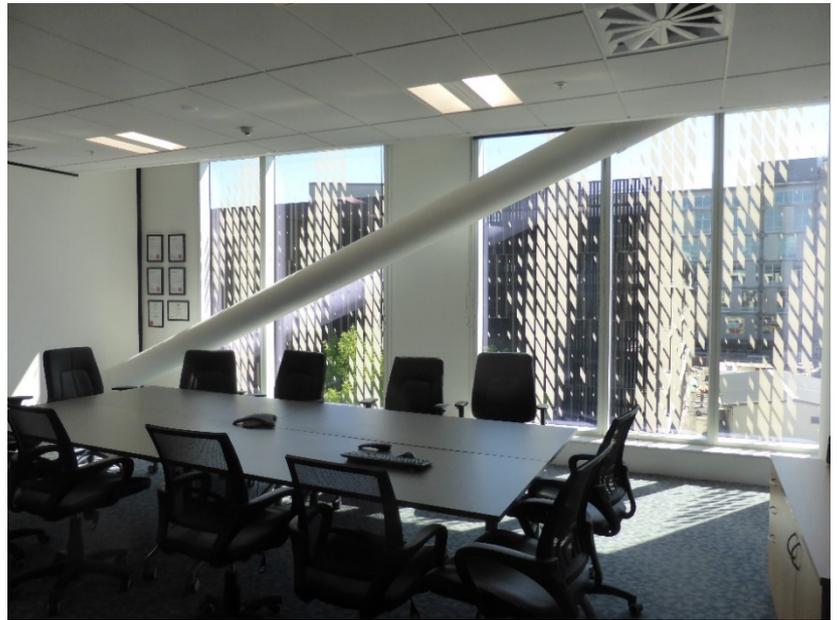
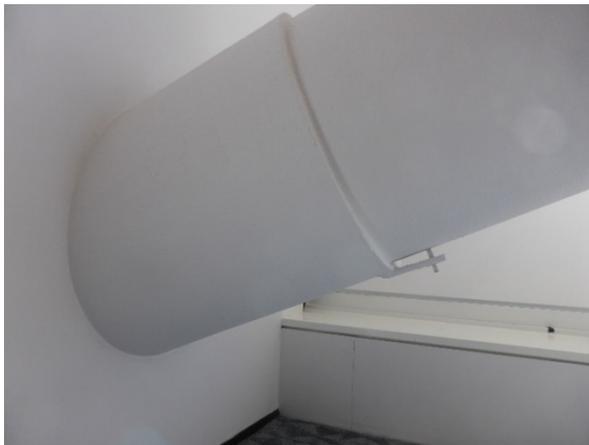
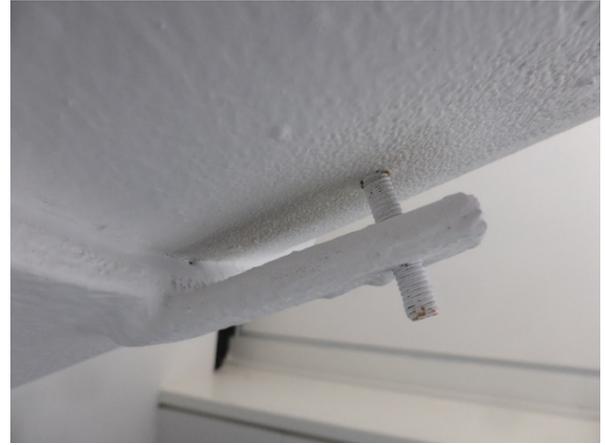
Figure 6-2: BRBs prominently featured in an engineering firm's office. (a) Inside working space (painted black), (b) Along the façade (painted white), (c) Close-up view of BRB end detail, (d) "Scratch" marker to indicate on BRB surface the maximum BRB elongation developed during the earthquake

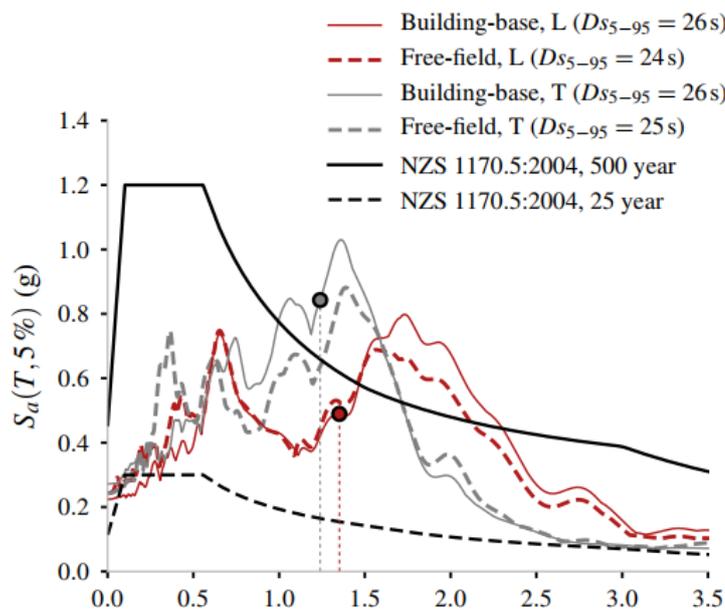
Figure 7-1: Spectral acceleration from 14 November 2016 earthquake, on a soft-soil site in Wellington (Courtesy of Dr. R. Chandramohan, University of Canterbury)

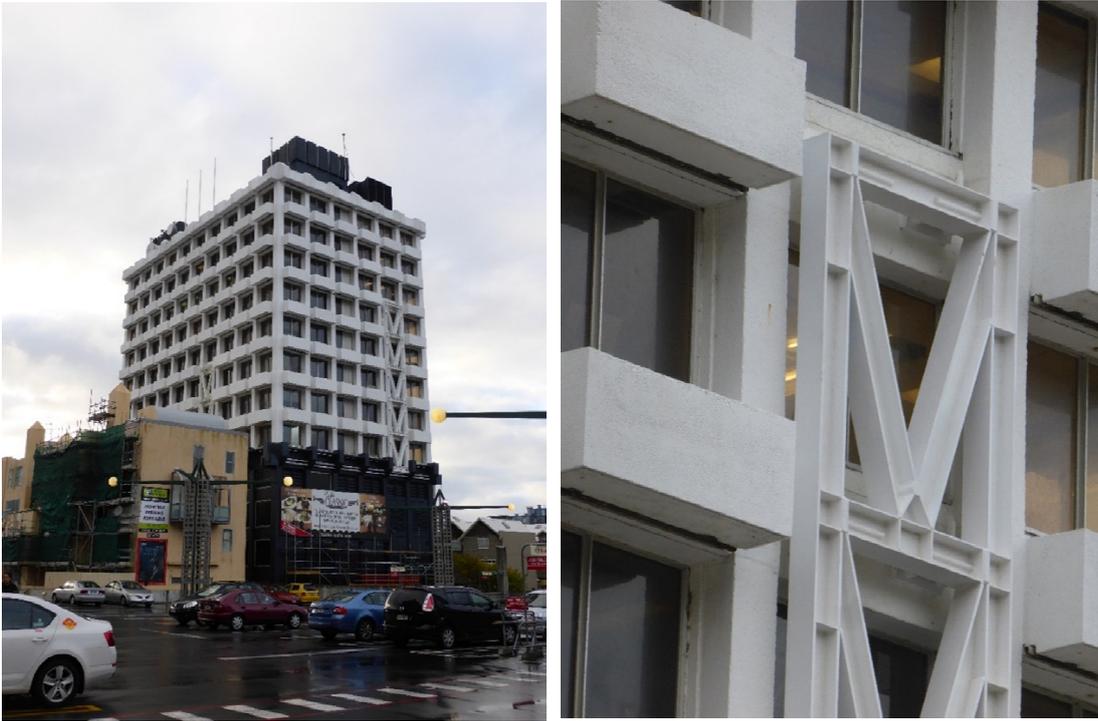
Figure 7-2: Example of Wellington building retrofitted with braced frames

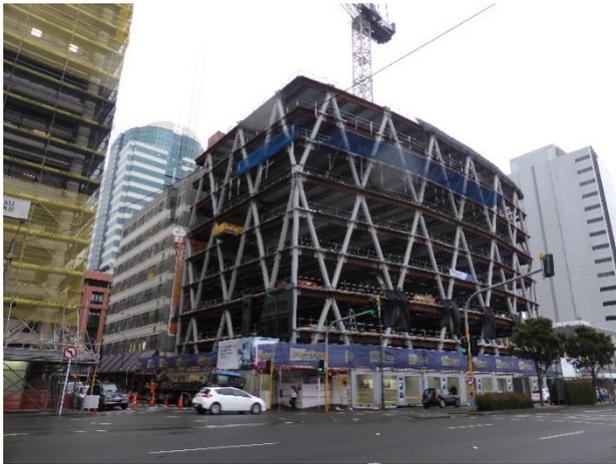
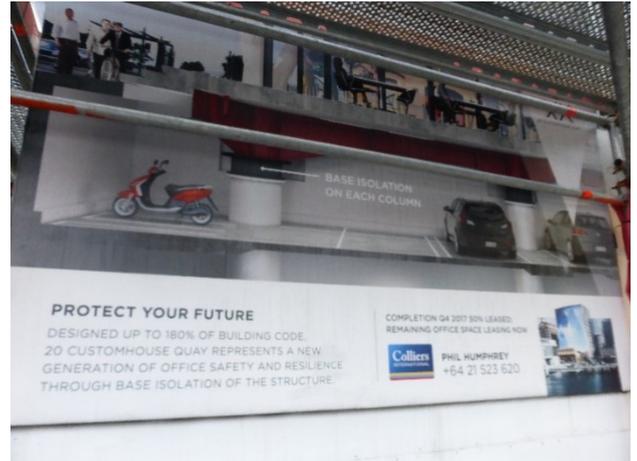
Figure 7-3: Wellington base-isolated building with exoskeleton CBF. (a) Global view, (b) Promotional information, emphasising high seismic-design level, (c) Base isolators and gap at ground level, (d) Close-up view of brace connections and floor system

- In spite of the construction trend in Christchurch, architects in Wellington “still do not like braces”. In Wellington, braces have been used extensively in building retrofits (as shown for example in Figure 7-2), and architects there do not find braces particularly interesting or “fashionable” compared to architects in Christchurch. Yet, this does not mean that braces are not used. One of the largest construction projects on the waterfront at the time of the interviews (evidently designed prior to the Kaikoura earthquakes) consisted of a large base-isolated structure having a steel exoskeleton prominently displayed, as shown in Figure 7-3. (Also note the posted advertisements promoting the seismic features of the building).

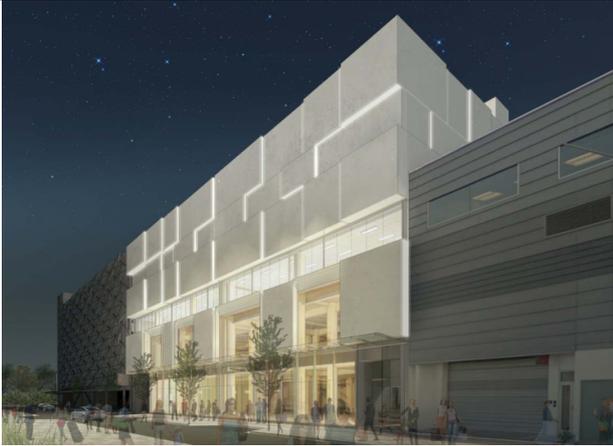
Lateral load resisting system consists of two way steel moment resisting frames with boundary concrete shear walls in one direction. The frames comprise of concrete filled steel CHS columns, and welded beams with reduced flange widths at hinge zones. The gravity load resisting structure consists of comflor steel deck flooring, steel secondary beams, a suspended concrete flat slab ground floor structure with RC beams and RC basement structure on a shallow raft above intermediate piles.

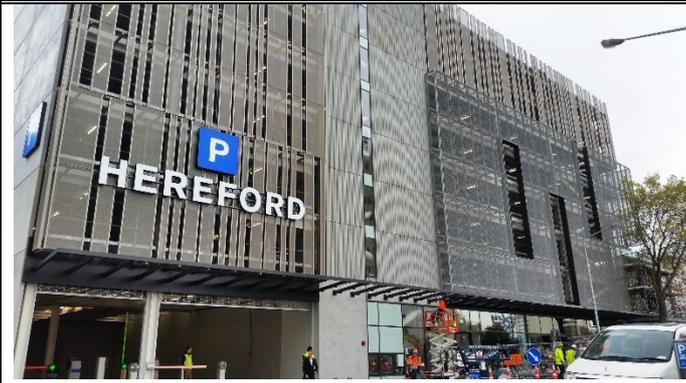
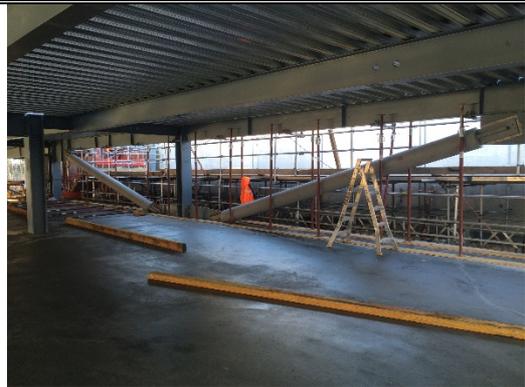
The lateral load resisting system for the eight-storey structure consists of Buckling Restrained Braces (BRB's), located with two opposing braces on each side of building on each level (64 braces in total). The gravity load resisting structure consists of unpropped steel deck flooring, unpropped secondary steel beams and propped primary beams. The foundations are shallow RC foundations above a hardfill raft above piles, with the raft and piles designed to suit multiple existing conditions on site (remnant piles and basement from previous demolished buildings).

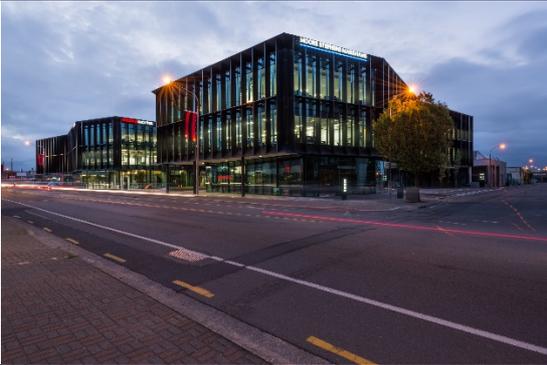
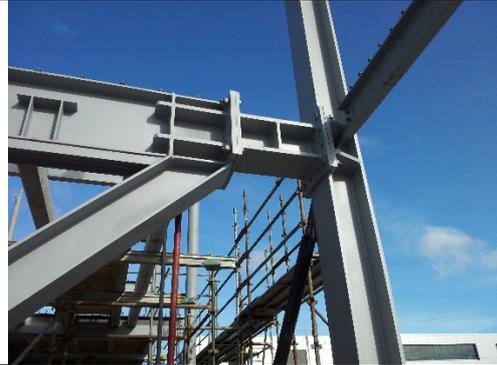
Lateral load resisting system consists of steel Eccentric Braced Frames (EBF's) utilizing bolted shear links. Gravity load resisting system consists of steel beams supporting steel purlins at the roof, steel composite beams supporting suspended rib and infill flooring at suspended floors, and a suspended concrete ground floor slab supported on concrete pilecaps, supported by steel screw-piles. First known use of replaceable-link EBF's in NZ.

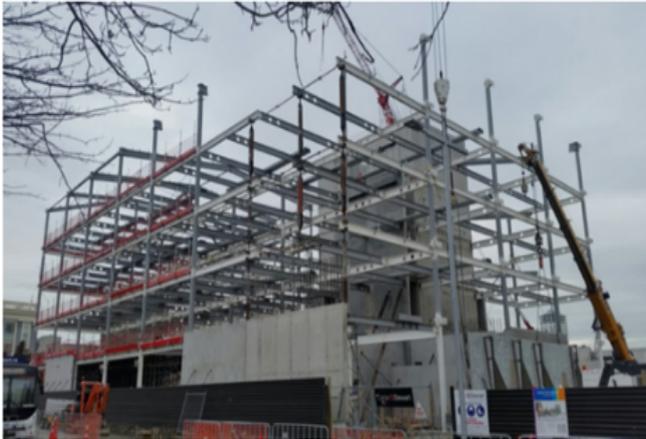
The gravity system is comprised of steel purlins on portal frames at roof level, precast concrete panels, metal deck tray flooring system (rib and infill at level 1), steel supporting beams and concrete filled CHS columns. The gravity loads of the floor structure will be supported by a steel-concrete composite superstructure. The vertical CHS columns are filled with concrete to minimise the application of intumescent paint for fire requirements. The lateral system of the building is made up of concrete shear walls in the core and around the perimeter of the building. Due to the open atrium a seismic gap has been installed in the level 1 floor which required an internal EBF frame from ground to first floor.

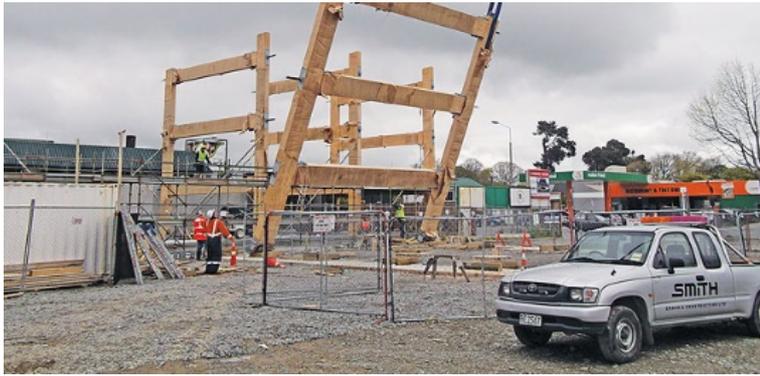
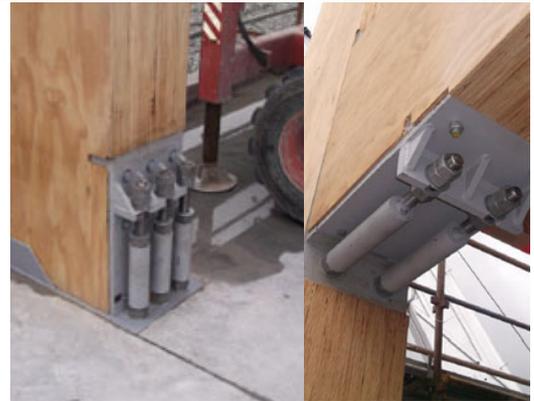
The gravity system consists of timber HyJOIST purlins to the roof spanning onto infill timber walls (at roof level) resting on the LVL post-tensioned moment frames. Precast concrete walls provide the gravity system in the orthogonal direction to the LVL portal frames. The gravity system to all floors comprises of a TCC (timber composite concrete) flooring system with LVL joists, plywood, and concrete slab spanning onto the LVL frames at each level.

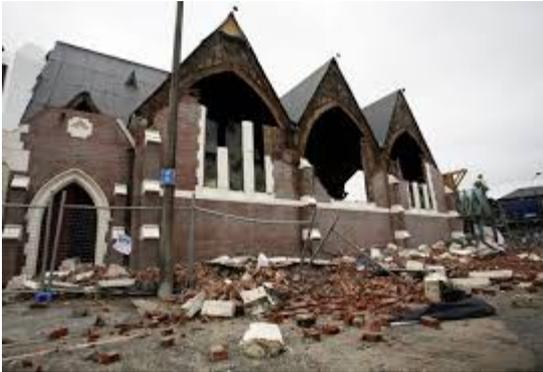
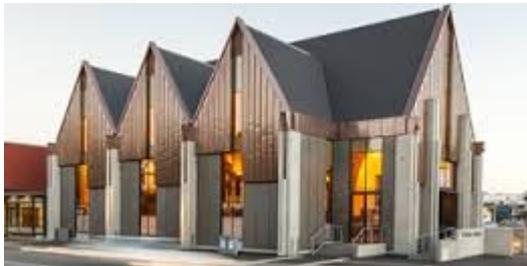
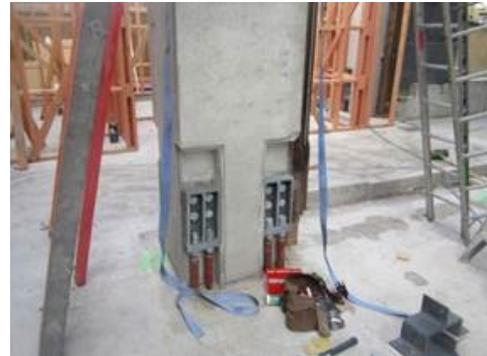
The rebuild of Knox Church used post tensioned rocking buttresses using plug and play replaceable energy dissipaters at the base of the column piers. The existing roof had a new ply diaphragm overlay and a structural steel ring frame was installed at the eave height to distribute seismic load to all buttresses.

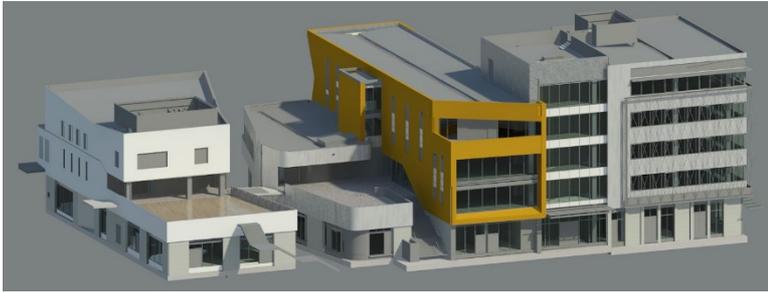
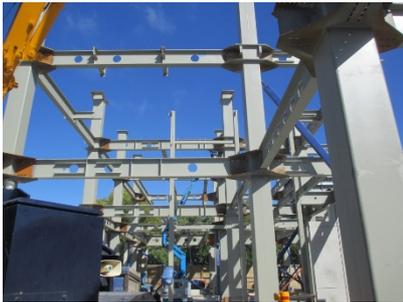
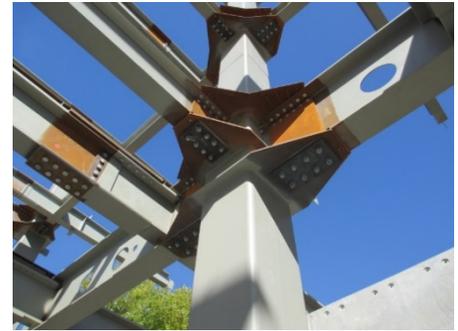
Two way moment frame using sliding hinge joints in each direction. Columns are 600mm square full height with plate thickness varying between 20mm, 16mm and 12mm. Secondary beams span to the moment frame with comflor 60 tray flooring over. All buildings are founded on reinforced concrete raft foundations.

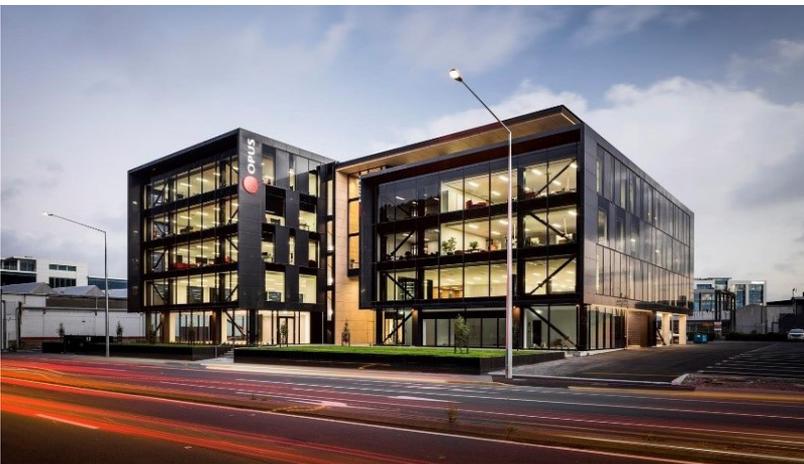
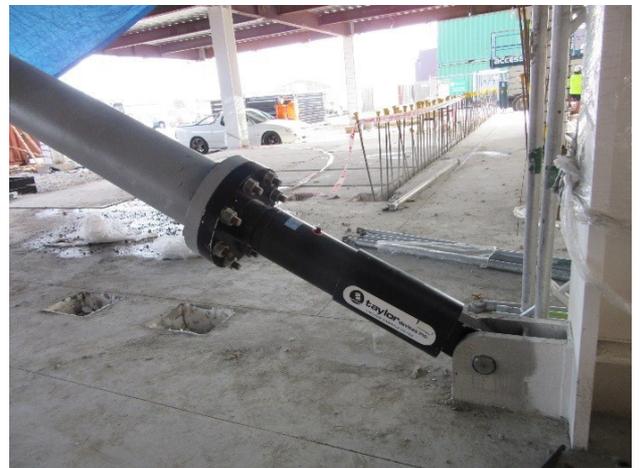
The lateral system design has been based on performance based design principles and utilises a low-damage design philosophy throughout to achieve the stipulated seismic performance criteria. To achieve these criteria, fluid viscous dampers were used in combination with a steel moment frame in both directions to reduce the peak response of the frame and the storey shears forces that would have been required for a conventional moment frame or braced frame design. This reduction in response and significant damping of base shear demand enabled substantial cost savings in the foundation and superstructure to be realised. As a result, the foundations were governed by gravity loads.

The use of fluid viscous dampers in combination with steel moment frames provide substantial benefits in terms of building performance. Whilst this technology has seen little application in New Zealand it has wide acceptance as part of a seismic system in the US, Asia and parts of Europe. With a move to greater focus on building performance and low damage design in New Zealand, the use of FVD's offers a solution that is cost effective and merits greater consideration by designers, both in new builds and seismic retrofit projects.

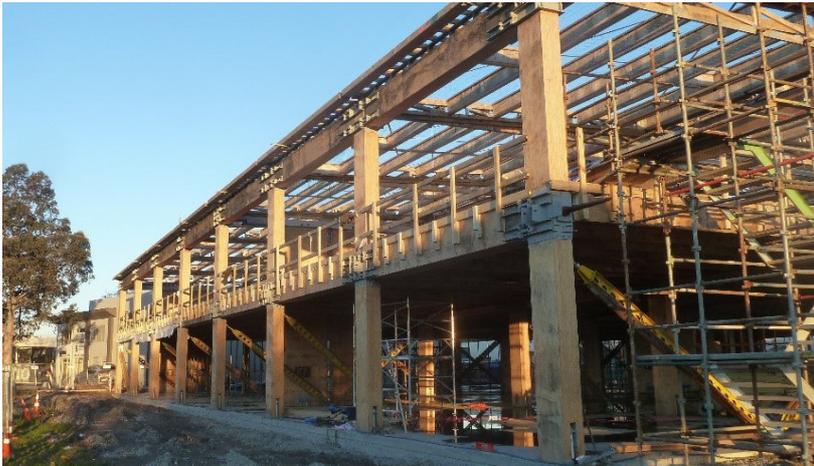
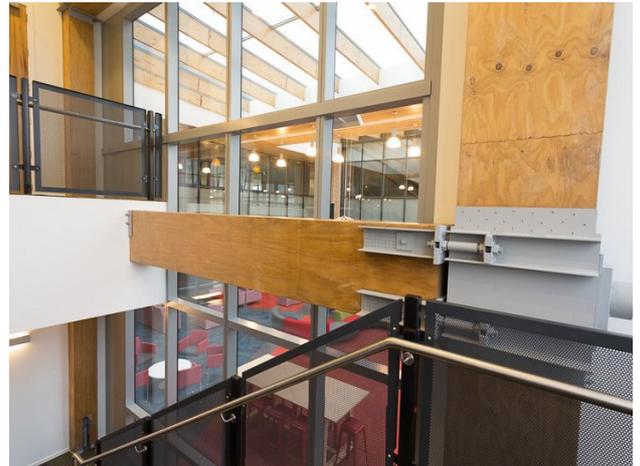
The lateral system is Pres-Lam utilising the post tensioned frames in one direction and including yielding mild steel dissipators mounted externally. In the other direction, the steel roof bracing, and concrete diaphragm transfer loads to the nine pre-fabricated, coupled Pres-Lam shear walls via steel collector beams and a pin connection, which transfers load through a steel plate screwed to the wall. Post tensioning is provided by three 50mm diameter Macalloy bars, which are connected to CFA piles for transferring high tension loads under seismic actions. U-shaped flexural plates provide the energy dissipation for the walls.

Using a displacement based design approach, and utilising emerging technology based on research at the Universities of Canterbury and Auckland, this damage limiting Pres-Lam design minimises damage in seismic events through the dissipation of energy and controlled rocking of the structure. Effective damping in excess of 10% was achieved with these externally mounted dissipators, which can yield reliably in multiple events, but can also be easily replaced to mitigate any repair costs after a significant earthquake. The timber is high grade laminated veneer lumber (LVL) fabricated in New Zealand from sustainable, locally grown timber. In the shear walls, this LVL is cross-banded to provide additional capacity.

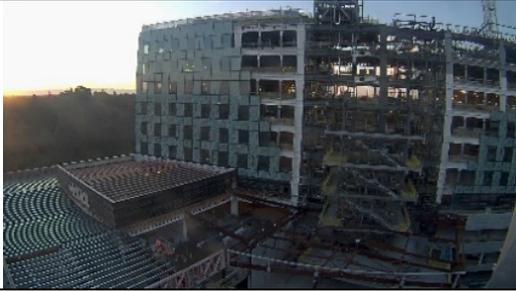
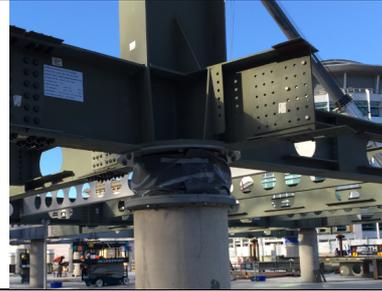
Description of Structural System: The Acute Services Building's structure comprises a 10 storey capacity designed steel moment frame—base isolated over a thick reinforced concrete raft foundation. Gravity frames use welded columns and simple un-propped composite construction on a relatively wide grid. Cellular secondary beams are used, and slabs are composite steel decked. The isolation system uses a mix of lead rubber bearings and flat sliders. Isolators are located directly below the first suspended level, supported on circular concrete columns. The 1.4m thick structural raft sits on a natural gravel raft 5-10m thick, overlying sands and silts, at a depth of 20m.
