Out-of-Plane Behavior of Foundation Inserts of Precast Panels: Alternative Connections

Hogan¹, L.S., Henry, R.S.¹, and Ingham, J. M.¹

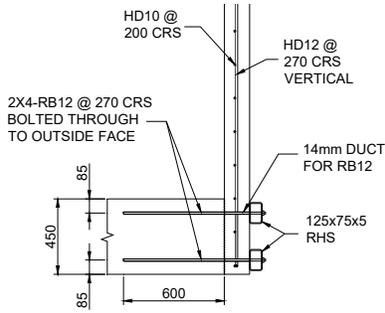
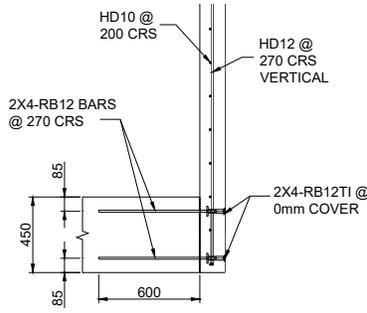
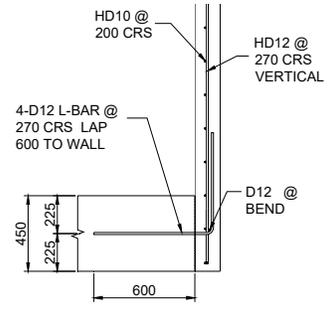
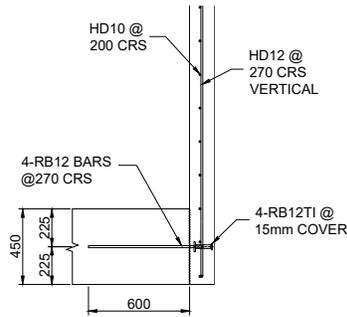
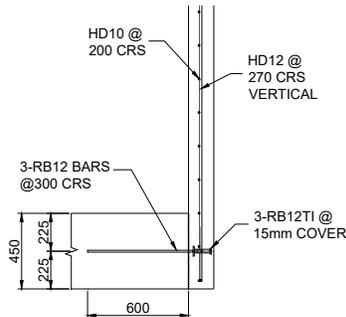
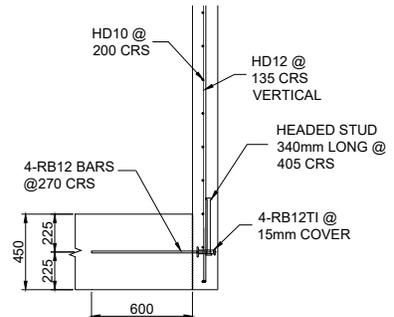
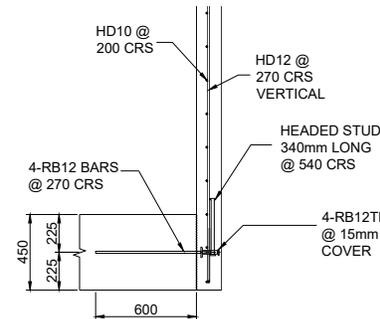
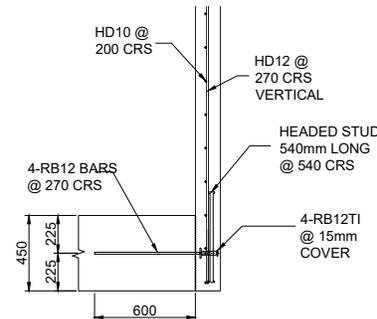
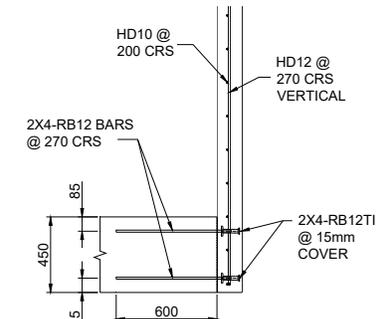
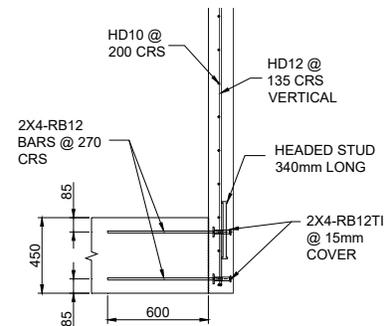
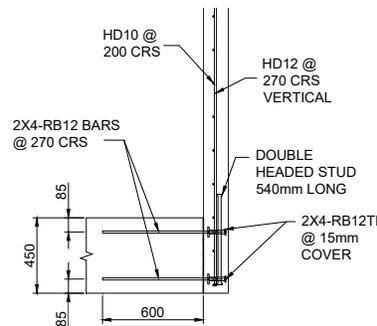
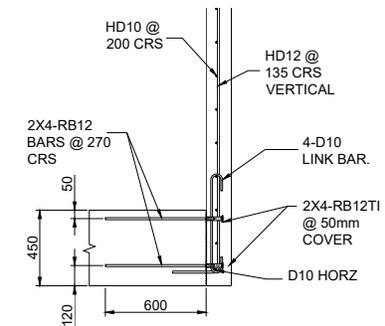
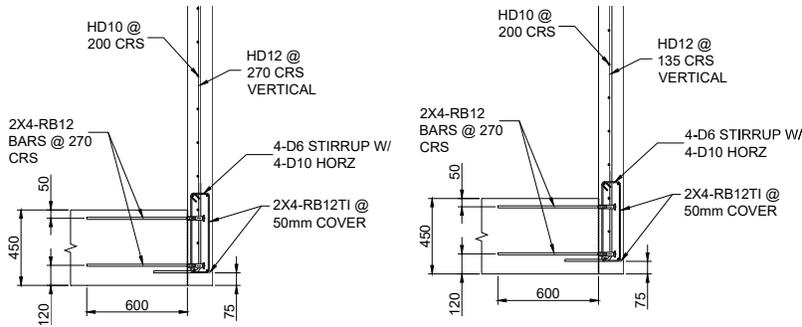
Figure 1: Details of foundation connections tested

Table 1: Test panel reinforcement details

Panel Name	Vert. Reinf		Connection Description	Cover	Insert Layers
	Vert Reinf	Spacing (mm)		behind insert (mm)	
BLT12-C0	HD12	270	Bolted through	0	2
TI12-C0	HD12	270	Threaded insert w/ 0 mm cover	0	2
TI12-C15	HD12	270	Threaded insert w/ 15 mm cover	15	2
TI12-C15-340ST-V135	HD12	135	340 mm headed stud in joint	15	2
TI12-C15-540ST	HD12	270	540 mm headed stud in joint	5	2

TI12-C15-LB-V135	HD12	135	Threaded insert w/ D10 link bar	15	2
TI12-C15-STRP	HD12	270	Threaded insert confined with stirrup at joint	15	2
TI12-C15-STRP-V135	HD12	135	Threaded insert confined with stirrup at joint	15	2
SL12-C50	HD12	270	Single "L" bar	50	1
STI12-C15	HD12	270	Single threaded insert layer w/15 mm cover	15	1
STI12-C15-NA	HD12	270	Single threaded insert layer w/15 mm cover, inserts not aligned w/vert. reinforcement	15	1
STI12-C15-340ST-V135	HD12	135	Single threaded insert layer w/ 340 mm headed stud	15	1
STI12-C15-340ST	HD12	270	Single threaded insert layer w/ 340 mm headed stud	15	1
STI12-C15-540ST	HD12	270	Single threaded insert layer w/ 540 mm headed stud	15	1

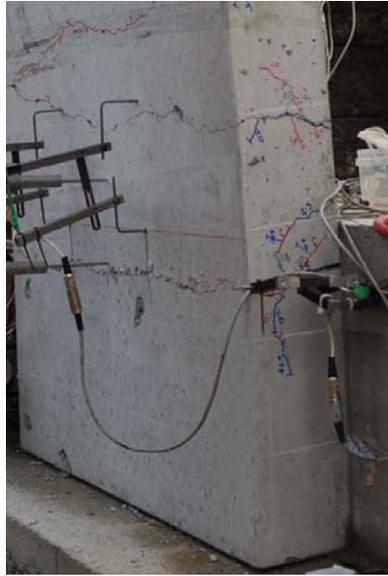
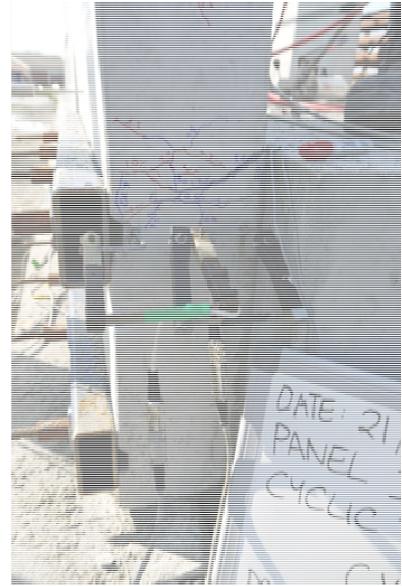
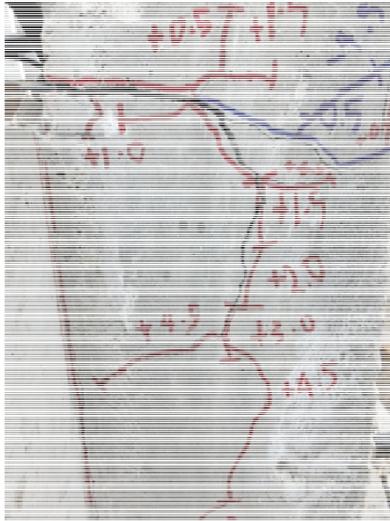
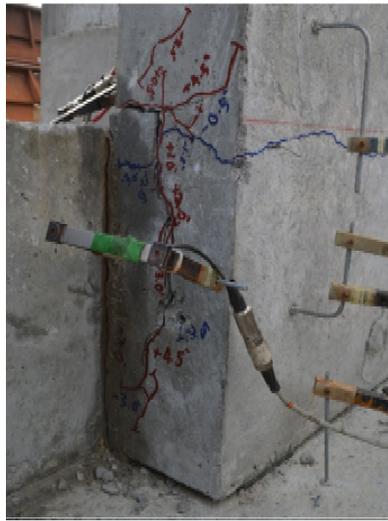
Figure 2: Damage to specimens with increased insert embedment depth compared to existing connections at maximum joint-opening drift

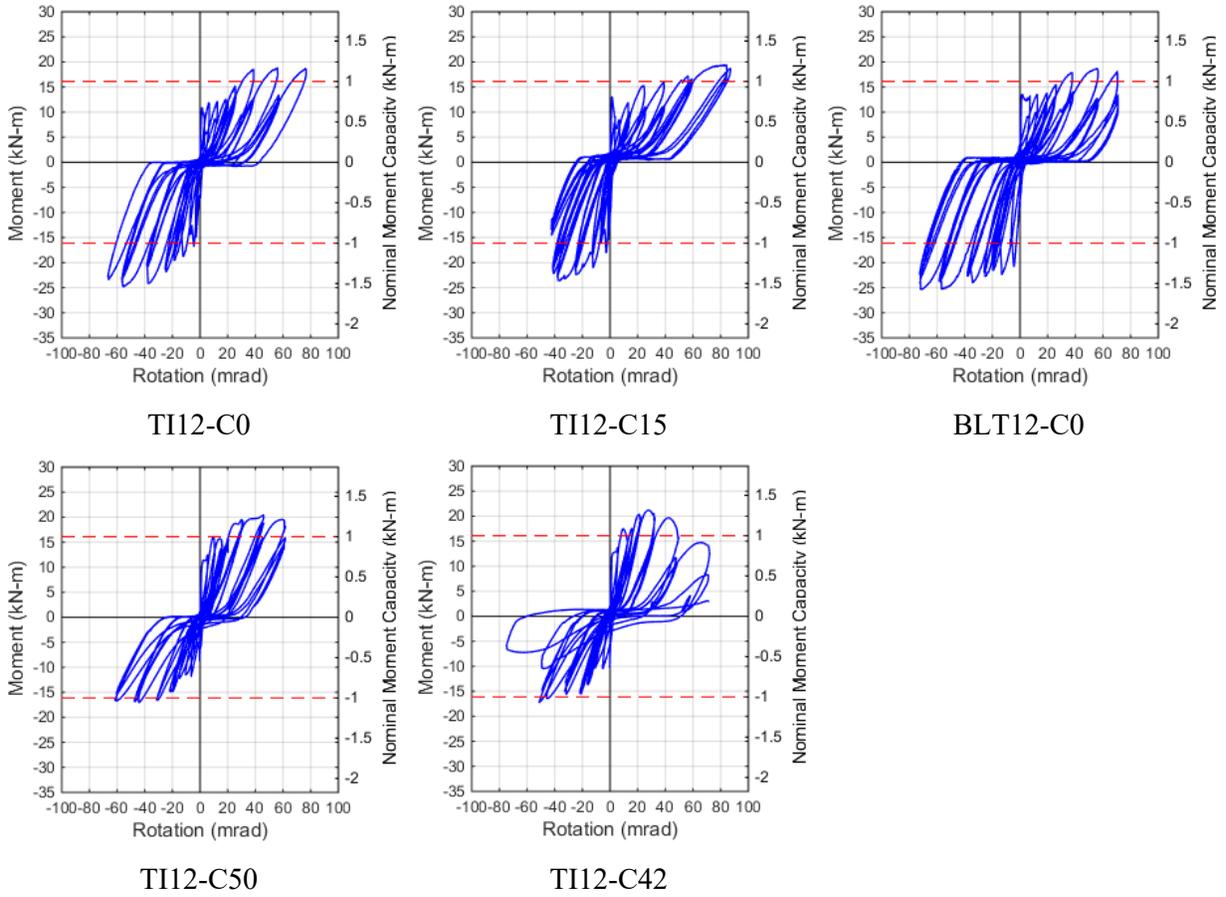
Figure 3: Global moment-rotation behavior of panels with increased insert embedment depth compared to existing connections. Positive values of moment and rotation correspond to joint-opening behavior.

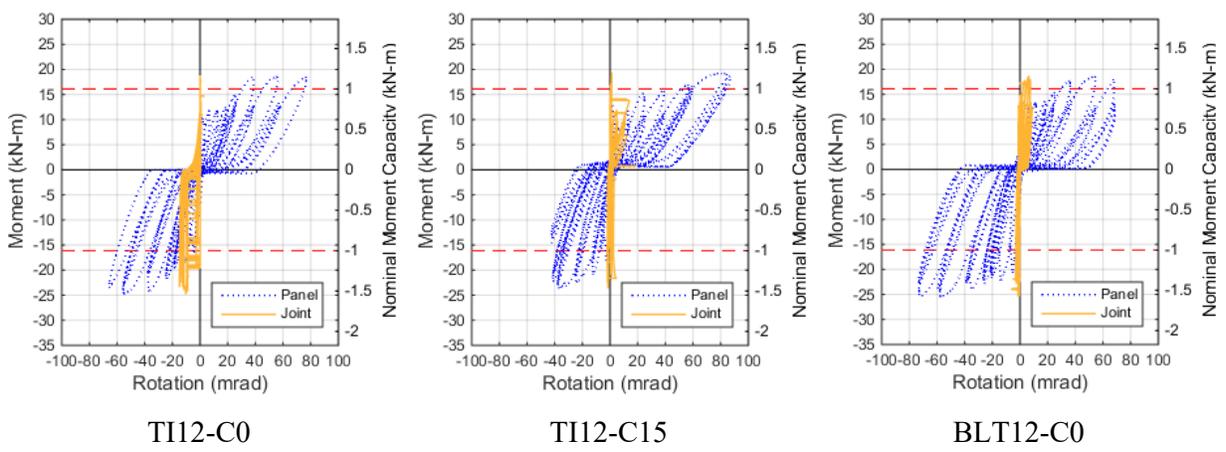
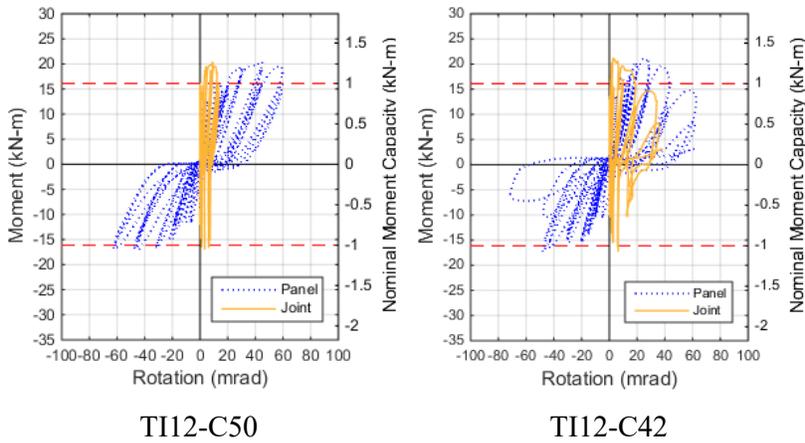
Figure 4: Joint vs panel moment-rotation behavior of panels with increased insert embedment depth compared to existing connections. Positive values of moment and rotation correspond to joint-opening behavior.

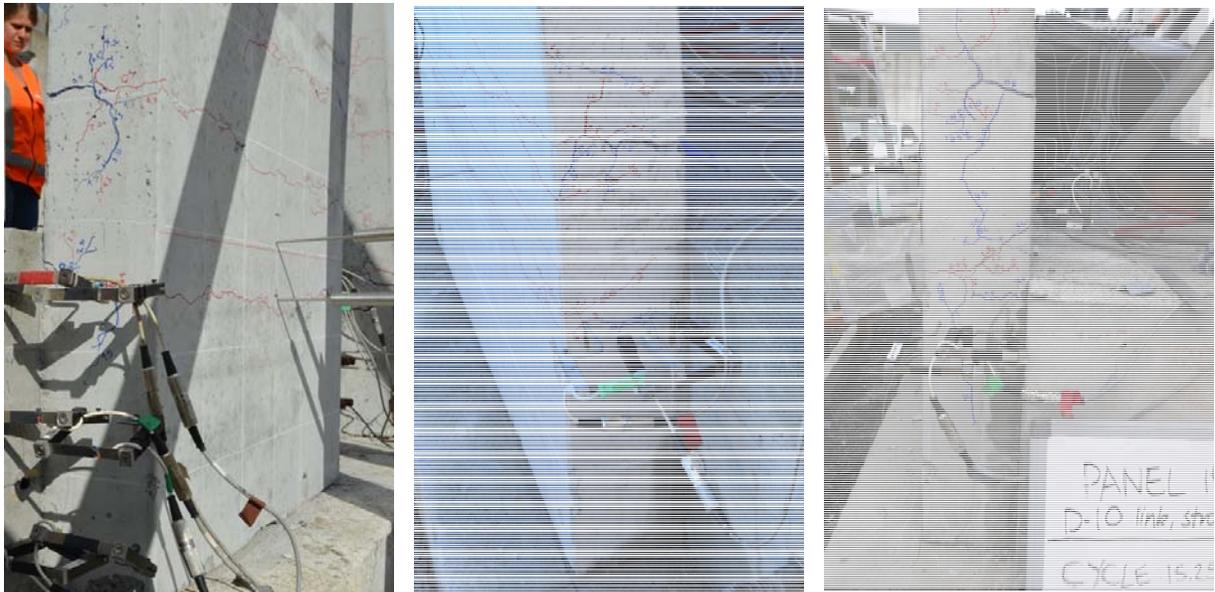
TI12-C15-340ST-V135 TI12-C15-540ST TI12-C15-LB-V135

Figure 5: Damage to specimens with strengthened joints compared to existing connections at maximum joint-opening drift

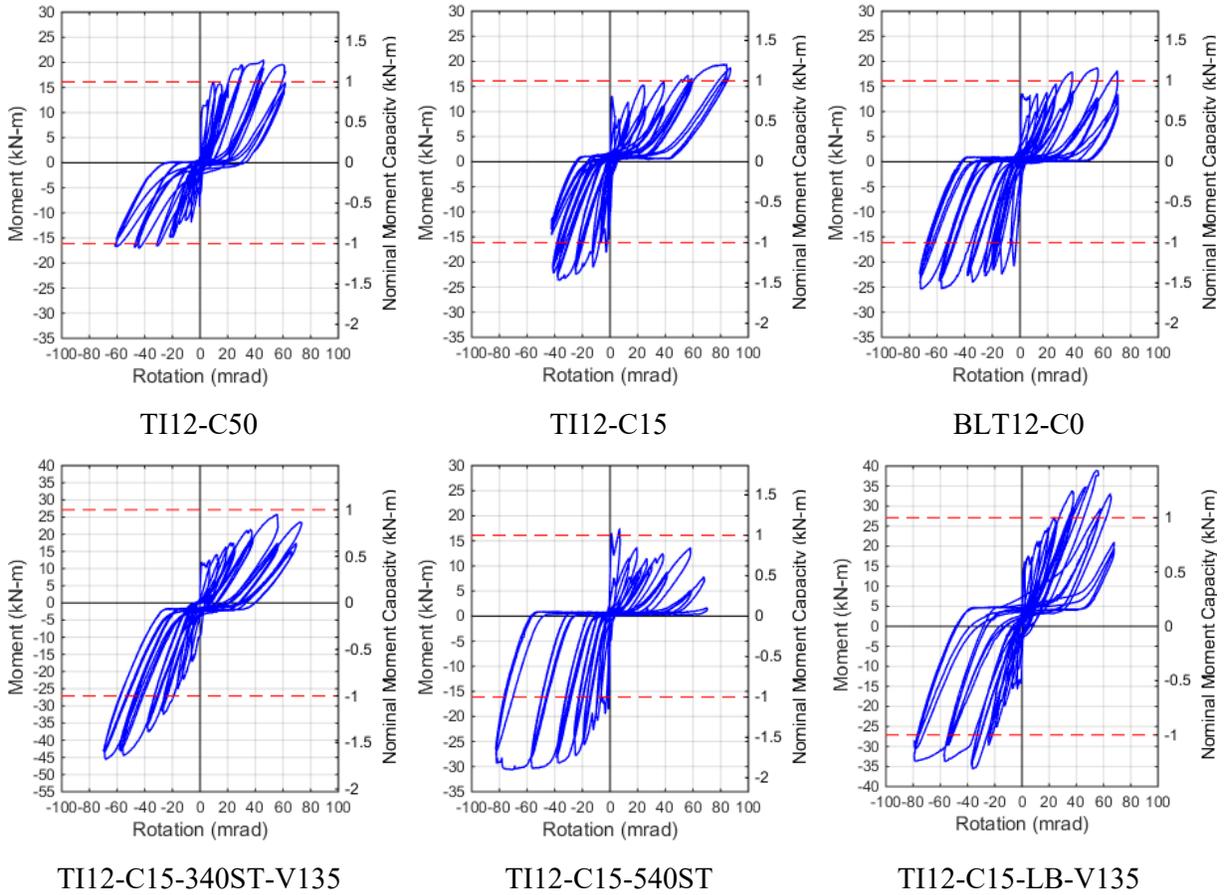
Figure 6: Global moment-rotation behavior of panels with strengthened joints compared to existing connections. Positive values of moment and rotation correspond to joint-opening behavior.

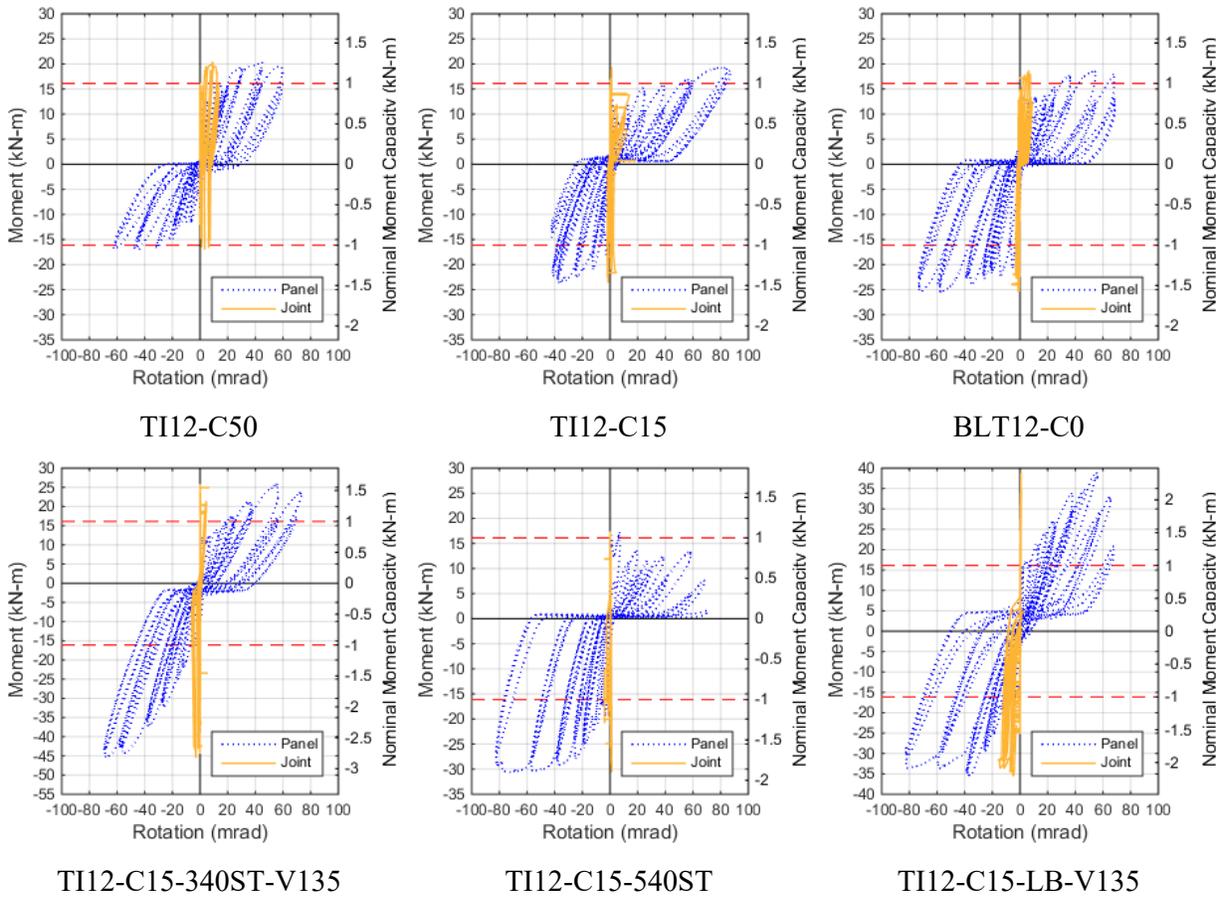
Figure 7: Joint vs panel moment-rotation behavior of panels with strengthened joints compared to existing connections. Positive values of moment and rotation correspond to joint-opening behavior.

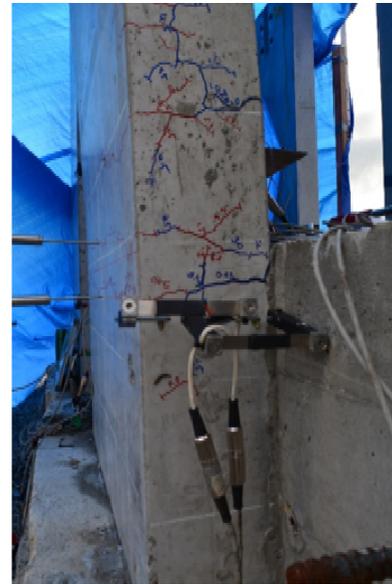
Figure 8: Damage to specimens with confined joints compared to existing connections at maximum joint-opening drift

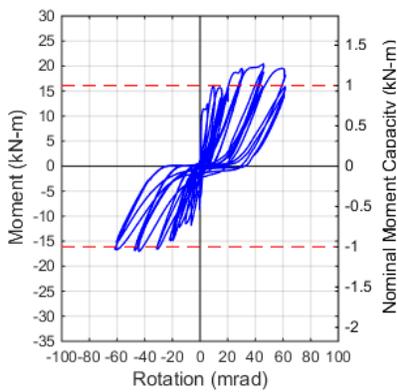
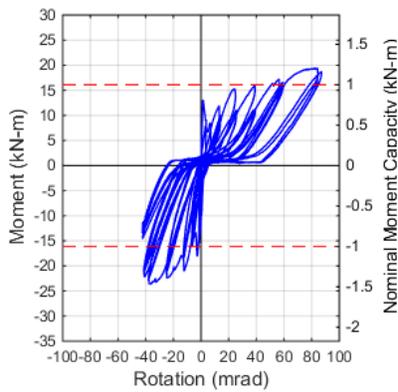
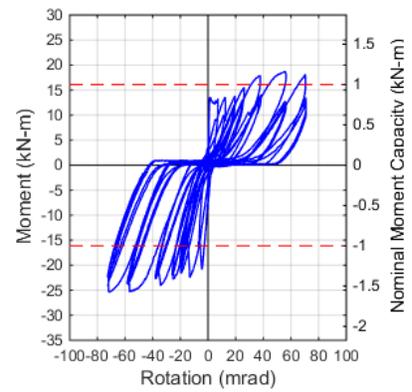
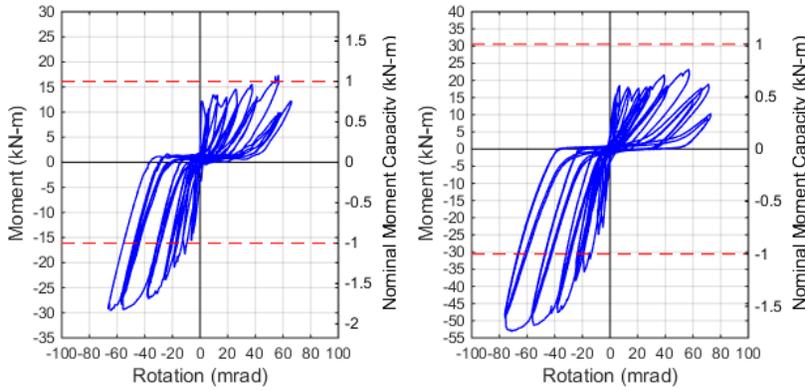
Figure 9: Global moment-rotation behavior of panels with confined joints compared to existing connections. Positive values of moment and rotation correspond to joint-opening behavior.

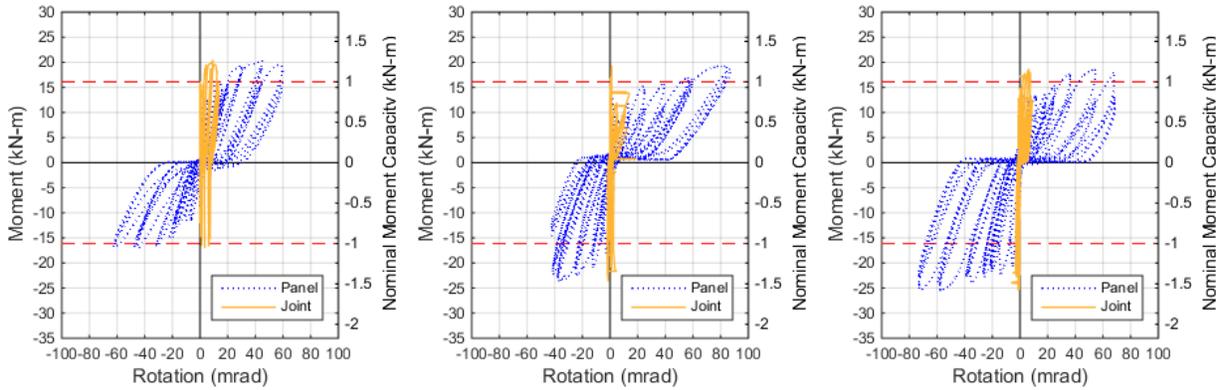
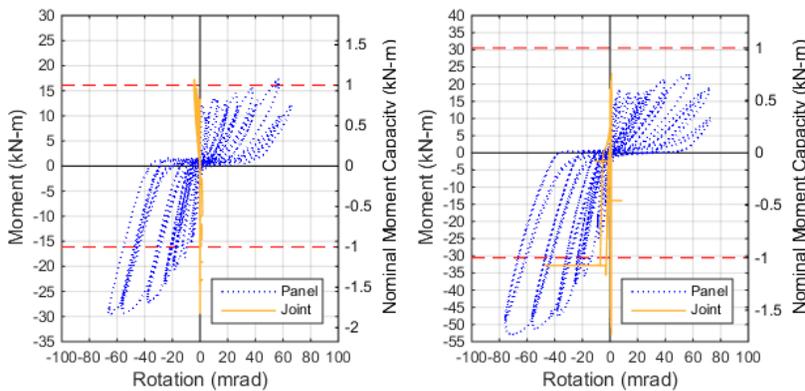
Figure 10: Joint vs panel moment-rotation behavior of panels with confined joints compared to existing connections. Positive values of moment and rotation correspond to joint-opening behavior.

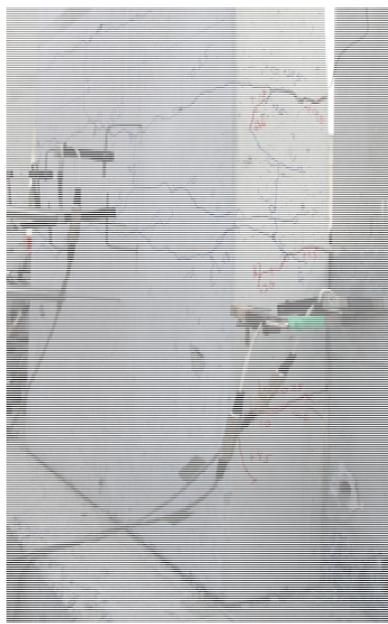
Figure 11: Damage to specimens with single layer of starter bars compared to existing connections at maximum joint-opening drift

- 53 • SL12-C50: cracking at top of hook extension as well as at level of starter bar. Significant
- 54 opening (10 mm) at foundation interface
- 55 • STI12-C15: Significant opening (5 mm) at foundation interface. Crack at insert level. Large

- 56 flexural crack for joint-closing direction
- 57 • STI12-C15-NA: Significant opening (5 mm) at foundation interface. Crack at insert level
- 58 with vertical cracking. Large flexural crack for joint-closing direction

- 59 • STI12-C15-340ST-V135: crack at insert and 5 mm opening at foundation level. Appears
- 60 to have crushing failure at large opening. Diagonal cracking at toe initiates at around 3.0%

- 61 • STI12-C15-340ST: Same large gap at foundation interface (5-10 mm). crack at top of stud
- 62 and at insert level
- 63 • STI12-C15-540ST: opening (3 mm) at foundation interface. Large flexural crack for

- 64 joint-closing direction. Slight cracking at insert level Joint stayed in good condition

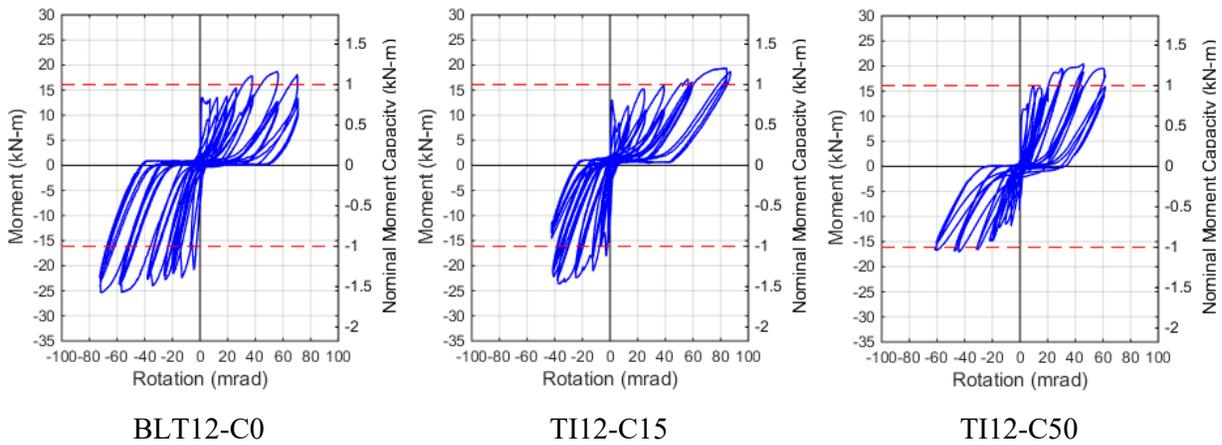
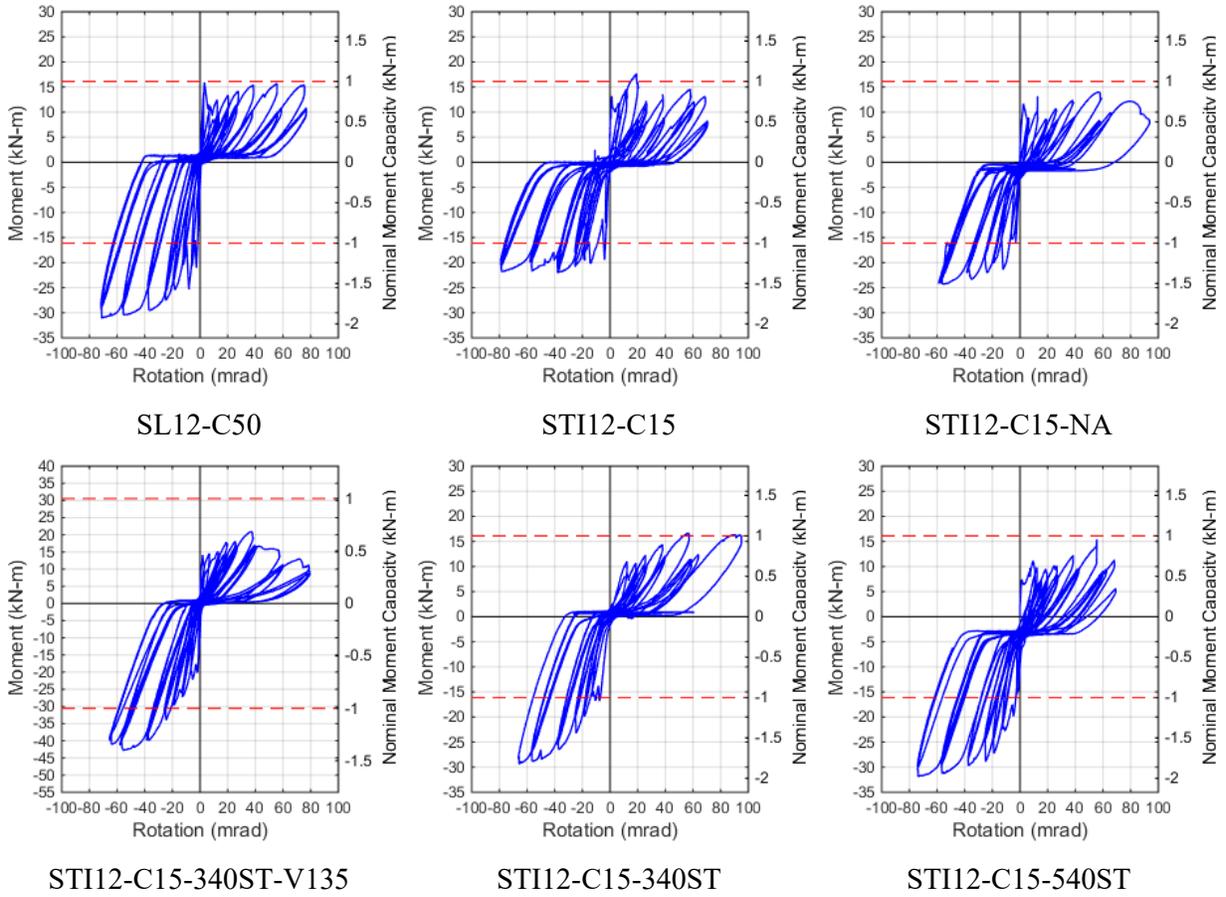
Figure 12: Global moment-rotation behavior of panels with single layer of starter bars compared to existing connections. Positive values of moment and rotation correspond to joint-opening behavior.

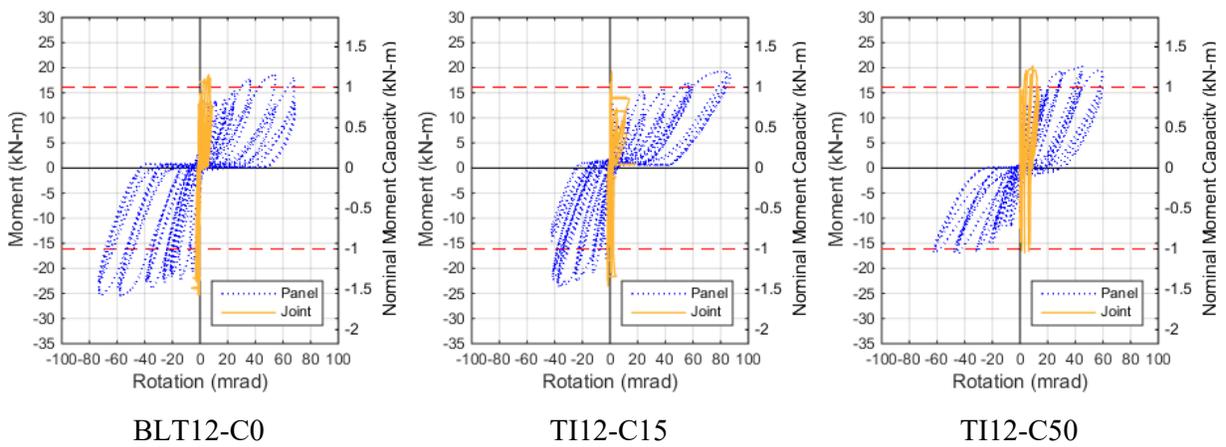
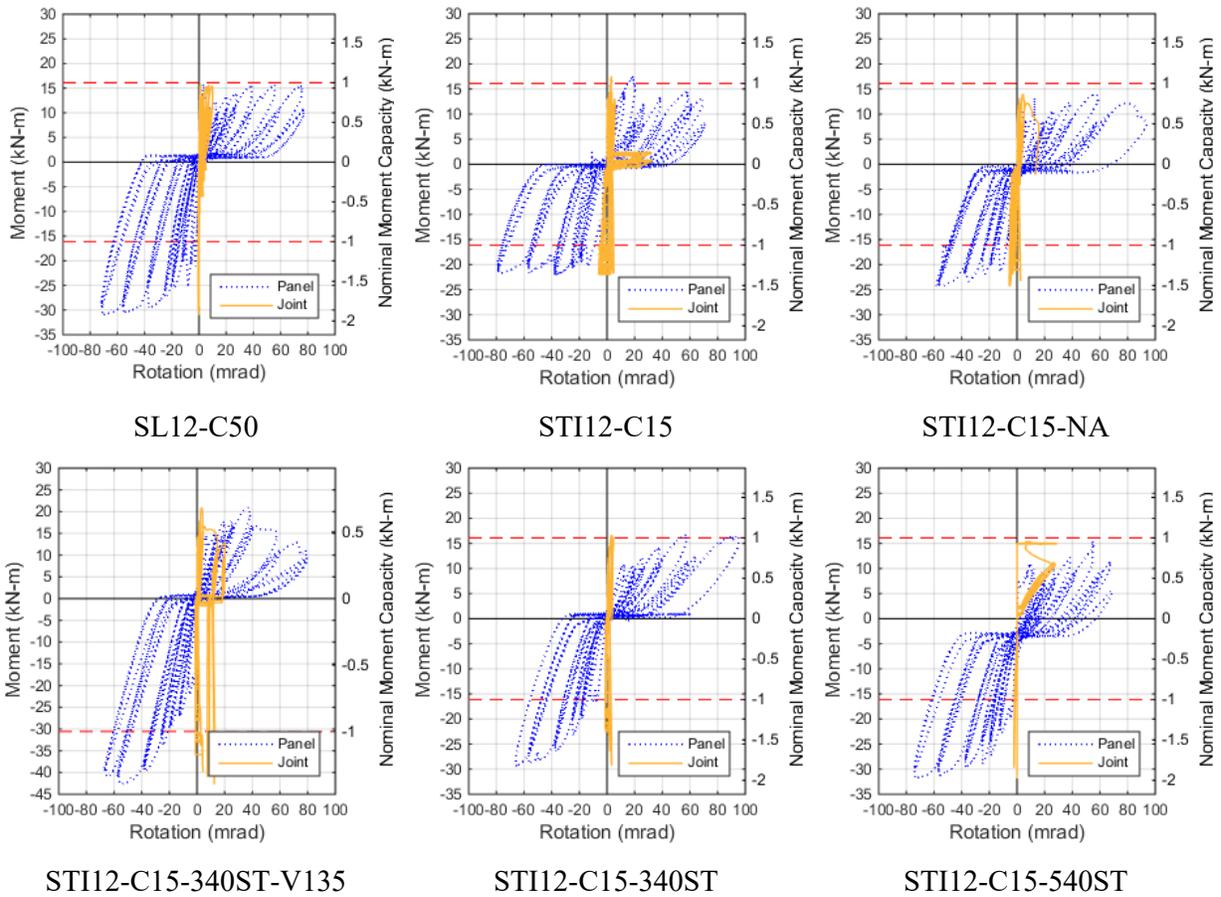
Figure 13: Joint vs panel moment-rotation behavior of panels with single layer of starter bars compared to existing connections. Positive values of moment and rotation correspond to joint-opening behavior.
