1           **Out-of-Plane Behavior of Dowel Type Precast Concrete**  
2           **Panel-to-Foundation Connections: Existing Connections**

3                           Hogan<sup>1</sup>, L.S., Henry, R.S.<sup>1</sup>, and Ingham, J. M.<sup>1</sup>

4           **Abstract:**

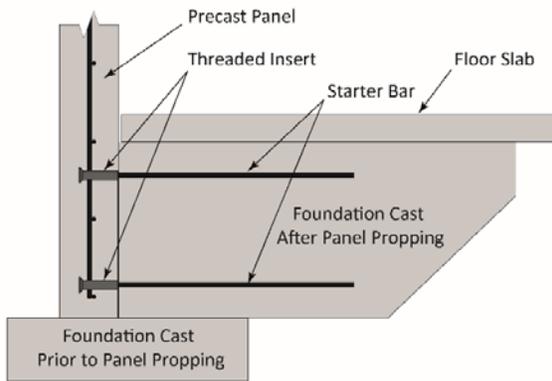
Figure 1: Schematic representation of a dowel type precast panel to foundation connection utilizing threaded inserts.

36 threaded inserts embedded in the panels to connect starter bars to the foundation (SESOC 2013).  
37 An example of a dowel type panel-to-foundation connection is shown in Figure 1. The use of  
38 threaded inserts has become popular in New Zealand for precast panel construction because the  
39 starter bars can be screwed into the panels after they were erected and thus avoided the need to bend  
40 bars for transport and storage thus reducing labor and time on site prior to pouring of the foundation  
41 (Beattie 2007). Because of the low out-of-plane strength of the panels, the demands on the starter  
42 bar reinforcement are typically below yield, and the pullout strength of the inserts often governs the

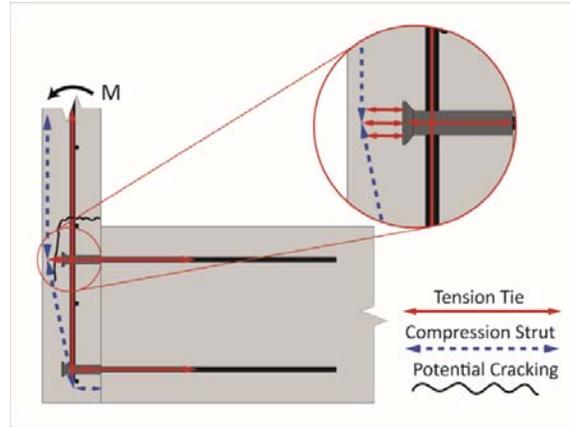
Figure 2: Strut and tie representation of load path for panel to foundation connection using threaded inserts with a shallow embedment depth

43 design of the foundation connection. As such, when the panel is loaded with a joint-opening  
44 moment, the concrete behind the insert head is required to act in tension to complete the primary  
45 load path (Figure 2), and when subjected to large moments, a vertical crack in the panel could  
46 develop as the concrete behind the insert head ruptures causing a significant loss in strength and  
47 stiffness. The limited testing on this type of connection performed by Ma (2000) showed that  
48 while no vertical cracking in the panel joint region was observed when using an embedment depth  
49 to panel thickness ratio of 0.87, the connection could not sustain the nominal moment capacity of  
50 the panel in the joint opening direction. Current practice typically uses a shallower embedment  
51 depth to panel thickness ratio of approximately 0.67, and it is expected that this shallower  
52 embedment could result in brittle joint failure. To investigate the strength and deformation

218 Panel BLT12-C0 was tested to benchmark the cyclic panel behavior by providing a clear load path  
219 that was consistent with the strut and tie load path described in Figure 2. Panel cracking initiated  
220 at 0.5% drift at the foundation level in both joint-opening and joint-closing direction with a  
221 corresponding cracking moment of 13.5 kN-m and an initial lateral stiffness of 2.85 kN/mm.

232 6.5% drift due to limitations of jack stroke. No cracking was observed in the joint (Figure 12),  
233 which was consistent with the expectations that the detail provide a clear load path based upon the  
234 strut-and-tie model in Figure 2.

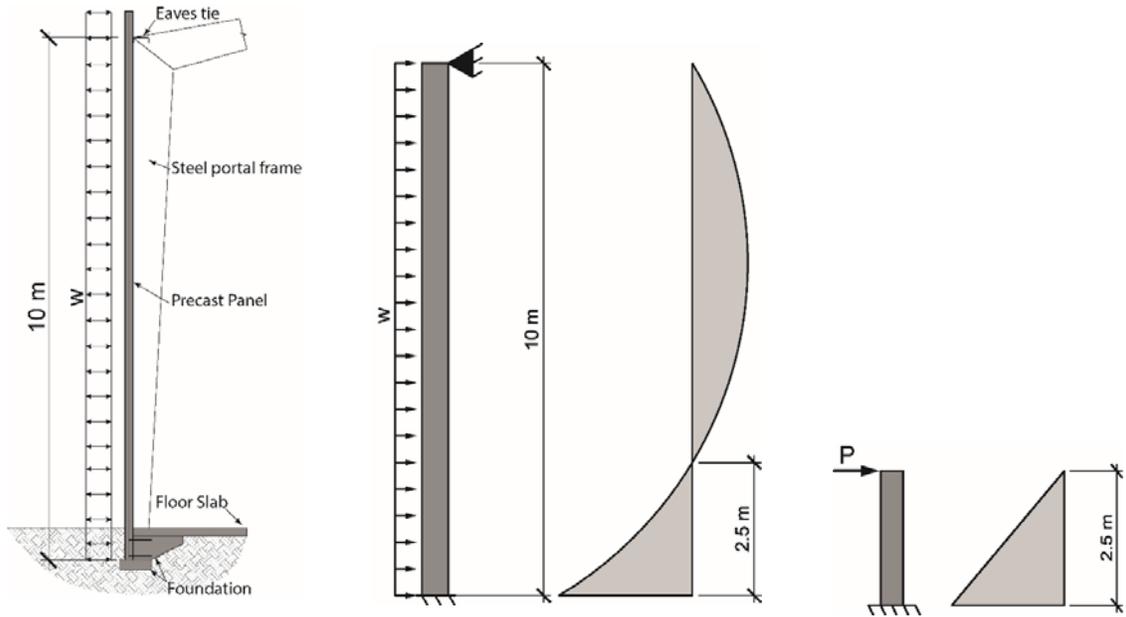
(a) Schematic section of 10 m tall panel subjected to face loading  
 (b) Boundary condition representation and moment distribution of panel  
 (c) Cantilever loading approximation for test set up

Figure 3: Prototype panel development based upon moment distribution

74 Due to the difficulty in testing full scale panels, a prototype panel was developed based upon a 10 m  
75 tall panel with fixed base and pinned top boundary conditions subjected to a uniform distributed  
76 load representing the inertial face loading of the panel in the out-of-plane direction, as shown in  
77 Figure 3. The moment and shear demands on the bottom 2.5 m height of the panel were  
78 approximately equivalent to that of a point load at the top of a 2.5 m cantilever panel. As the  
79 out-of-plane response was being investigated, only a unit width of panel was tested to allow for all  
80 requisite panels to fit on the test site. From these considerations the test panels were constructed to  
81 be 2.5 m tall and were cast into a self-reacting test set up, as shown in Figure 4. Panels were  
82 erected on top of a 200 mm tall strip foundation and starter bars were installed or bent into place as

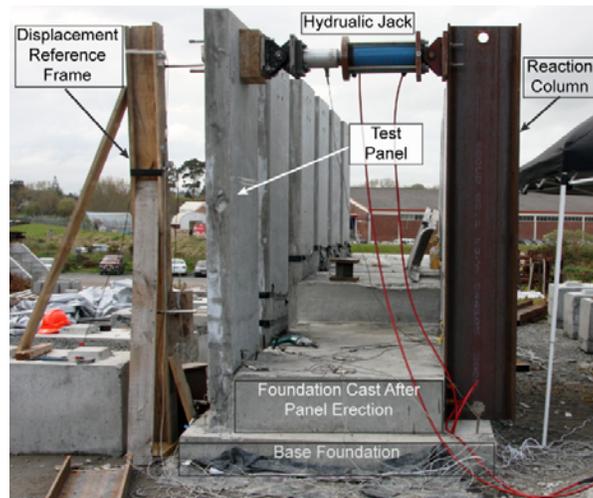
Figure 4: Panel test set up

83 required, after which the foundation beam was constructed in-situ. Load was applied to the panel  
84 top by a hydraulic jack reacting against a steel column that was bolted to the foundation opposite  
85 the panel. Apart of the panel self-weight, no additional axial load was applied as axial load ratios  
86 of these panels are typically low ( $\sim 0.4\% A_g f_c'$ ).

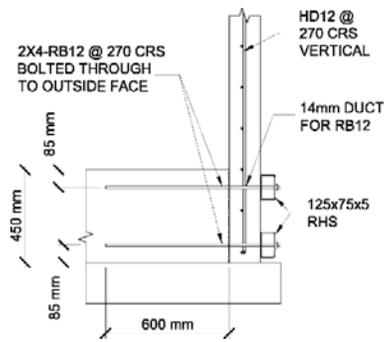
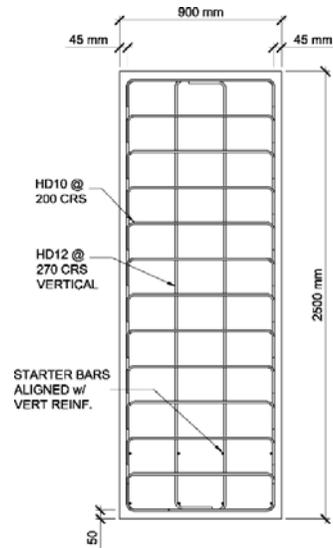
(a) Panel BLT12-C0

(b) Typical Panel Reinforcing

Figure 5: Details of bolted through foundation connection tested and panel reinforcing

106 reinforcing and were distributed in two rows 85 mm from both the top and bottom of the 450 mm  
107 tall foundation (Figure 5b).

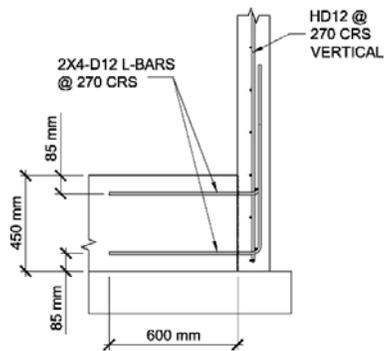
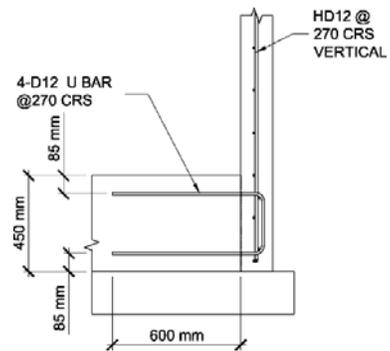
(a) Panel DL12-C50

(b) Panel U12-C50

Figure 6: Details of conventional starter bar foundation connections tested

281 The damage state following cyclic testing of the two panels that utilized conventional starter bar  
282 details, Panels DL12-C50 and U12-C50, is shown in Figure 15. For the panel that utilized two  
283 rows of 600 mm 90-degree hooks, Panel DL12-C50, cracking initiated at 0.5% drift in the  
284 joint-opening direction at the foundation level. In the joint-closing direction, four flexural cracks  
285 formed starting at the foundation level and at 150 mm increments at 0.5% drift. The panel had an  
286 initial stiffness of 3.4 kN/mm and cracking was a result of 13.8 kN-m at the foundation level. The  
287 crack at 600 mm above foundation had largest opening with a crack width of 2 mm at 2% (Figure  
288 15). The large opening of this crack is due to its location directly above the returns of the hooked  
289 bar returns that formed the starter bars (Figure 6a), as these bars effectively tripled the vertical

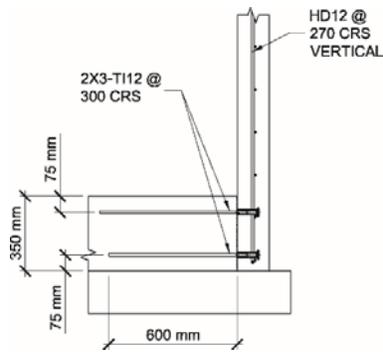
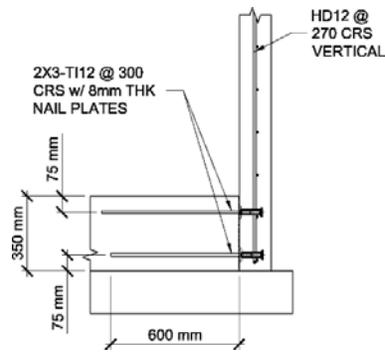
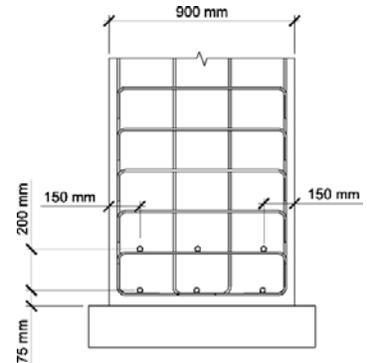
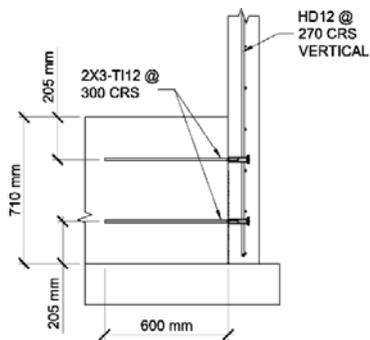
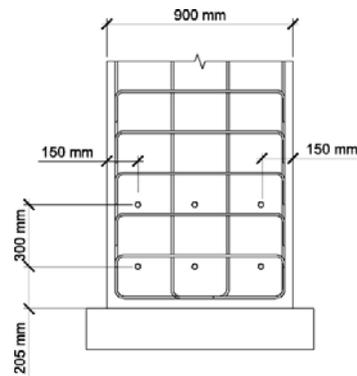
(a) Panel TI12-C50

(b) Panel TI12-C42

(c) Insert Spacing for Panels TI12-C50 & TI12-C42

(d) Panel TI12-C50FC

(e) Insert Spacing for Panel TI12-C50FC

Figure 7: Details of 12 mm threaded insert foundation connections tested

151 connection. All inserts had a minimum horizontal spacing of 300 mm and consisted of two rows  
152 of three inserts for all insert panels, and as such the inserts were not aligned with the vertical  
153 reinforcing (Figure 7c and Figure 8c). Such detailing is common in practice as inserts are often  
154 puddled into fresh concrete and such spacing allows the inserts to be installed without conflicting  
155 with the vertical reinforcement. For both the 12 mm and 16 mm inserts, two panels were  
156 constructed that allowed for the inserts to develop the full theoretical failure cone without failure  
157 cones of adjacent inserts overlapping based on the design equations present in the New Zealand  
158 Concrete Structures Standard, NZS 3101:2006 (Standards New Zealand 2006), which are the  
159 equations as those in Appendix D of ACI 318-08 (ACI 2008). These panels had the inserts

362 Panel TI12-C50 utilized two rows of three inserts which were installed flush to the panel-foundation  
 363 interface with an embedment depth of 100 mm (Figure 7a). The panel had an initial stiffness of  
 364 1.4 kN/mm and cracking initiated in the panel just above foundation level at 0.5% drift when  
 365 subjected to an 11.4 kN-m moment. An additional flexural crack formed approximately 300 mm  
 366 above foundation at 1% drift, and the crack at foundation level began to extend vertically towards  
 367 the base of the panel. At 1.5% drift, an additional flexural crack at 150 mm above foundation, and  
 368 the vertical crack in joint began to extend down to the level of the top dowels, and by 3% drift the  
 369 vertical crack in the joint had extended down to 120 mm below foundation level with a width of

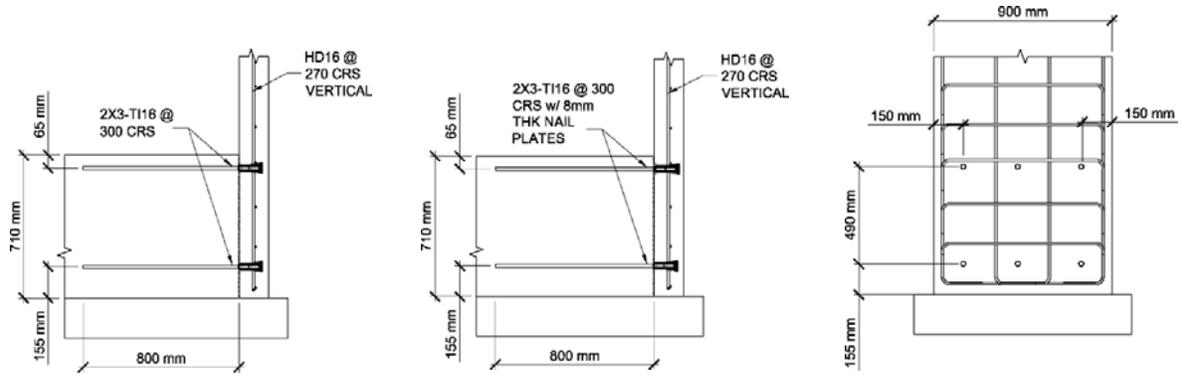
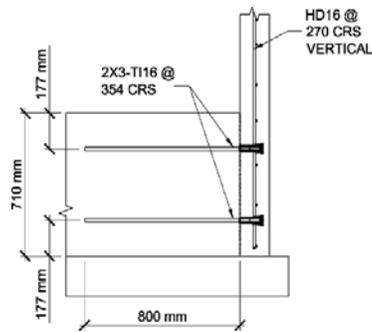
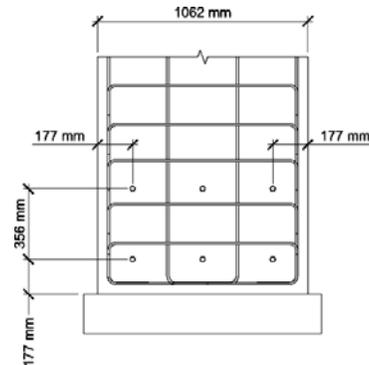
(a) Panel TI16-C32

(b) Panel TI16-C24

(c) Insert Spacing for Panels TI16-C32 & TI16-C24

(d) Panel TI16-C32FC

(e) Insert Spacing for Panel TI16-C32FC

Figure 8: Details of 16 mm threaded insert foundation connections tested

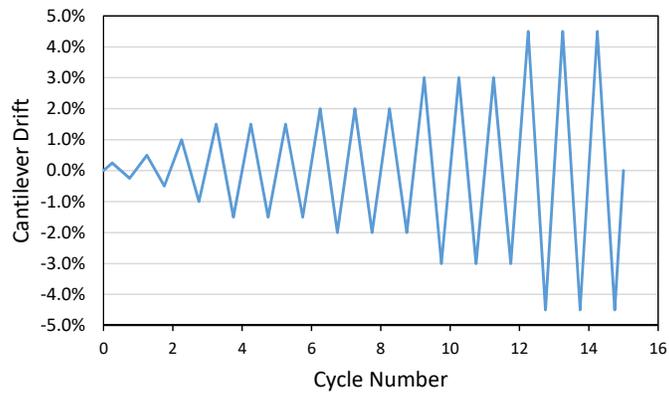
Figure 9: Loading protocol used for cyclic testing

171 developed based on recommendations by ACI (2007, 2013) which is shown in Figure 9. The

174 1.0%, 1.5%, 2.0%, 3.0%, 4.5% and 6.25% drift calculated using the height of the 2.5 m cantilever  
175 panel.

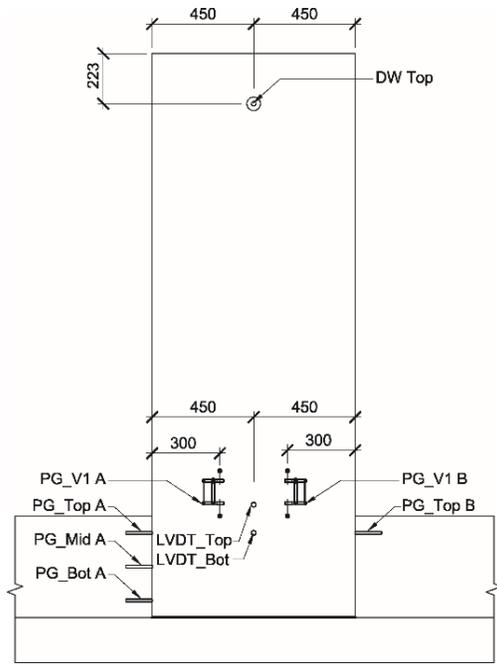
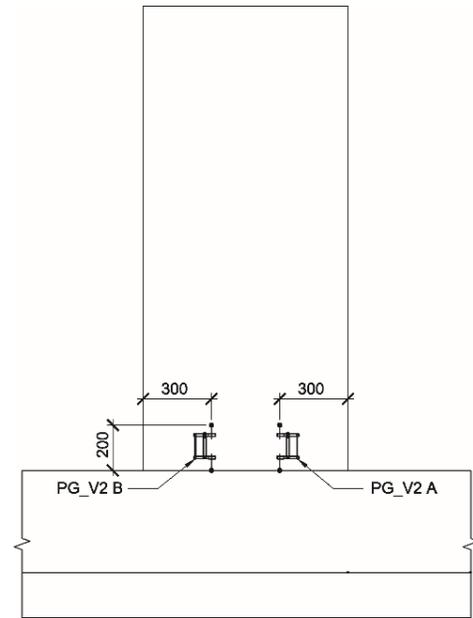
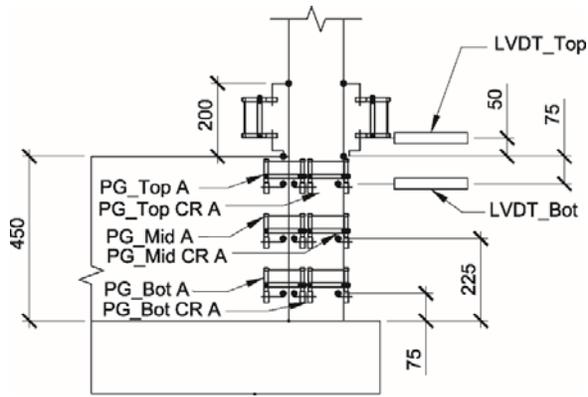
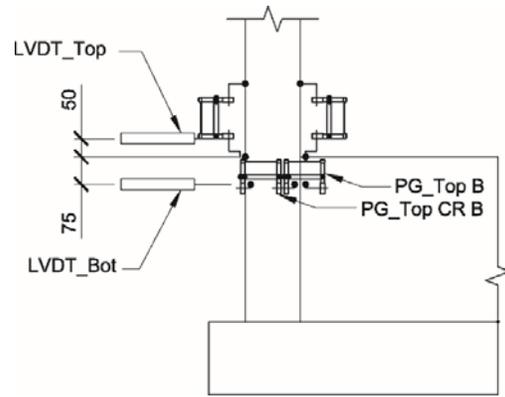
Figure 10: Instrument layout for panels with 450 mm tall foundations. All dimensions in mm, "PG" refers to portal gauge extensometers.

181 In addition to measurement of the applied lateral force and top panel deformation, the  
182 panel-foundation connection joint was instrumented with several displacement transducers. The  
183 panels were tested in two phases and so two different instrumentation schemes exist for the panels  
184 with 450 mm foundations and those that used either 350 mm or 710 mm foundations as is shown  
185 Figure 10 and Figure 11 respectively. For both instrumentation set ups, the opening of the vertical  
186 joint at the panel and foundation interface and the potential for vertical cracking to develop in the

187 panel were measured at the top, bottom, and mid-height of the foundation. Gauges PG\_Top,  
188 PG\_Mid, PG\_Bot measured the gap development between the panel and foundation, and gauges  
189 PG\_Top CR, PG\_Mid CR, and PG\_Bot CR measured vertical cracking in the panel for the 450 mm  
190 tall foundation specimens (Figure 10c,d). Gauges PG\_Top, PG\_Mid, and PG\_Bot measured both  
191 the gap development between panel and foundation as well as vertical panel cracking for the  
192 350 mm and 710 mm foundation specimens (Figure 11c,d). Gauge PG\_Crack provided an  
193 independent crack width measurement for the 350 mm and 710 mm foundation specimens (Figure  
194 11d). Horizontal displacement just above and below the panel was also measured (gauges  
195 LVDT\_Top and LVDT\_Bot in 450 mm tall foundations and PG\_Gap A and B for the 350 mm and  
196 710 mm foundation specimens). The potential for panel uplift and additional rotation about the

197 10 mm thick shims that supported the panel during construction was measured using gauges  
198 PG\_VB\_A and B 350 mm and 710 mm foundation specimens, and the panel curvature was  
199 estimated using the gauges with the prefix PG V1 or PG V2 for the 450 mm tall foundation  
200 specimens. Finally, strain gauges were mounted on the starter bars 20 mm into the foundation.

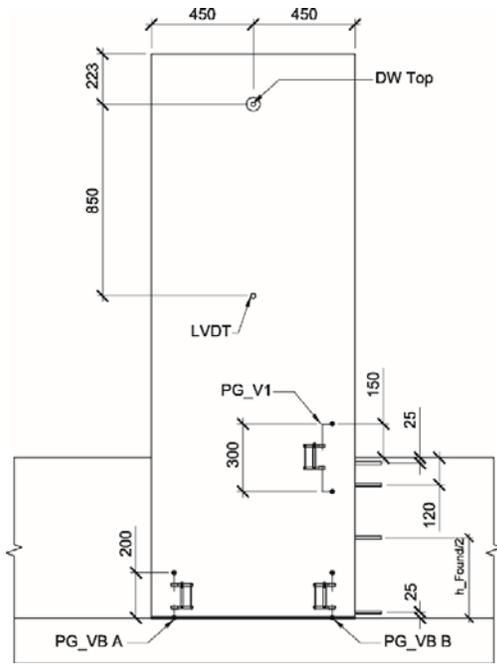
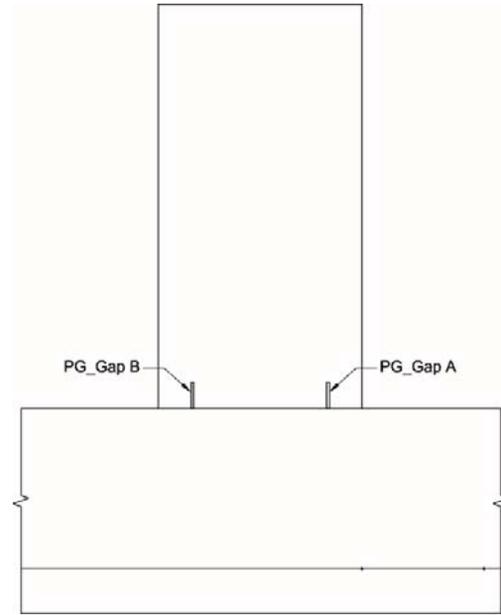
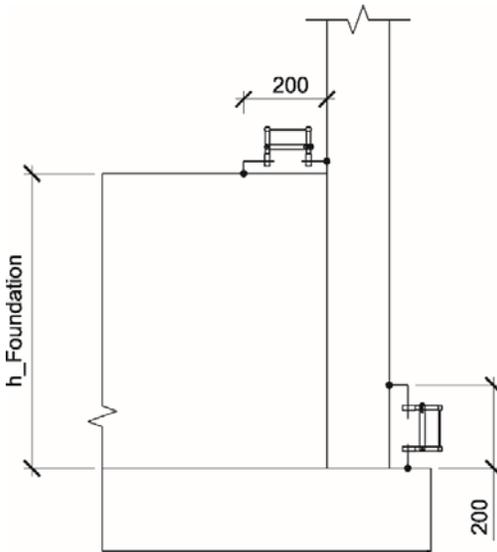
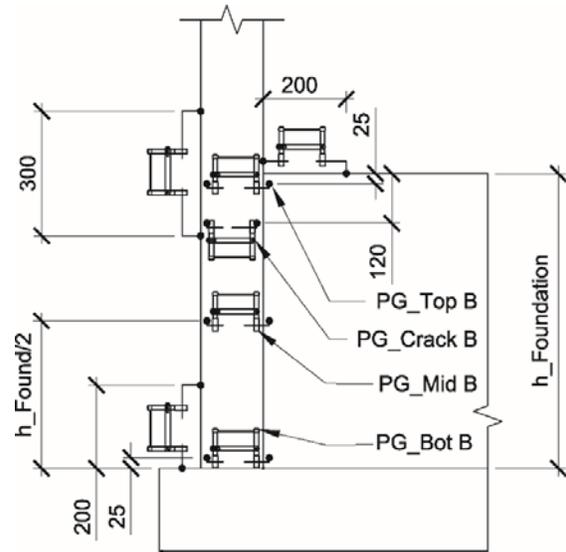
Figure 11: Instrument layout for panels with either 350 mm or 710 mm tall foundations. All dimensions in mm, “PG” refers to portal gauge extensometers.

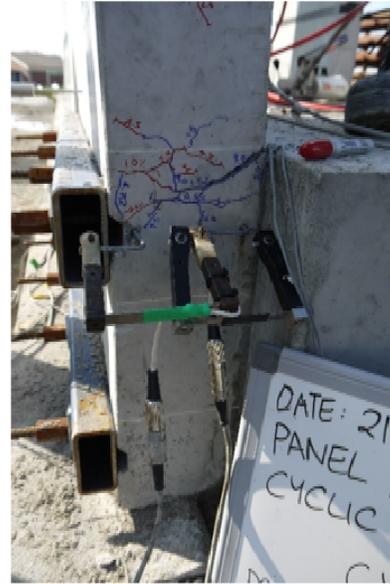
Figure 12: Damage of Panel BLT12-C0 at -4.5% Drift

222 Three additional flexural cracks formed at approximately 150 mm intervals above the initial crack  
223 at the foundation level, as can be seen in Figure 12. These additional cracks formed during both  
224 the 1% and 1.5% drift cycles. Crack opening concentrated at the foundation level with the  
225 foundation level cracks opening to a width of 4 mm at 4.5% drift. From the global  
226 moment-rotation hysteretic plot shown in Figure 13, it can be seen that the panel reached nominal  
227 moment capacity in both the joint-opening and joint-closing directions with strength increases  
228 observed until the panel reached 3% drift with an 18 kN-m capacity in the joint-opening direction  
229 and a 25 kN-m capacity in the joint-closing direction. Above 3% drift the strength capacity in  
230 each respective loading direction remained constant until the final cycle at 6.5% drift. No  
231 degradation of strength was observed between different drift levels and the test was ended at

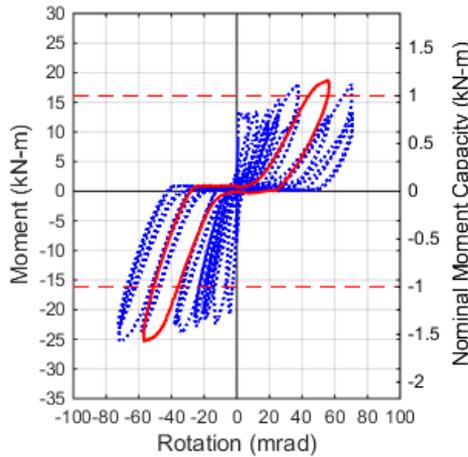
Figure 13: Global Moment-Rotation behavior of Panel BLT12-C0 with 4.5% drift cycle highlighted. Positive values of moment and

rotation correspond to joint-opening behavior.

235 Significant pinching in the hysteretic behavior was observed, particularly in drift levels above 2.0%  
236 (Figure 13). This pinching resulted from inelastic extension of the single layer of reinforcement  
237 coupled with low axial load which meant that the reinforcement did not yield in compression and so  
238 flexural cracks could not close until the panel translated through a rotation that was greater than the  
239 previous cycle. Panel BLT12-C0 also displayed a significant amount of asymmetry in the

240 hysteretic response (Figure 13). The panel exhibiting a lower strength and stiffness in the when  
241 subjected to joint-opening moments, with the panel not reaching nominal moment capacity in the  
242 joint-opening direction until 1.5% drift as opposed to the joint-closing direction in which nominal  
243 moment capacity is reached on the first cycle. Due to the symmetric vertical reinforcing layout,  
244 the asymmetric response is a result of the joint geometry and reinforcing. For joint-closing  
245 loading, the panel bears against the top of the foundation and the starter bars are located such that  
246 the foundation interface has greater moment capacity than the panel, thus allowing the panel to  
247 develop its nominal capacity and subsequent over-strength as expected. When loaded in the  
248 joint-opening direction, the panel-foundation interface cracks, and the panel is loaded with an

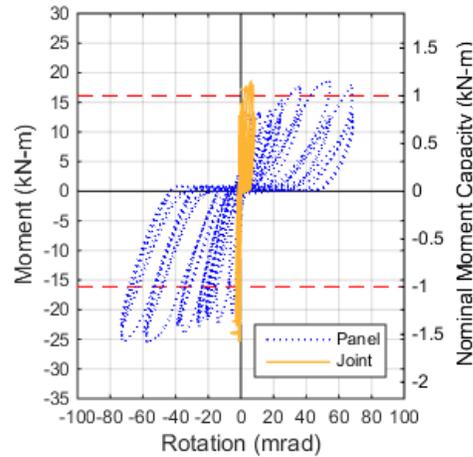
Figure 14: Comparison between rotation in panel and rotation in joint of Panel BLT12-C0

258 A comparison between the measured joint and panel rotations with respect to applied moment at the  
259 foundation level is shown in Figure 14. The joint rotation is calculated by first determining the  
260 center of rotation in the joint from the portal gauge sensors on the foundation interface (Figure 10  
261 and Figure 11) and calculating the inverse tangent of between the horizontal displacement at the top  
262 foundation sensor and the center of rotation. The horizontal displacement of the panel at the top of  
263 the foundation includes both the separation at the panel-foundation interface as well as any potential  
264 vertical cracking that could form in the panel joint region. The panel rotation is calculated by the  
265 inverse tangent of the displacement at the applied load minus the displacement of the top foundation  
266 sensor divided by the distance from the load to the top level of the foundation. Most the

267 deformation observed in the test was a result of panel rotation at the large flexural crack at the  
268 foundation level, with panel rotation being approximately ten times larger than the joint rotation in  
269 the joint-opening direction. Figure 14 supports that the reduced stiffness in the joint-opening  
270 direction resulted from joint deformations as the joint rotations joint-opening direction are  
271 approximately seven times larger than those in the joint closing direction. This discrepancy was  
272 expected as in the joint-opening direction the center of rotation occurred between the two layers of  
273 starter bars and the moment arm in the joint is between one half and one third of the foundation  
274 depth depending on drift level, while in the joint-closing direction, the panel bears against the  
275 foundation and the bottom dowels is in tension thus allowing almost the full depth of the foundation

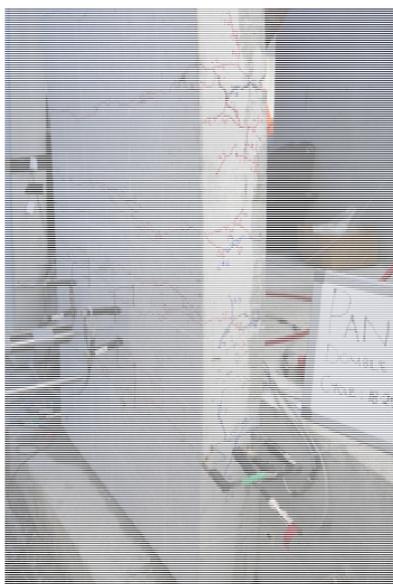
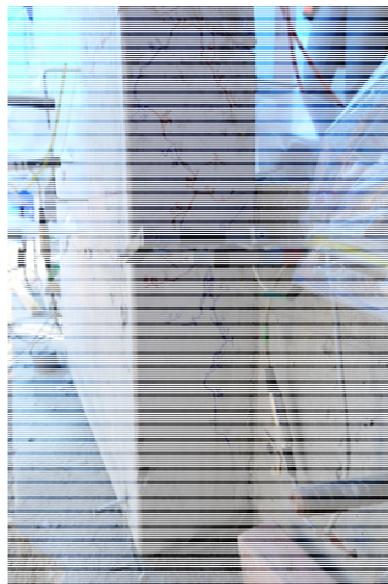
Figure 15: Damage to specimens with conventional 12 mm starter bars at maximum joint-opening drift

317 directions without significant damage to the joint (Figure 15). The panel had an initial stiffness of

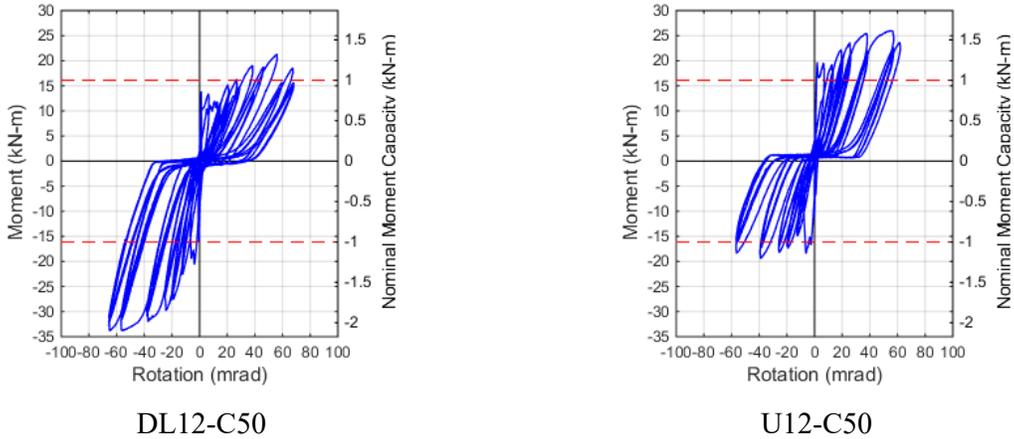
Figure 16: Global moment-rotation behavior of panels with conventional 12 mm starter bars. Positive values of moment and rotation correspond to joint-opening behavior.

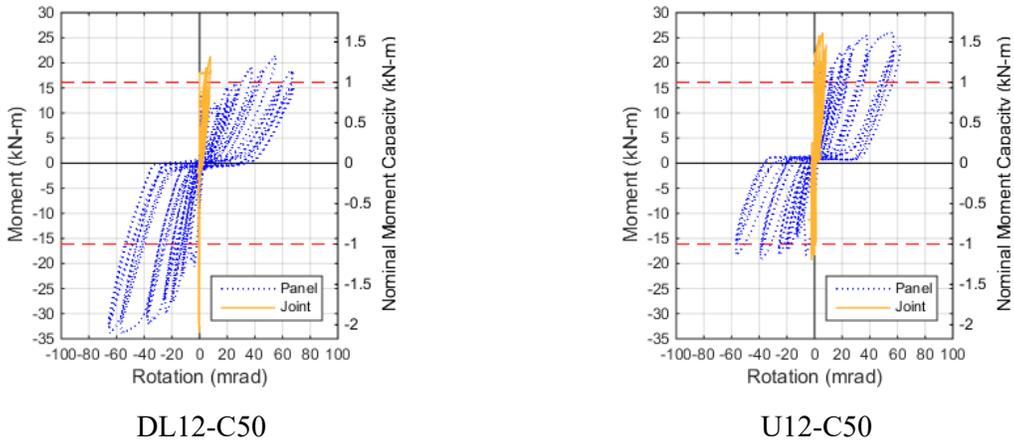
Figure 17: Joint vs panel moment-rotation behavior of panels with conventional 12 mm starter bars. Positive values of moment and rotation correspond to joint-opening behavior.

338 Panel U12-C50 also had similar joint rotations to the idealized BLT12-C0 connection (Figure 17).  
339 The better than expected performance of Panel U12-C50 likely results from efficient transfer  
340 between the vertical reinforcement and the starter bars. Because the starter bars were of Panel  
341 U12-C50 were tied directly to the vertical reinforcement and well anchored, the panel was able to  
342 more effectively transfer loads between the panel and the foundation than threaded insert panels  
343 with similar cover depth behind the starter bars as discussed in the next section.

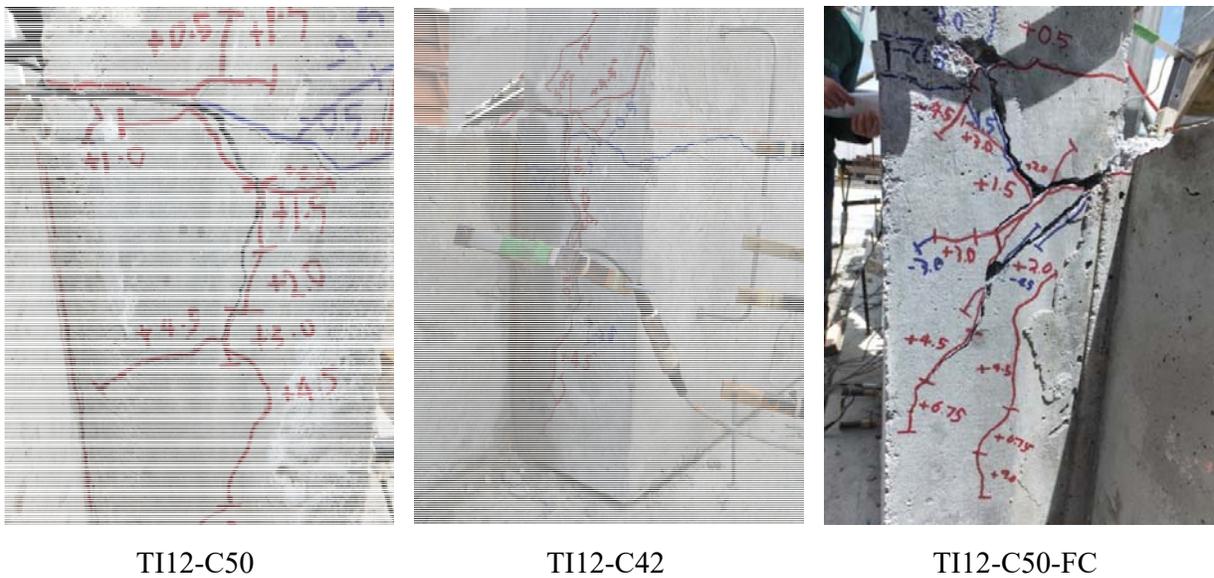
Figure 18: Damage to specimens with 12 mm starter bars at maximum joint-opening drift

349 Three panel details utilizing 12 mm threaded inserts were tested and included Panels TI12-C50,  
350 TI12-C42, and TI12-C50-FC. The observed damage of these panels at the end of cyclic testing is  
351 shown in Figure 18 while the observed damage to the panel joint following demolition and removal  
352 of the panel is shown in Figure 19. The global moment-rotation hysteretic behavior is shown in  
353 Figure 20 and the joint rotations and crack widths forming on the side of the panels due to concrete  
354 breakout behind the inserts are provided in Figure 21 and Figure 22 respectively. It should be  
355 noted that the calculated joint rotation includes deformation arising from both separation between  
356 the panel and foundation as well as any vertical cracking in the panel in the joint region.

397 actions. At 4.5% drift the vertical crack in the joint extended to within 25 mm of the bottom of the  
398 panel and has opened up to over 2 mm (Figure 18). As can be seen from post-demolition  
399 inspection in Figure 19, a breakout-style failure plane formed behind all of the inserts in a similar  
400 manner to that which was observed in Panel TI12-C50.

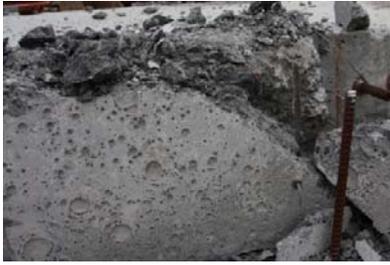
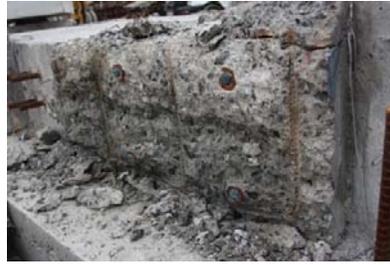
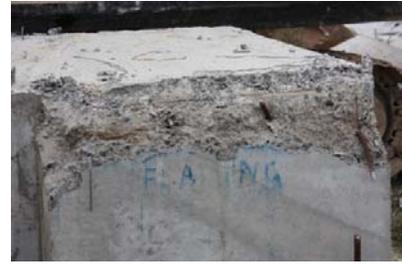
Figure 19: Observed joint damage to 12 mm insert panels following panel demolition

370 0.6 mm at the top end. At 4.5% drift, the panel vertical cracking continued to extend to three  
371 quarters the depth of the foundation and curved around back towards the foundation, similar to a  
372 cone breakout crack pattern (Figure 18). At 6% drift, the vertical crack extended to within 25 mm  
373 of the base of the panel, and post-test demolition of the panel revealed that a breakout-style failure  
374 plane had formed behind the top level of inserts (Figure 19).

451 direction. The vertical crack in the joint remained open and the panel appeared to “kick out” at the  
452 foundation level. Post-demolition investigation did not reveal any break out behind dowels  
453 (Figure 19), and crushing of the compression zone started to occur at 6.5% drift.

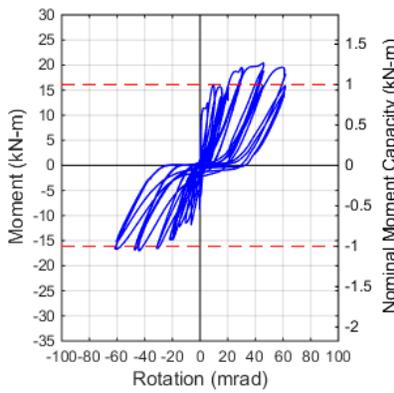
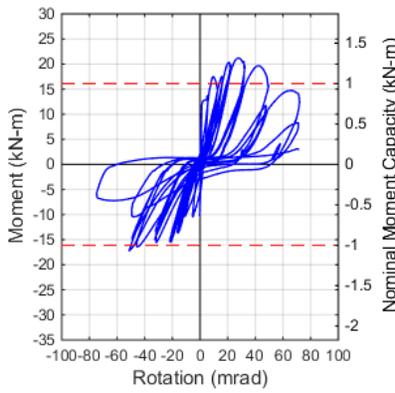
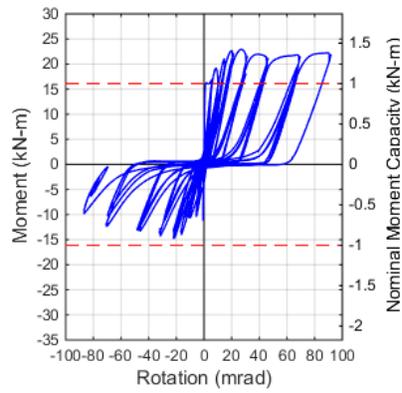
Figure 20: Global moment-rotation behavior of panels with 12 mm starter bars and inserts. Positive values of moment and rotation correspond to joint-opening behavior.

415 The addition of the nail plate appears to have caused the panel to perform worse than if it were  
416 neglected. When no nail plate was used and the insert was at the panel-foundation interface, such  
417 as on Panel TI12-C50, there was a larger crack opening the panel and foundation interface than  
418 when for Panel TI12-C42 which utilized a nail plate. This additional interface opening likely  
419 resulted in slip of the threaded bar in the insert, which Ma (2000) noted was an average of 0.28 mm  
420 for this type of threaded insert. This additional flexibility would have reduced the joint-opening  
421 rotational demand on the panel demand for a given the same level of drift as can be seen in the  
422 hysteretic response in Figure 20 and would have resulted in less breakout behind the inserts (Figure  
423 19).

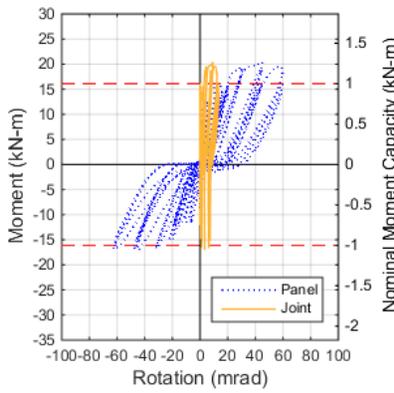
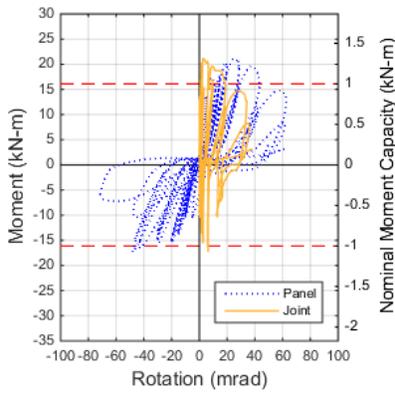
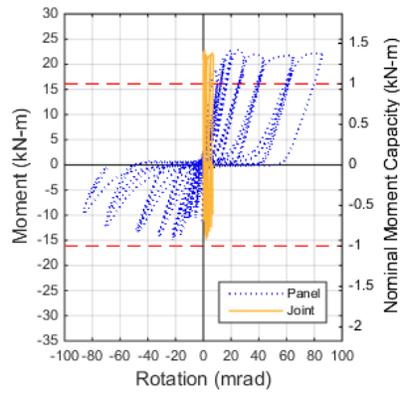
Figure 21: Joint vs panel moment-rotation behavior of panels with 12 mm starter bars and inserts. Positive values of moment and rotation correspond to joint-opening behavior.

454 As shown in Figure 21, Panel TI12-C50-FC exhibited a similar magnitude of joint rotation in the  
455 joint-opening directions as observed in Panel DL12-C50, even though a crack width of up to  
456 2.5 mm was measured (Figure 22). It is expected that this limited rotation was observed because  
457 the foundation was twice as tall as the other 12 mm insert connections and the location of the insert  
458 205 mm below the foundation line (Figure 7e) meant that the vertical crack in the panel only just  
459 reached the level of the top row of starter bars and as such the panel connection still was able to

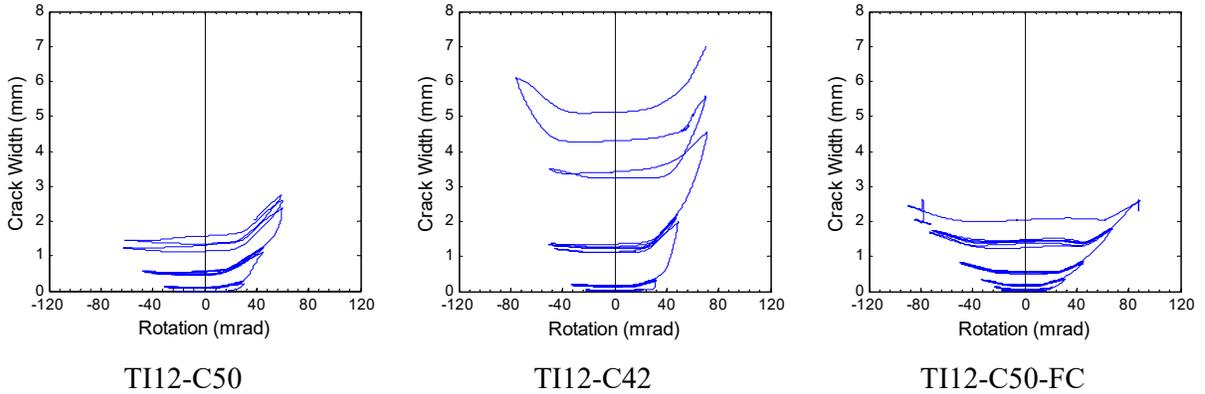
Figure 22: Typical width of vertical crack forming behind threaded insert with respect to panel rotation for panels with 12 mm starter bars

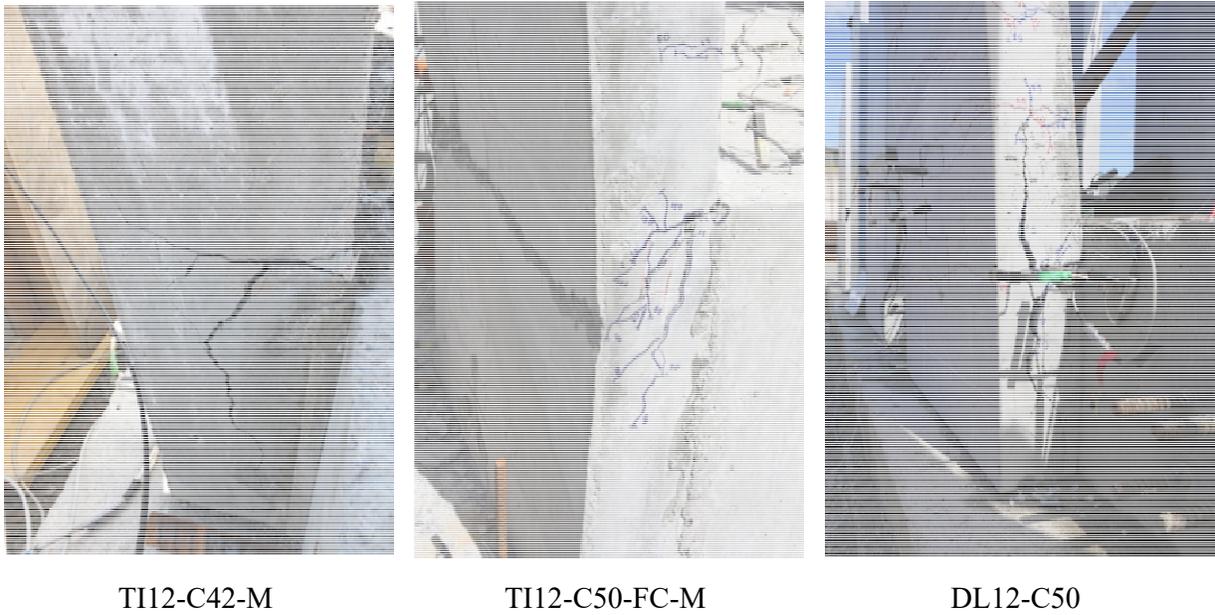
Figure 23: Damage to specimens with 12 mm starter bars following monotonic pushover in joint-opening direction

471 Panel DL12-C50, which during cyclic loading had damage concentrated at the point where the  
472 starter bar hooks terminated, failed during monotonic loading by splitting of the panel at the depth  
473 of the vertical reinforcement (Figure 23). This failure was brittle when compared to the panels  
474 with inserts as can be seen from the relative rotations of the joint and panel in Figure 21 and Figure  
475 25. During monotonic loading the panel lost strength rapidly after a rotation of 110 mrad and  
476 significant joint rotations were detected as the vertical crack propagated behind the vertical  
477 reinforcement. Conversely, Panel TI12-C42 experienced large joint rotations as a result of vertical

478 cracking behind the inserts, but lost strength in a more controlled manner.

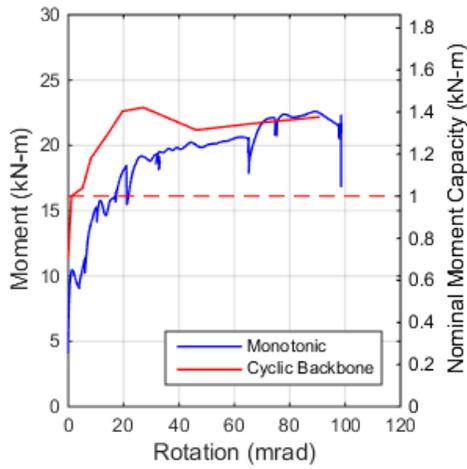
Figure 24: Comparison between cyclic backbone and monotonic joint-opening moment-rotation behavior of TI12-C50-FC-M.

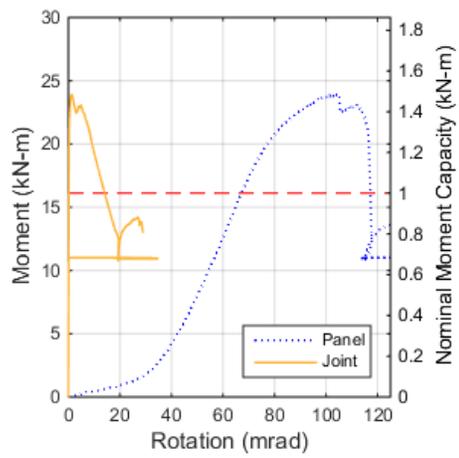
Figure 25: Joint vs panel joint-opening moment-rotation behavior of Panel DL12-C50.

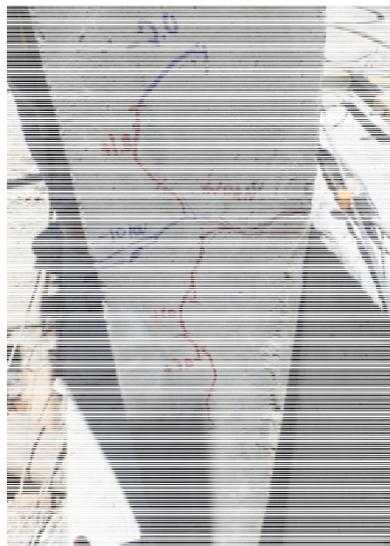
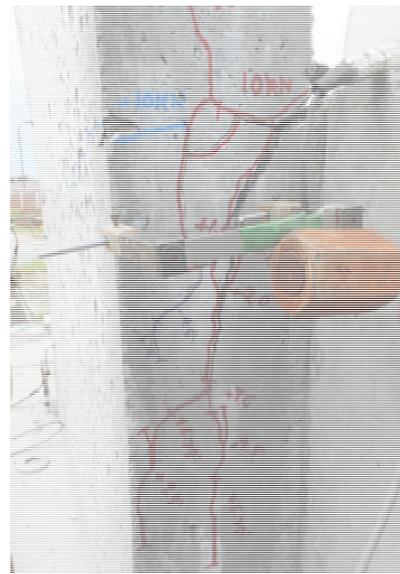
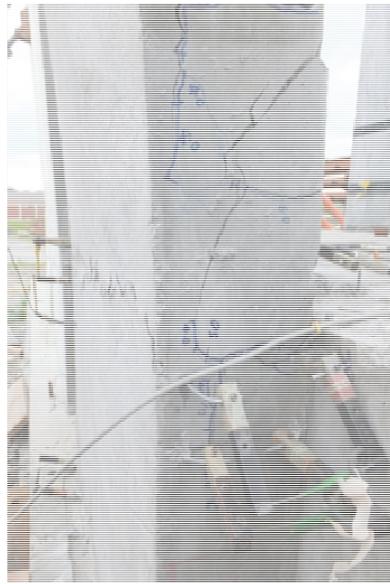
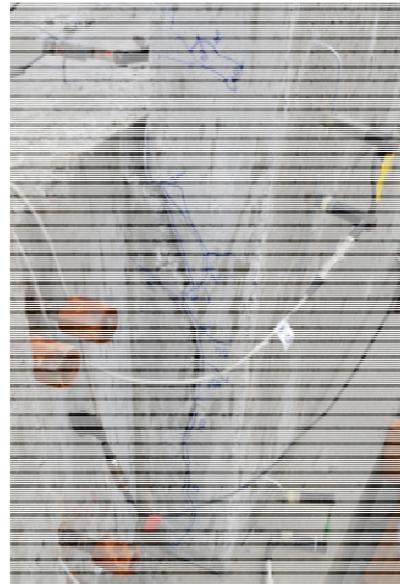
Figure 26: Damage to specimens with 16 mm starter bars at maximum joint-opening drift

481 Three panel details utilizing 16 mm threaded inserts were tested and included Panels TI16-C32,  
482 TI16-C24, and TI16-C50-FC. These details were tested both cyclically and monotonically, with  
483 the specimens that were tested monotonically denoted with an “M”. The observed damage of  
484 these panels at the end of cyclic testing is shown in Figure 26 while the observed damage to the  
485 panel joint following panel demolition is shown in Figure 27. The global moment-rotation  
486 hysteretic behavior is shown in Figure 28 and the joint rotations and crack widths forming behind  
487 the inserts are provided in Figure 29 and Figure 30 respectively. It should be noted that the  
488 calculated joint rotation includes deformation arising from both separation between the panel and  
489 foundation as well as any vertical cracking in the panel in the joint region.

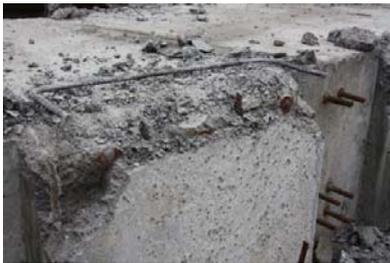
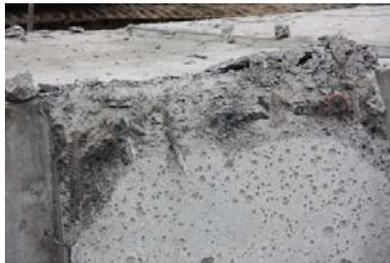
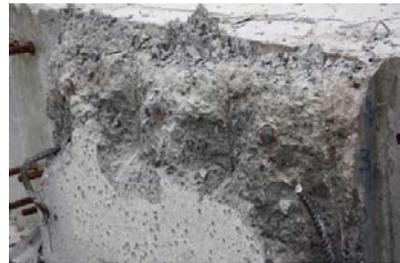
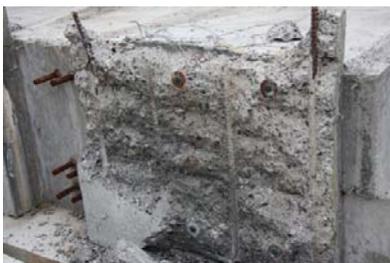
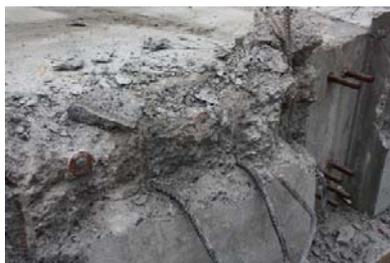
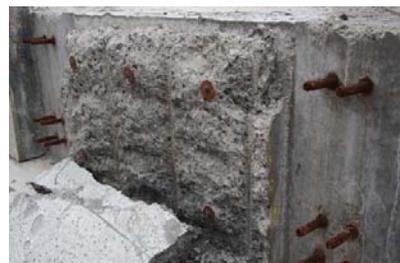
Figure 27: Observed joint damage to 16 mm insert panels following panel demolition

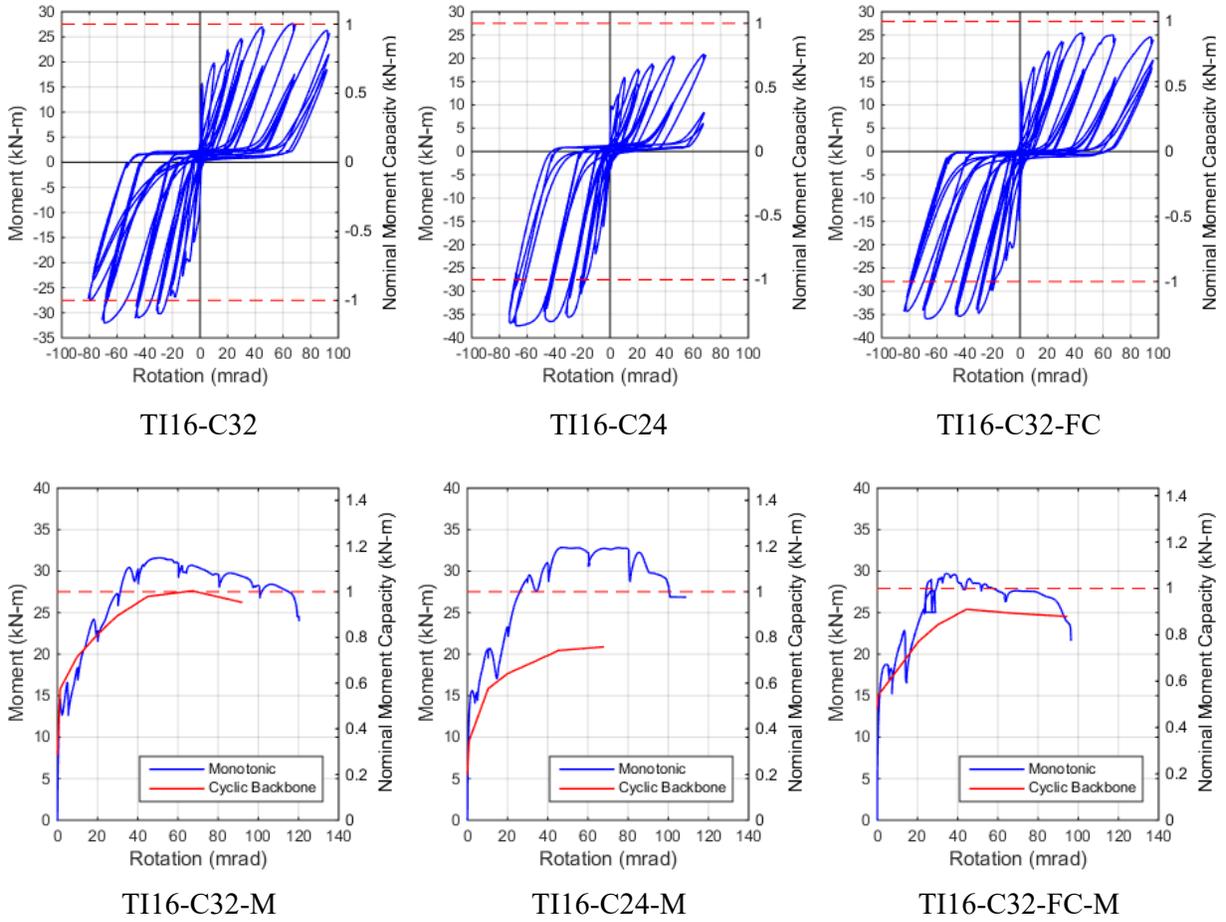
Figure 28: Global moment-rotation behavior of panels with 16 mm starter bars and inserts. Positive values of moment and rotation correspond to joint-opening behavior.

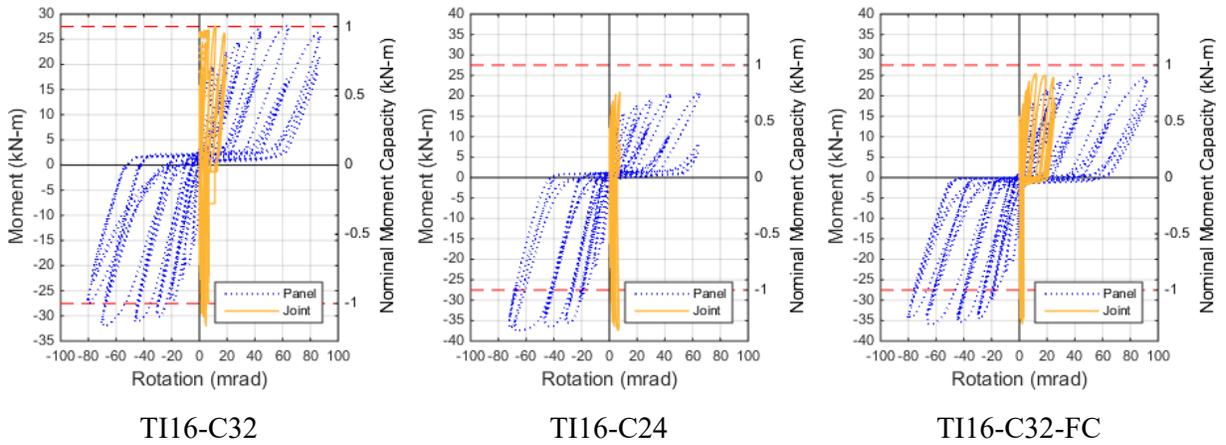
Figure 29: Joint vs panel moment-rotation behavior of panels with 16 mm starter bars and inserts. Positive values of moment and rotation correspond to joint-opening behavior.

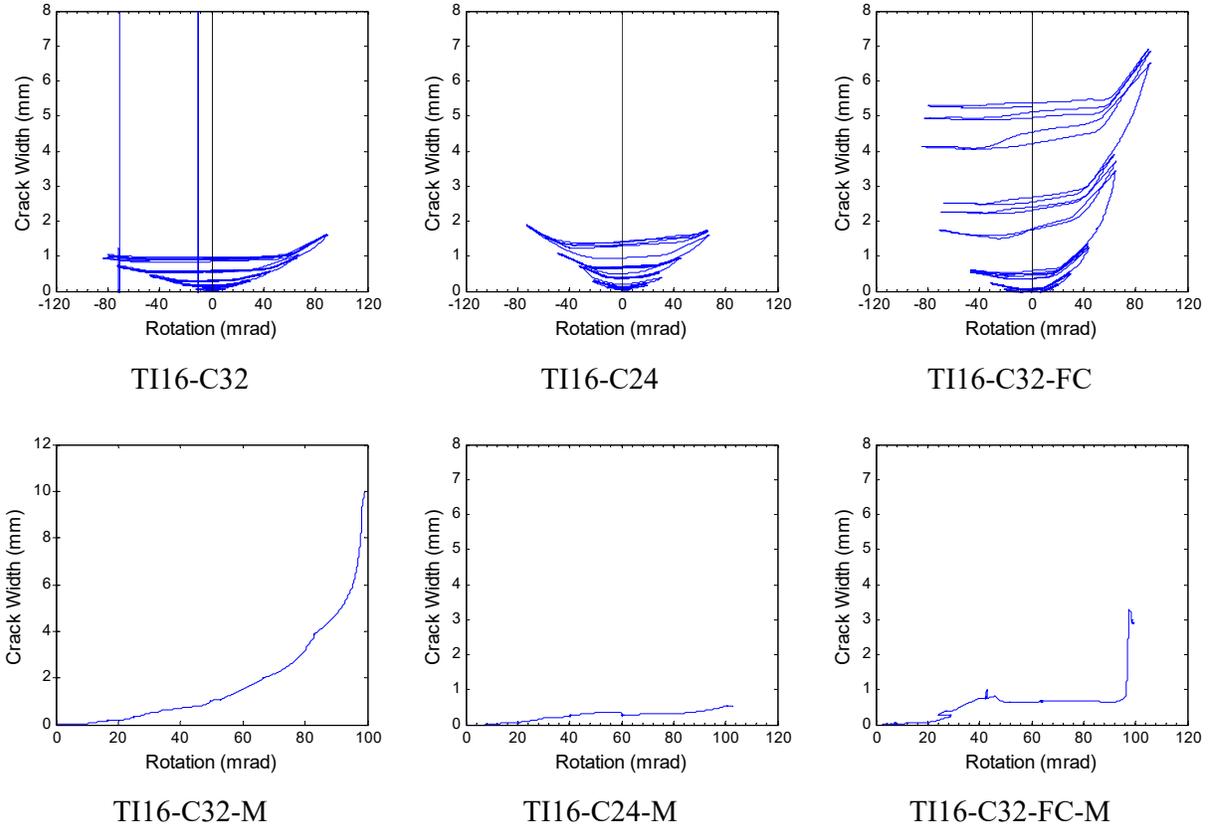
Figure 30: Typical width of vertical crack forming behind threaded insert with respect to panel rotation for panels with 16 mm starter bars
