In-plane seismic testing of precast concrete wall panels with grouted metal duct base connections

Abstract

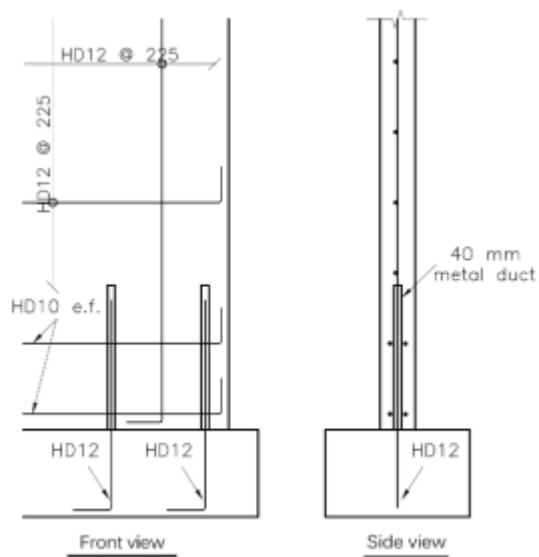
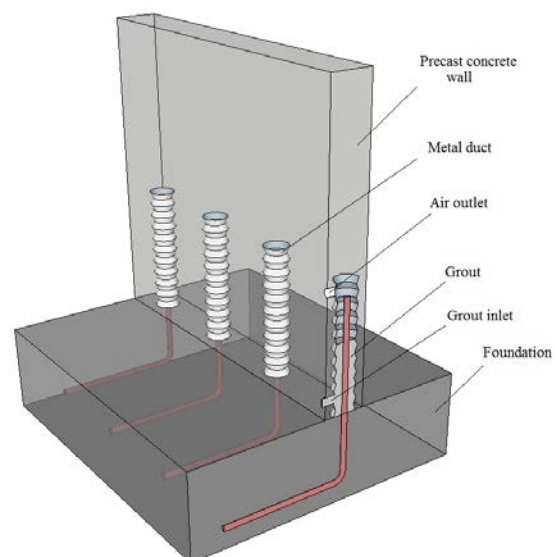
Fig. 1. Grouted metal duct connection details.

(a) An example of a conventional metal duct wall-to-foundation connection detail

(b) Grouted metal duct connection (wall panel and foundation reinforcement not shown)

One method that is used in New Zealand to connect precast concrete wall panels to their foundations entails the use of metal duct grouted connectors, with an example of a metal duct connection shown in Fig. 1a (Seifi et al. 2016). In this type of connection the starter bars from the foundation are positioned inside metal ducts with a thickness of 0.3 mm that are cast inside the wall panel, and then the metal ducts are filled with grout at the construction site, as shown in Fig. 1b. The main advantage of the metal duct grouted connection is the simplicity of this detail, but the vulnerability of the connection detail was revealed during the 2010/2011 Canterbury earthquakes (SESOC 2013). Fig. 2 shows an example of metal duct connection damage during the 2010/2011 Canterbury earthquakes. To increase the seismic robustness of the grouted connection between precast wall panels and the foundation, the Structural Engineering Society of New Zealand (SESOC) has recommended new detailing for this connection type (SESOC 2013). The proposed detailing requires that rectangular stirrups be used around ducts to provide confinement for the connection and also to improve the robustness of the splice between the connection and the vertical wall reinforcement, as shown in Fig. 3. It is generally accepted that confinement improves the strength of the splices (Riva 2006).

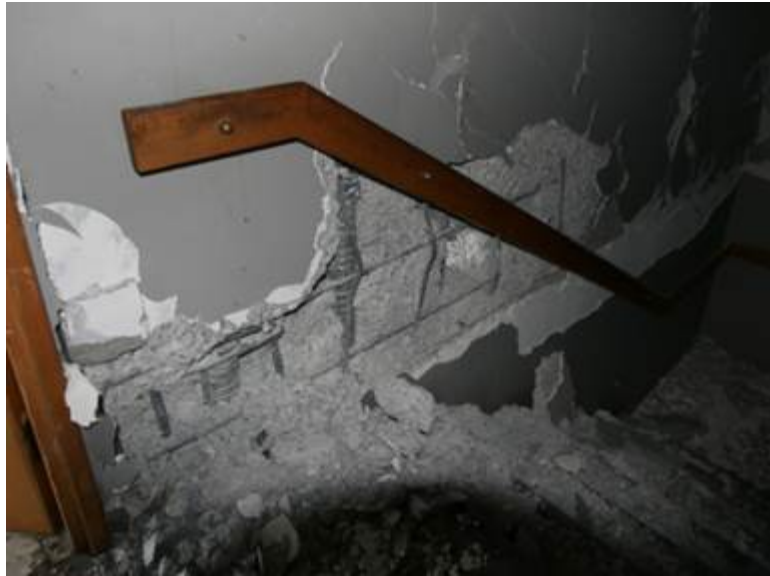
Fig. 2. An example of metal duct connection damage during the 2010/2011 Canterbury earthquakes.

The vulnerability of metal duct connections when used in precast concrete walls has been demonstrated in several past studies (Riva et al. 2006; Kim 2000) and also during the 2010/2011 Canterbury earthquakes in New Zealand (SESOC 2013). As an example, Crisafulli et al. (2002) tested a reinforced concrete shear wall that was connected to its foundation using metal ducts, in order to evaluate the seismic performance of walls having a lightly reinforced metal duct connection. The results of the experiment indicated that the wall lateral stiffness decreased significantly at small lateral drifts, and large residual displacements were measured during the experiment. In other research, the reversed cyclic behaviour of columns connected to their foundation using grout filled metal ducts was compared with the behaviour of cast-in-situ monolithic concrete columns (Kim 2000). It was found that the grouted metal duct connection performed poorly due to deterioration of the longitudinal bar splice, which caused reinforcement pull-out from the metal duct. Riva (2006) tested grouted-sleeve and grouted-pocket column-to-foundation connections, and compared the behaviour of two precast concrete columns having different connection types with the behaviour of cast-in-situ reinforced concrete columns. Cyclic horizontal displacement was applied to the top of the columns to generate cyclic moments at the column-to-foundation connection, and a constant axial load was applied. Although all columns had almost the same flexural capacity, their energy dissipation and failure displacement were different depending on the level of confinement provided to the connections, with enhanced ductility and lower pinching observed in the connections that had a larger confinement level. It was established that metal duct connections generally performed poorly as the column stiffness decreased due to the formation of large cracks that spread around the metal ducts.

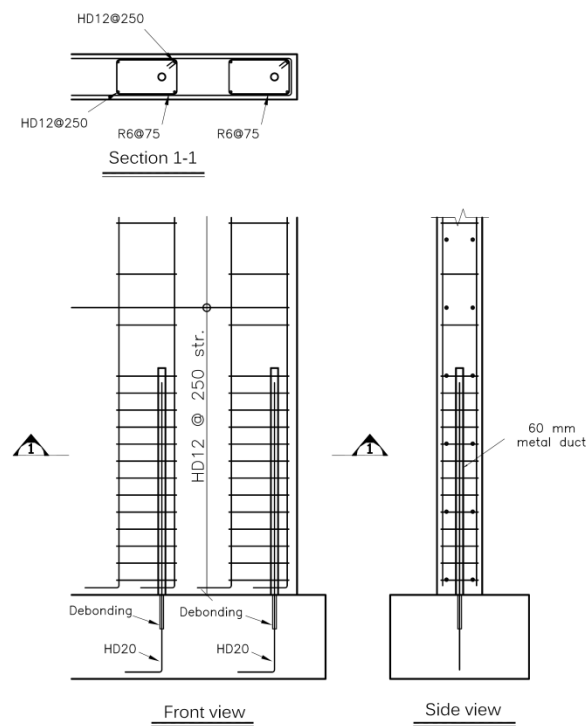
Fig. 3. An example of SESOC recommended detailing (SESOC 2013) for metal duct connections.

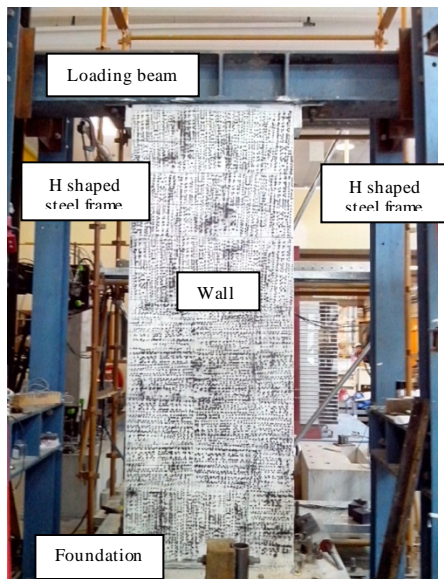
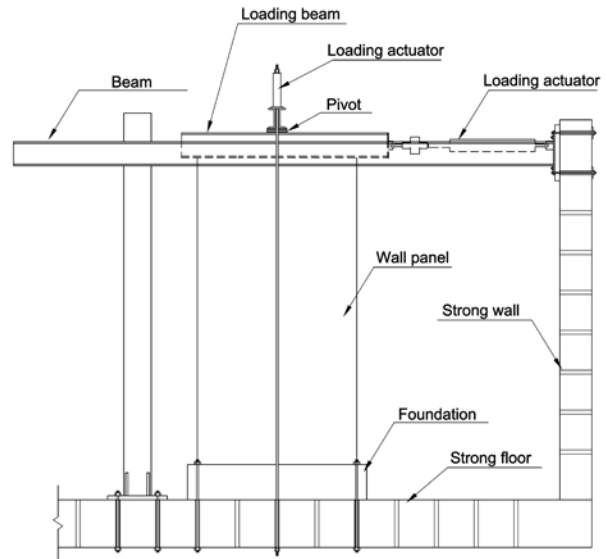
Fig. 4. Test setup

(a) Test setup without application of axial load

(b) Test setup with application of axial load

Two different test setups were used for testing the wall panels. For test specimens without applied axial load, the test setup primarily consisted of a reinforced concrete footing, a precast concrete wall panel, and a horizontally mounted hydraulic actuator providing the horizontal cyclic lateral force. The movements of wall panels were restrained in their out-of-plane direction by two parallel H shape steel columns that were positioned on each side of the wall panel. The details of the test setup are shown in Fig. 4a. Both sides of the gap between the H shape steel columns and the loading beam were lubricated with oil to minimize friction forces.

A different test setup was used in the experiments where axial load was applied, as the application of axial load was achieved using two post-tensioned bars that were placed on each side of the wall panel. During each of these latter experiments the bar force was adjusted to keep the applied axial force to within $\pm 5\%$ of the target force. The post-tensioned bars were connected to a beam that was placed perpendicularly on top of the steel I section beam positioned on top of the wall panel, and a pivot was used between two beams in order to prevent application of any out-of-plane moments to the wall panel. Two channel section beams were installed on each side of the wall panel in order to prevent out-of-plane wall panel movement. One end of the beams was connected to the strong wall and the other end was connected to a column placed at the other end of the wall panel. The beams restrained movement of wall panels in their out-of-plane direction. The details of the second test setup are shown in Fig. 4b.

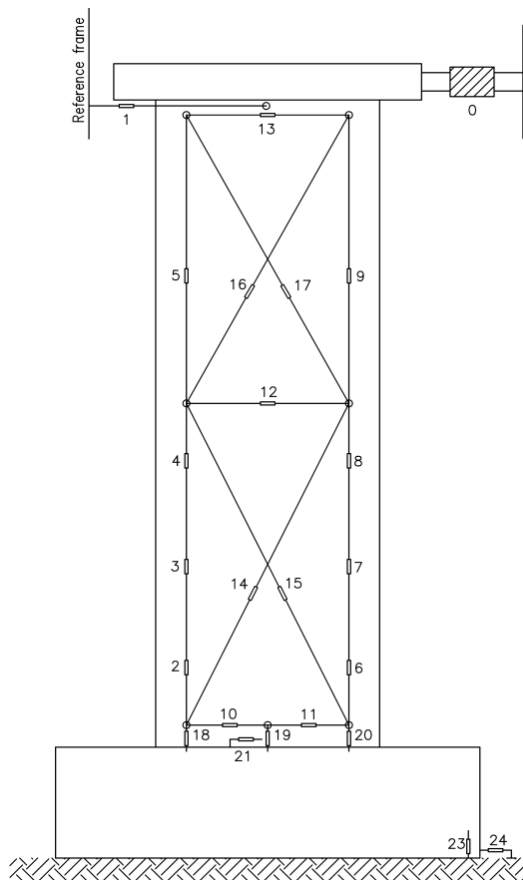
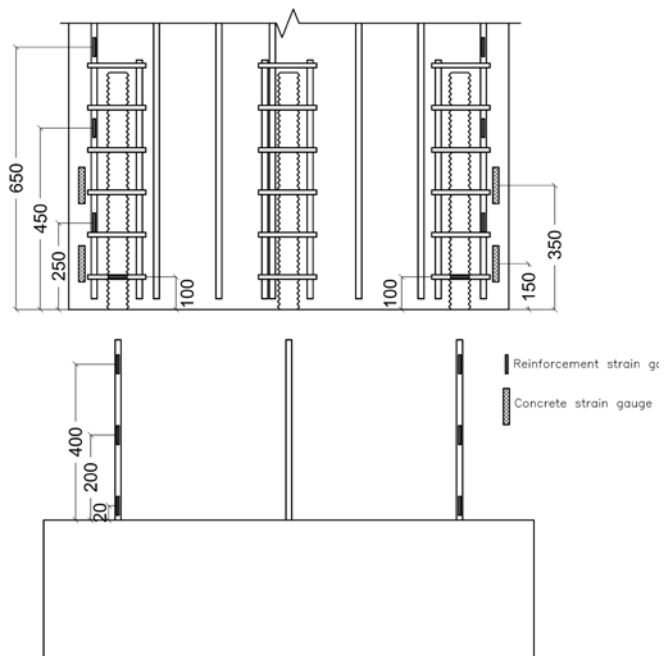
(a) Non-embedded instrumentation

* Not to scale; horizontal reinforcement not shown for clarity

(b) Distribution of embedded strain gauges

Fig. 5. Distribution of instrumentation (front view of wall panel)

The layout of instrumentation is shown in Fig.5. The walls were instrumented to monitor important aspects of wall panel response when subjected to in-plane lateral loads, with the lateral load measured by a load cell placed in series with the actuator. Two additional load cells were installed between the post-tensioned bars and the strong floor to measure the applied axial load, and the lateral displacement at the top of the wall panels was measured by a string potentiometer. To measure the lateral drift of post-tensioned bars during testing of Panel 5 another string potentiometer was used to monitor the lateral displacement that occurred at the top of the post-tensioned bars due to movement of the wall panel. Because the magnitude of this displacement was found to be negligible, a decision was made to not measure this displacement during the final two experiments. In-plane rocking deformations of the wall panels were measured using three displacement gauges that were positioned at the two ends and at the middle of the connection between the wall panel and the foundation. In addition, the relative in-plane sliding displacement between the wall panel and foundation was monitored by a displacement gauge and a LVDT installed midway along the connection. Shear and flexural deformations of the wall panels were measured by 16 displacement gauges installed on each wall panel, and two displacement gauges were used to measure sliding and uplift of the foundation relative to the laboratory strong floor.

Embedded strain gauges were utilized in each wall panel to measure reinforcement strains at critical locations, with the pattern of embedded strain gauges shown in Fig. 5. Three reinforcement strain gauges were positioned at the bottom, middle and top of the two outside connection bars extending from the foundation, at elevations of 20 mm, 200 mm, and 400 mm above the connection level. In addition, three reinforcement strain gauges were placed on the two outermost vertical bars of each wall panel. In the wall panels where confinement reinforcement was provided to the connection, two additional reinforcement strain gauges were attached to the bottom stirrups that confined the two extreme connection bars, as shown in Fig. 5. In addition, two concrete strain gauges were positioned at heights of 150 mm and 350 mm above the base of each wall.

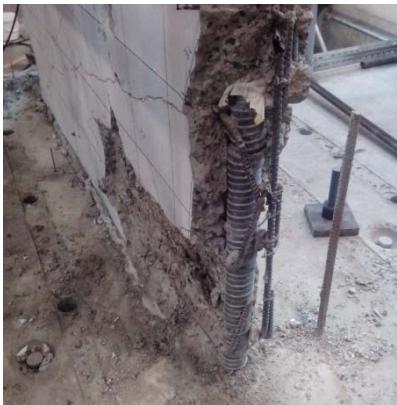
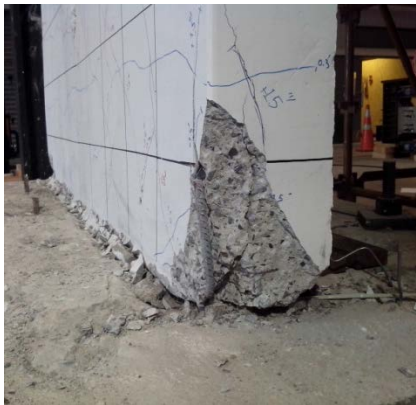
(a) Wall 6

(b) Wall 7

509 **Fig. 8.** Condition of compression zones of Wall 6 and Wall 7 at the conclusion of testing

- The extensive concrete damage at a drift level of 1.5% caused the outermost metal duct to be exposed and subsequently be pulled out of the wall panel as the connection splice failed , as shown in Fig. 8a.
- The wide cracks and more extensive concrete spalling observed in Wall 6 demonstrated the larger contribution of the wall panel flexural deformation to the overall response of Wall 6 in comparison with the previous five tests.
- Concrete spalling occurred in smaller area in Wall 7 in comparison with Wall 6 due to both the confinement reinforcement that ensured that the splice was maintained and the increased vertical reinforcement that supported the confinement reinforcement, as shown in Fig. 8b. Testing concluded at a drift level of 1.5% after the outermost connection reinforcement fractured at both ends of the wall panel.

In Fig. 10b and Fig. 10c the force-displacement response of Wall 6 and Wall 7 are shown. Larger lateral strengths were measured in these wall panels when compared with the previous five tests, due to the greater dimensions of the wall panels and the larger value of the axial load. At drift levels below 1.5% the behaviour of Wall 6 and of Wall 7 were almost identical, with peak lateral strengths reaching similar magnitudes of 308 kN for Wall 6 and 307 kN for Wall 7, although these peak strengths occurred at differing drift levels of 1.5% for Wall 6 and of 1.0% for Wall 7. The reason for the different drift capacity between the two experiments was attributed to the different failure mode in each experiment. Failure of Wall 6 was due to progressive concrete spalling which resulted in the metal duct becoming detached from the wall panel, as shown in Fig. 8a. In contrast the failure of Wall 7, which had more

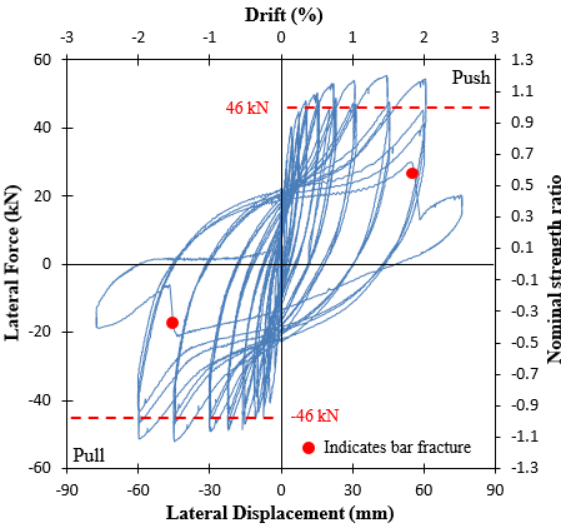
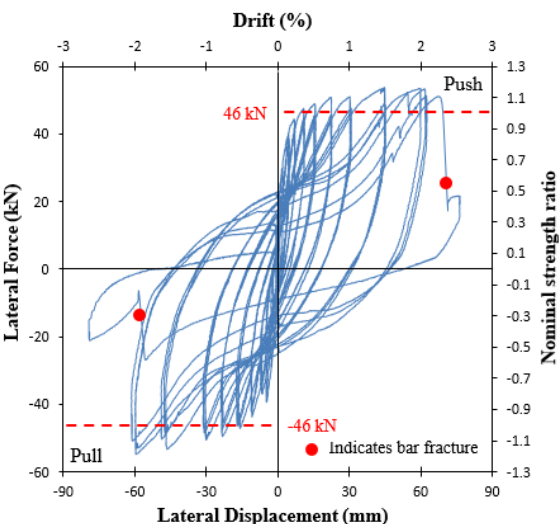
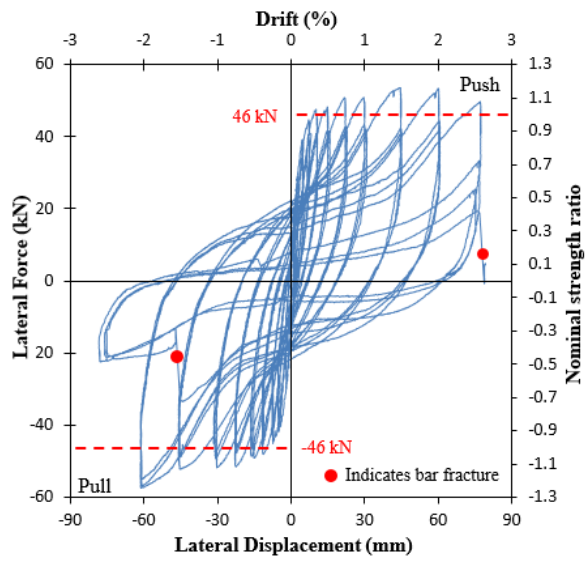
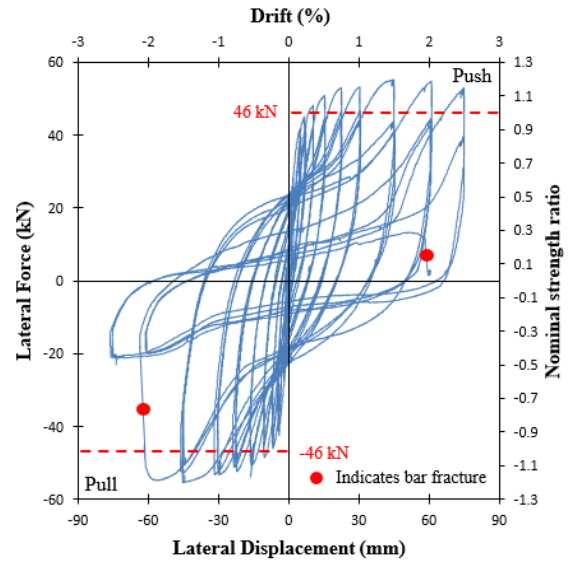
Fig. 9. Hysteresis response of wall panels with no applied axial load

The resultant force-displacement hysteresis responses for Wall 1 to Wall 4 are shown in Fig. 9. The behaviour of the four wall panels was very similar as their connection characteristics and subsequent failure modes were the same. During the first three forced-controlled loading cycles the wall panels were effectively elastic, whilst in the fourth cycle a nonlinear response was observed due to the commencement of both panel cracking and yielding of the wall-foundation connection reinforcement. In the following cycles a gap opened at the bottom of each of the four tested wall panels, causing pinching of the force-displacement response. This behaviour was due to the gap opening in the connection zone which decreased the stiffness of the wall panels because the moment was carried by only the connection reinforcement. Finally, all four tests were concluded when the connection reinforcement fractured, causing rapid strength degradation. The four wall panels had similar maximum lateral strengths of approximately 53 kN, and in all four wall panels the maximum measured lateral force was larger than the calculated nominal strength of the panel-foundation connection which was equal to 46 kN for Wall 1 to Wall 3, and 47 kN for Wall 4. All four wall panels achieved a drift capacity of 2% prior to fracture of the connection reinforcement.

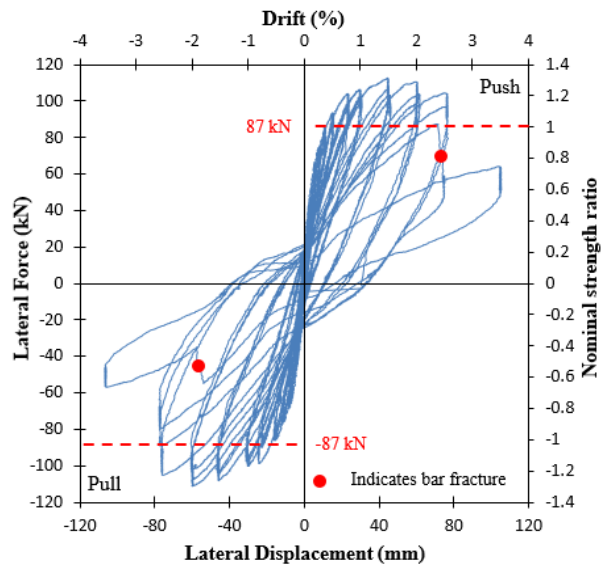
(a) Wall 5

Fig. 10. Hysteresis response of wall panels with applied axial load

The obtained force-displacement response for Wall 5 is shown in Fig. 10a. The wall panel behaved linearly during three force-controlled cycles, and in the next cycle yielding of the connection reinforcement commenced. At larger drift levels the hysteretic response began to display nonlinear behaviour, with larger residual displacement due to wall panel cracking and plastic deformation of the connection reinforcement. The magnitude of residual displacement was less than that measured during testing of Walls 1-4 due to fewer cracks forming in the wall panel and smaller gap opening at the

connection, attributed to the increased magnitude of applied axial load. When the 2.0% drift level was applied to the wall panel the lateral force reached the maximum recorded magnitude of 110 kN and at the next drift level of 2.5% more extensive cracking and concrete spalling occurred, leading to a reduction in wall panel stiffness, with the lateral force dropping to a magnitude of 75 kN (68% of the peak strength). Testing was concluded by applying a 3.5% drift level that caused fracture of the connection reinforcement. This reinforcement fracture occurred at a larger drift level than in the previous four experiments due to the reduced extent of gap opening at the connection and consequently smaller strains in the connection reinforcement for a given drift level. The maximum lateral force measured in this test was approximately twice the magnitude measured in the previous four experiments due to the larger axial load applied to the wall panel. The lateral strength of Wall 5 was also larger than the corresponding calculated lateral force for nominal flexural strength of the wall panel connection (87 kN). The other difference between this experiment and the earlier wall panel tests was that the unloading curve was less steeply inclined than for the four previous tests, causing smaller residual displacement at each cycle. In addition, there was less pinching of the force-displacement diagram for Wall 5 than for the previous four experiments. The reason for the differences in hysteretic response of Wall 5 in comparison to the previous four experiments was again attributed to the application of axial compression to the wall, which helped to close the wall-to-foundation joint when unloading.

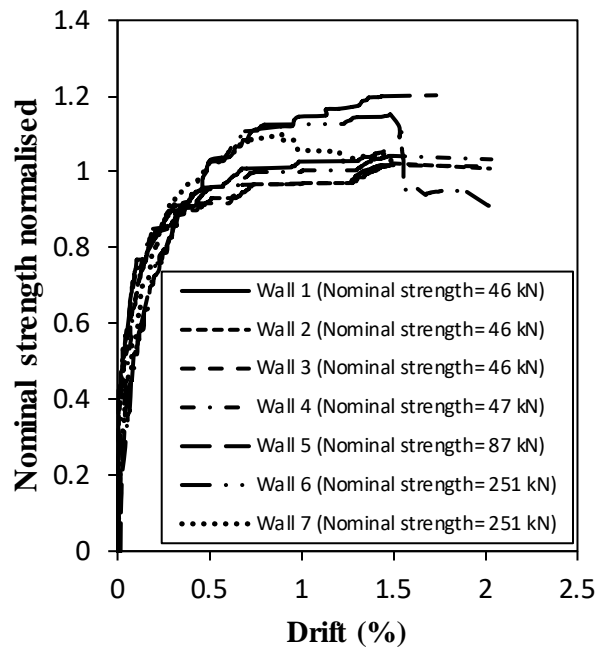
Fig. 11. Force-displacement backbone curves normalised against calculated nominal strength

The back-bone force-displacement responses extracted from the first cycle to each drift level for each of the seven experiments are compared in Fig. 11. In order to eliminate the effects of the different wall panel lengths and heights the ratios of measured lateral force to calculated nominal strength of the connections were plotted versus the magnitude of drift level, to reveal that the backbone curves of all wall panels were similar. It was also found that the last three tested wall panels, where axial load was applied, had larger margins above the normalized nominal strength than for the other four experiments.

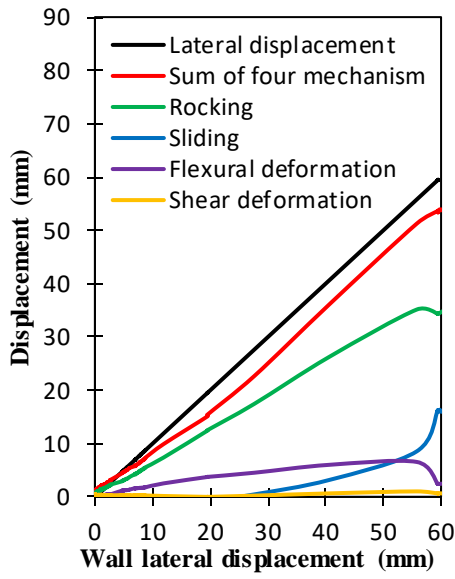
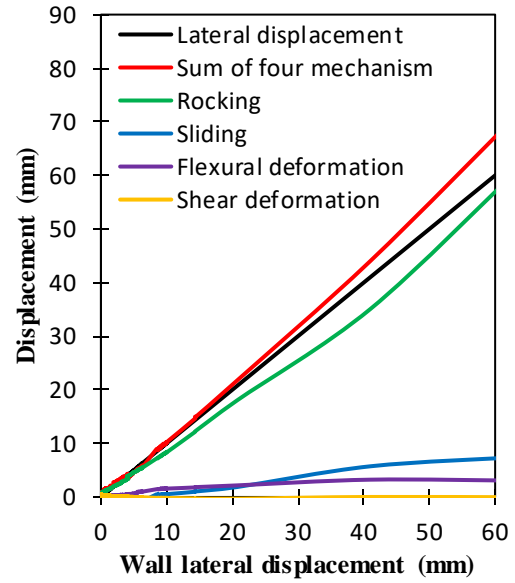
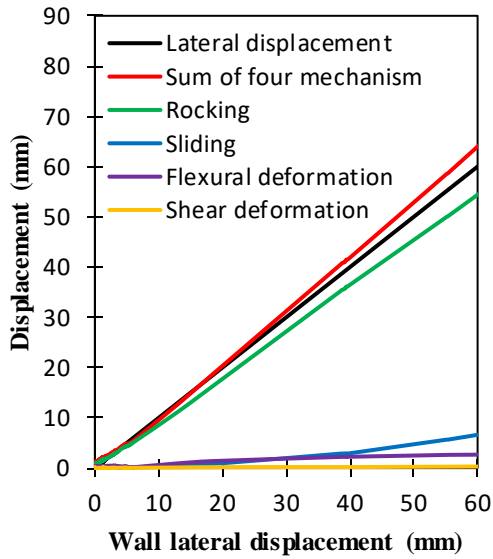
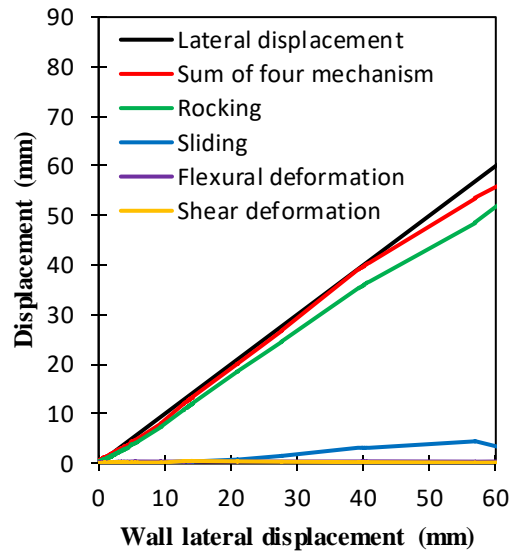
Fig. 12. Contribution of each deformation mode to overall response for wall panels with no applied

axial load

The contributions of the four in-plane mechanisms consisting of rocking, sliding, flexure, and shear deformation were measured in all experiments by using displacement gauges that were positioned on the wall panels and their connections to the foundation. Flexural deformations were obtained by measuring the rotation of the wall panel horizontal cross sections as proposed by Hiraishi (1984) and shear deformations were obtained using diagonal displacements, again based upon a previously proposed method (Hiraishi 1984) which considered the influence of flexural deformation on the measured diagonal displacements. The extent of wall panel rocking was calculated according to the uplift measured by two displacement gauges positioned at the extreme edges of the wall panel and sliding was obtained directly by a displacement gauge and an LVDT that were installed at the middle of the wall panel connection with the foundation. The sum of the four displacement mechanisms was compared with the measured displacement at the top of the wall panels and the difference between these two values indicated the measurement error, which was less than 10% for all seven tests. The contributions of each force-displacement mechanism to the overall response of the seven wall panels are shown in Fig. 12 and Fig. 13.

In general, the response of Walls 1-4 was dominated by rocking at the wall-to-foundation interface, contributing to between 69-90% of the total lateral displacement during larger drift cycles. The flexural deformation of Wall 1 was approximately 15% of the overall displacement when the connection

reinforcement was below the yield stress, but at larger drift levels yielding of the connection reinforcement resulted in a gap opening at the connection that facilitated rocking and sliding of the wall panel. Sliding displacements contributed more than flexural displacements to the total response of the wall panel at larger drift levels. Shear deformation had a negligible contribution to the force-displacement behaviour of Wall 1. A similar behaviour was observed for Wall 2 and Wall 3 but the contribution of rocking in Wall 4 was larger than for the previous three experiments because Wall 4 had a greater thickness and greater vertical reinforcement content, which limited both the flexural and shear deformations of the wall panel.

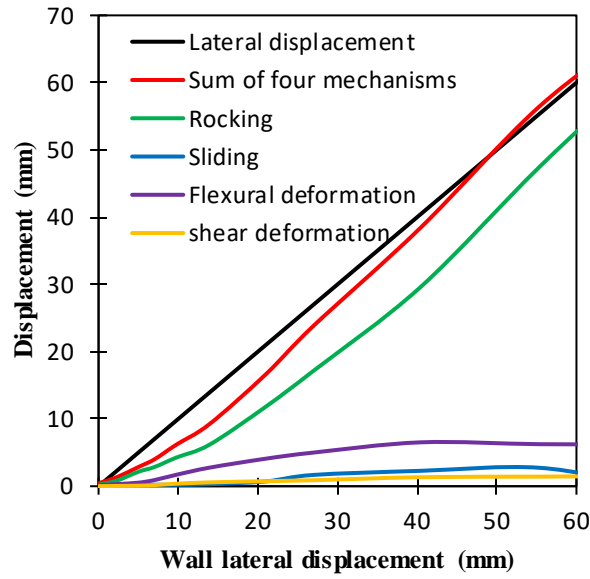
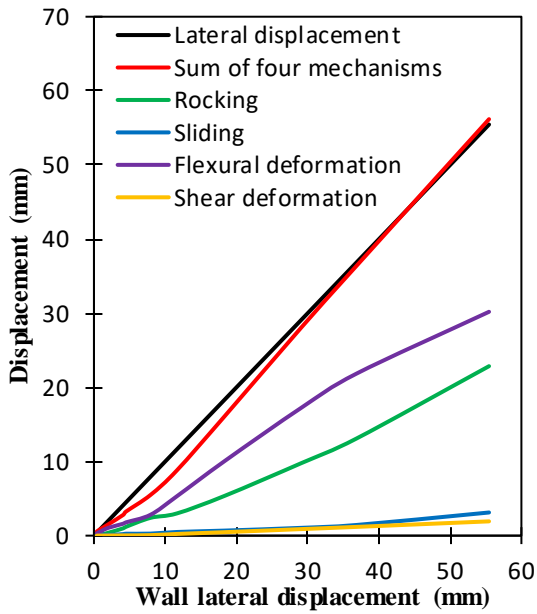
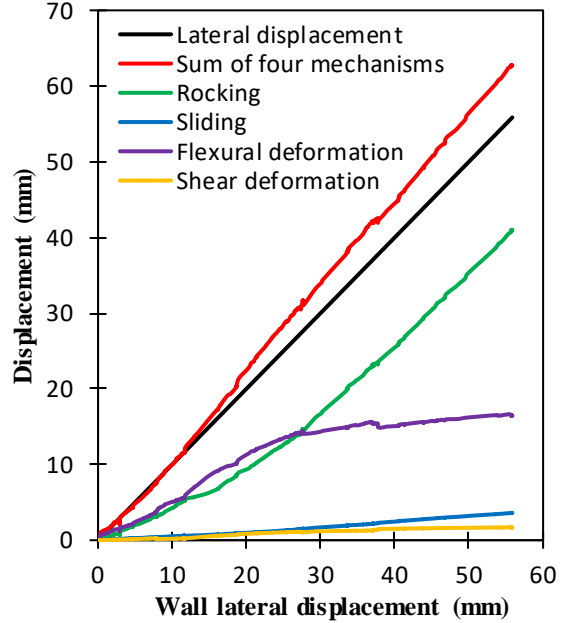
Fig. 13. Contribution of each deformation mode to overall response for wall panels with applied axial load

The contribution of rocking to the overall response of Walls 1-4 was larger than for Walls 5-7. The reason for this response was that the absence of applied axial load for Walls 1-4 facilitated rocking and limited the extent of concrete spalling, consequently decreasing the flexural deformation of these wall panels when compared to Walls 5-7. The contributions of sliding and rocking in Wall 5-7 were lower due to the application of axial load.

In Wall 6 and Wall 7 the flexural deformations of the wall panels had a greater contribution in comparison to the behaviour observed in the previous five tests. The increased flexural deformations were attributed to the increased panel dimensions and increased axial load, which resulted in increased panel cracking and spalling. Wall panel flexural deformation provided the largest contribution to the lateral displacement for Wall 6, whilst in Wall 7 panel rocking was more dominant. The larger contribution of flexural deformation in Wall 6 correlated with the observed increase in panel crack widths and spalling when compared to Wall 7 where the panel and connection splice remained less damaged and instead the wall panel rocked about the wall base.

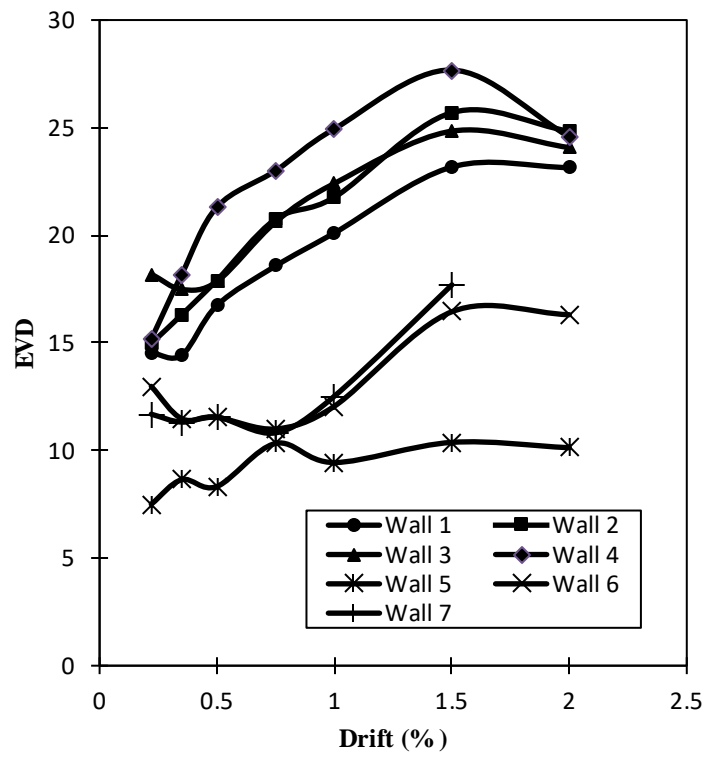
Fig. 14. Equivalent viscous damping of each wall panel

where ξ is equivalent viscous damping, A_h is the enclosed area of each cycle of the force-displacement diagram, Δ_m is the maximum displacement in a cycle, and F_m is the maximum lateral force in a cycle. The calculated EVD for the first cycle of each drift level for all wall panels is shown in Fig. 14. All wall panels had lower EVD when compared with commonly adopted values for monolithic reinforced concrete walls, which are typically greater than 20% at the failure cycle for wall panels subjected to moderate level of axial load and greater than 25% for wall panels having no applied axial load (Lu et al. 2016, Zhang and Zhihao 2000). The reason for this reduced level of EVD, when compared with comparable monolithic construction, was attributed to the reduced extent of plastic deformations, which mostly developed in the connection zone rather than as distributed plasticity associated with a traditional plastic hinge region at the base of the wall. The EVD increased as greater drift levels were applied to the wall panel up to a drift level of 1.5%, because at larger drift levels a larger extent of plastic deformation of the connection reinforcement and more extensive concrete cracking occurred than at smaller drift levels. In all experiments the EVD reached a peak value at a drift level of 1.5% and then reduced as larger drift levels beyond 1.5% were applied to the wall panels. This behaviour was mainly because of greater pinching of the force-displacement diagram at larger cycles that was attributed to a combination of bond slip and plastic deformation of the connection reinforcement as a gap opened between the wall panel and the foundation.

Wall 1 to Wall 4 had larger EVD than for the other three tested wall panels because no axial load was applied to these walls, resulting in a fatter hysteresis response. Walls 5-7 had lower EVD than for the previous four experiments because the applied axial load resulted in a more steeply inclined unloading force-displacement curve and an associated reduction in the enclosed area of each cycle. The EVDs of Wall 6 and Wall 7 were approximately the same when the applied drift level was below 1.5%, but the EVD of Wall 6 reduced at higher drifts due to splice degradation and disconnection of the two outermost reinforcing bars that caused a reduction in the capacity of the wall panel to dissipate energy.
