## **IMPROVED DETAILING OF PRECAST CONCRETE PANEL TO FOUNDATION CONNECTIONS TO WITHSTAND OUT-OF-PLANE EARTHQUAKE LOADS**

S.M. Burridge, M.P. Casey, M.L. Raby, H.D. Wright, L. Hogan, R.S. Henry, J.M. Ingham

Department of Civil and Environmental Engineering, University of Auckland

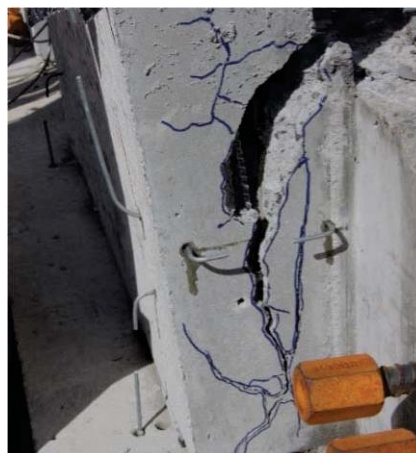
During almost all of the Burley et al. tests the flexural crack at the base of the panel propagated vertically down into the joint region, as shown in Figure 2. The vertical crack appeared to pass behind the threaded inserts, which were embedded slightly over halfway onto the panel thickness. The cracking in the joint severely degraded the response when subjected to higher drift levels, and was considered undesirable when compared to the ductile flexural response of the panel that was intended from the design.

Figure 2 - Panel vertical crack propagation

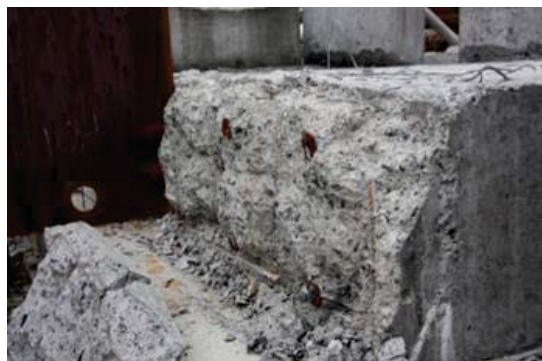
At the start of this study, damage to the Burley et al. (2014) test panels was inspected to better understand the failure mechanisms within the connection. To do this the 12 test panels were carefully deconstructed, while photographic evidence of the failure plane within in the panel and connection was collected. It was confirmed that the vertical crack in the connection region propagated behind the threaded inserts, resulting in a cone type failure developing in most of the test panels, as shown in Figure 4.

Figure 4 - Cone breakout failure observed during panel demolition

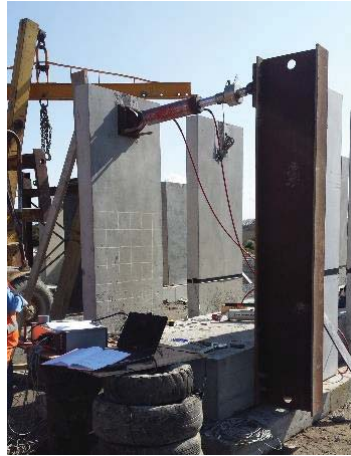
The test setup is shown in Figure 11, and was based on the test setup used by Burley et al. (2014) during the previous out-of-plane panel tests. Displacement controlled, quasi-static, reverse cyclic loading was applied at a height of approximately 2.5 m above foundation using a 500 kN hydraulic jack. Testing commenced with a single cycle at each level until the panel reached its calculated nominal yield strength, after which three cycles were conducted for each drift level.

Lateral displacements were measured close to the top of the panel and both above and below the panel-to-foundation interface using a draw wire and two LVDT's. Crack widths, joint rotation and separation of the panel to foundation connection were monitored by using portal gauges near the panel base. Additionally, strain gauges were placed on the reinforcement that extended into the foundation.

Figure 11 - Test setup

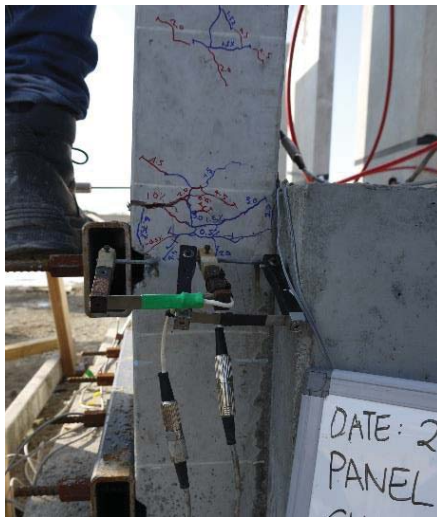
Panel 1 was designed as the 'ideal' connection detail and performed as expected due to the foundation connection reinforcement being well developed from the outside face of the panel. Initial flexural cracks formed at the base of the panel during cycles to 0.5% drift, as shown in Figure 12a. As the drift levels increased, additional flexural cracks formed higher up the panel, at approximately 200 mm centres. The highest crack occurred at approximately 600 mm above the top of the foundation. At 2% drift, the two largest flexural cracks were approximately 1.5 mm to 2.0 mm wide. By 4.5% drift, 4 mm cracks were observed immediately above the top rectangular hollow section, and concrete crushing was observed on the reversing cycle. The response was dominated by flexural deformations in the panel itself, with no damage occurring within the connection joint region.

(a) Panel cracking

Figure 12 - Panel 1 test results connection cracking and moment-drift hysteresis plot

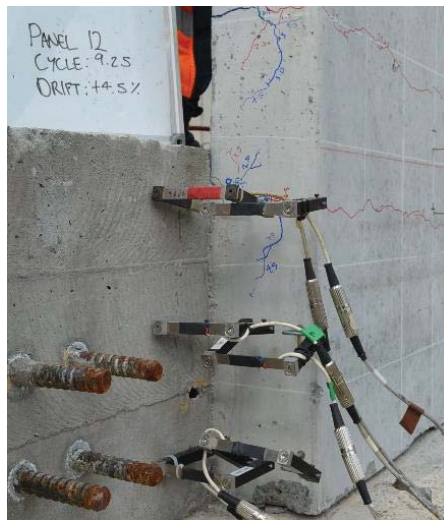
Panel 12 was one of the threaded inserts connections with additional double headed studs. As with Panel 1, flexural cracks initiated at the panel base during early drift cycles. During larger drift cycles additional flexural cracks formed up the height of the panel and crack widths widened. The highest flexural crack occurred at approximately 1200mm above the foundation. No significant damage was observed to the panel connection joint region, apart from a slight vertical hairline crack propagating from the horizontal crack at the level of the top insert during cycles to 4.5% drift, as shown in Figure 13a.

(a) Panel cracking

Figure 13 - Panel 12 connection cracking and moment-drift hysteresis plot
