## TESTS ON SLENDER DUCTILE STRUCTURAL WALLS DESIGNED ACCORDING TO NEW ZEALAND STANDARD

Farhad Dashti<sup>1</sup>, Rajesh P. Dhakal<sup>2</sup> and Stefano Pampanin<sup>3</sup>

### ABSTRACT

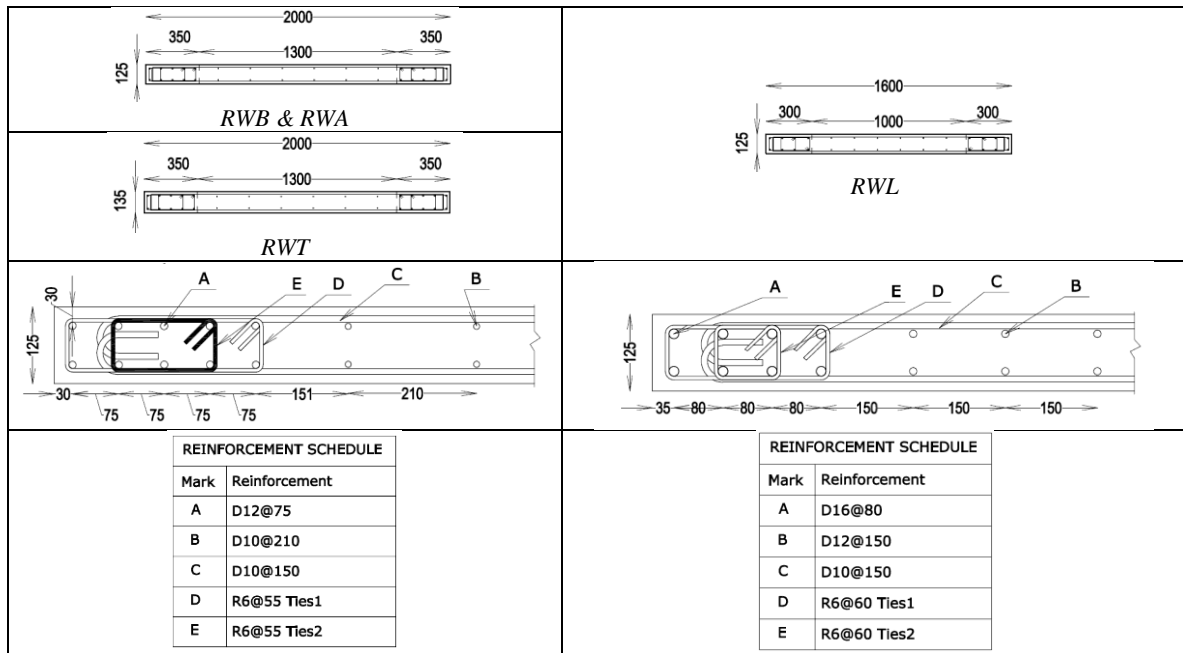
Figure 1. Geometry and reinforcement configuration of the four specimens (D refers to deformed bars, R to plain round bars).

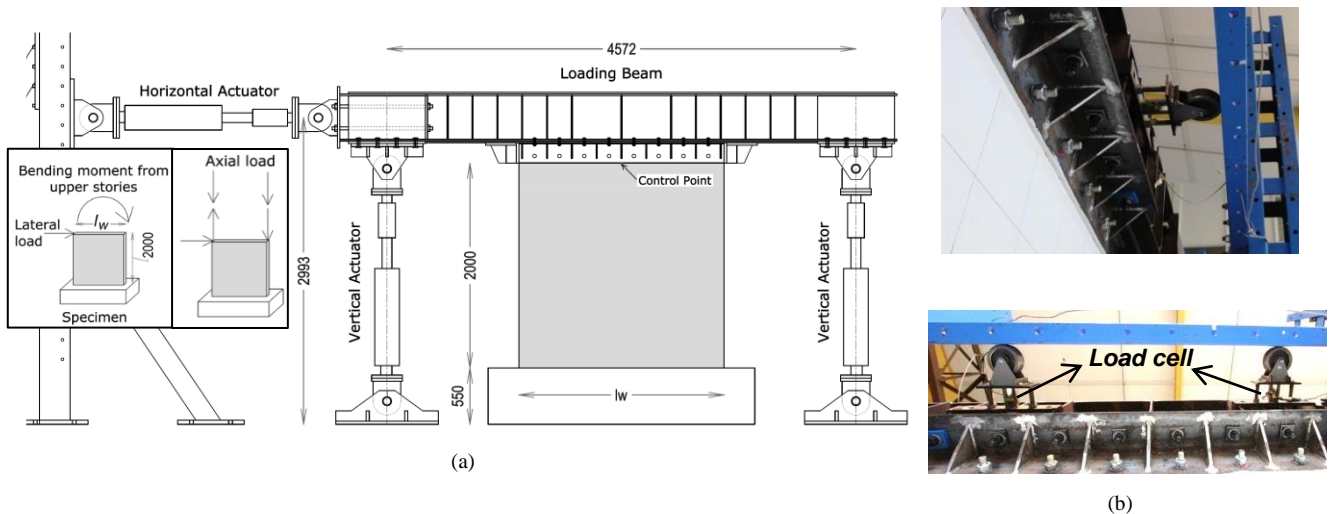
Figure 2. Test set up: (a) configuration of actuators (units in [mm]); (b) out-of-plane support and connection details of the loading beam.

The test setup was designed to apply the lateral load as well as the bending moment coming from the upper stories. Figure 2a displays the configuration of horizontal and vertical actuators producing this loading pattern. As the movements of the horizontal and vertical actuators were interdependent, a control program was designed to balance the actuators at each step through an iterative approach so that they comply with the above mentioned loading conditions and satisfy the shear-span of 6.0m. A safety frame was designed to avoid any instability issues of the loading frame in the event of a sudden wall failure. The specimen was connected to the loading beam by two steel angles bolted to the wall panel through embedded threaded rods and to the loading beam by high strength bolts.

Figure 2a shows the elevation of Specimen RWB where the wall is connected to the loading beam using steel angles clamping the specimen at both sides. This height is the story height determined in the design phase of the specimen. The loading beam was restrained against out-of-plane displacement using roller supports, as shown in Figure 2b.

These roller supports were positioned at different elevations of the loading beam to restrain the rotation of the loading beam and consequently of the top of the specimen, representing the restraints at the storey level of a structural wall connected to the floor system in a building. A load cell was attached to each roller to measure the variations of the out-of-plane load at different stages of loading (Figure 2b).

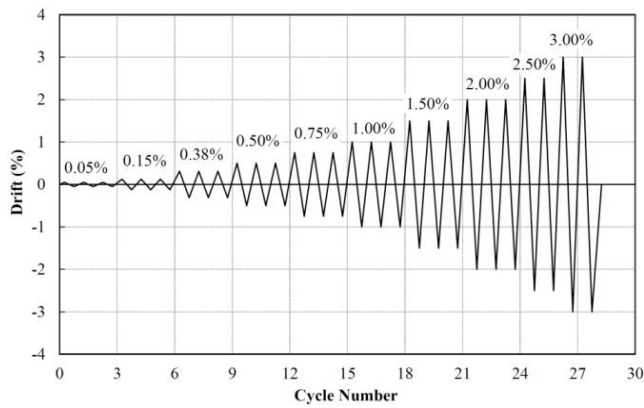
Figure 3. Applied displacement history.

The specimens were subjected to an in-plane quasi-static cyclic loading regime with three cycles at each drift level. Figure 3 displays the displacement history of the control point, located at elevation of 2.0m from the wall base (Figure 2a), which was used to control the horizontal actuator. As the inter-storey drift (not the overall building/wall drift) is considered as a performance limit/target by the New Zealand standard for structural design actions [18], the horizontal displacement within the bottom storey was used to control the loading program. The loading applied by the vertical actuators consisted of the axial load and the bending moment corresponding to every increment of the lateral displacement.

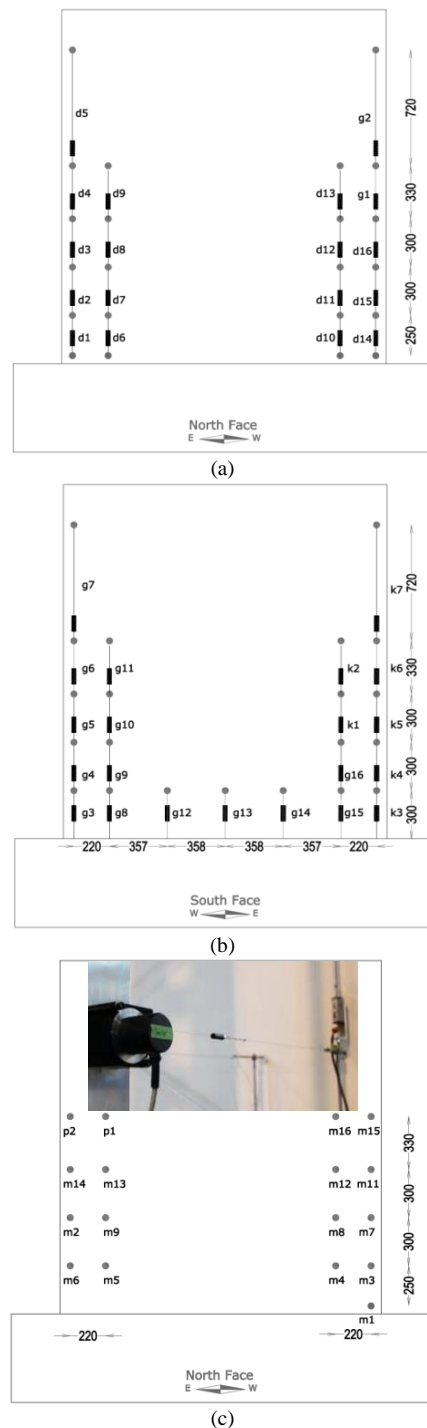
Figure 4. Instrumentation: (a) potentiometers-north face; (b) potentiometers-south face; (c) strain gauges and welded couplers and potentiometers attached to the couplers for measuring the average reinforcement strain; (d) string potentiometer for measuring out-of-plane displacements.

Thirty-six linear potentiometers were attached to the boundary zones at two faces of the wall to measure the vertical displacements of the wall boundary regions at different positions along the wall height. This information could be used to capture the variation of vertical displacements along the wall thickness and identify the loading stage corresponding to the initiation of out-of-plane displacements. Figure 4a and Figure 4b indicate these linear potentiometers in the north and south faces of the specimen, respectively. As it can be seen in Figure 4b, in addition to the potentiometers attached to the boundary regions, three potentiometers were used along the wall panel and at the base to capture the variation of vertical displacements along 300 mm distance from the base. This information would help to analytically derive the nonlinear strain profile along the wall length and identify the neutral axis position at different stages of loading. Shear deformation of the wall panel was measured using diagonal potentiometers. Reinforcement strain at different stages of loading, unloading and reloading has been identified as one of the main parameters controlling out-of-plane deformations of rectangular walls [11, 19, 20]. In order to investigate the effect of this parameter, in addition to seventy strain gauges attached to the reinforcement along the half-height of the wall, couplers were welded to the longitudinal reinforcement at each extreme end to capture the average reinforcement strain along the distance between two couplers (400-550 mm). Figure 4c displays a typical string potentiometer used for measuring the out-of-plane deformations of the specimens and their positions along the half height of the wall.

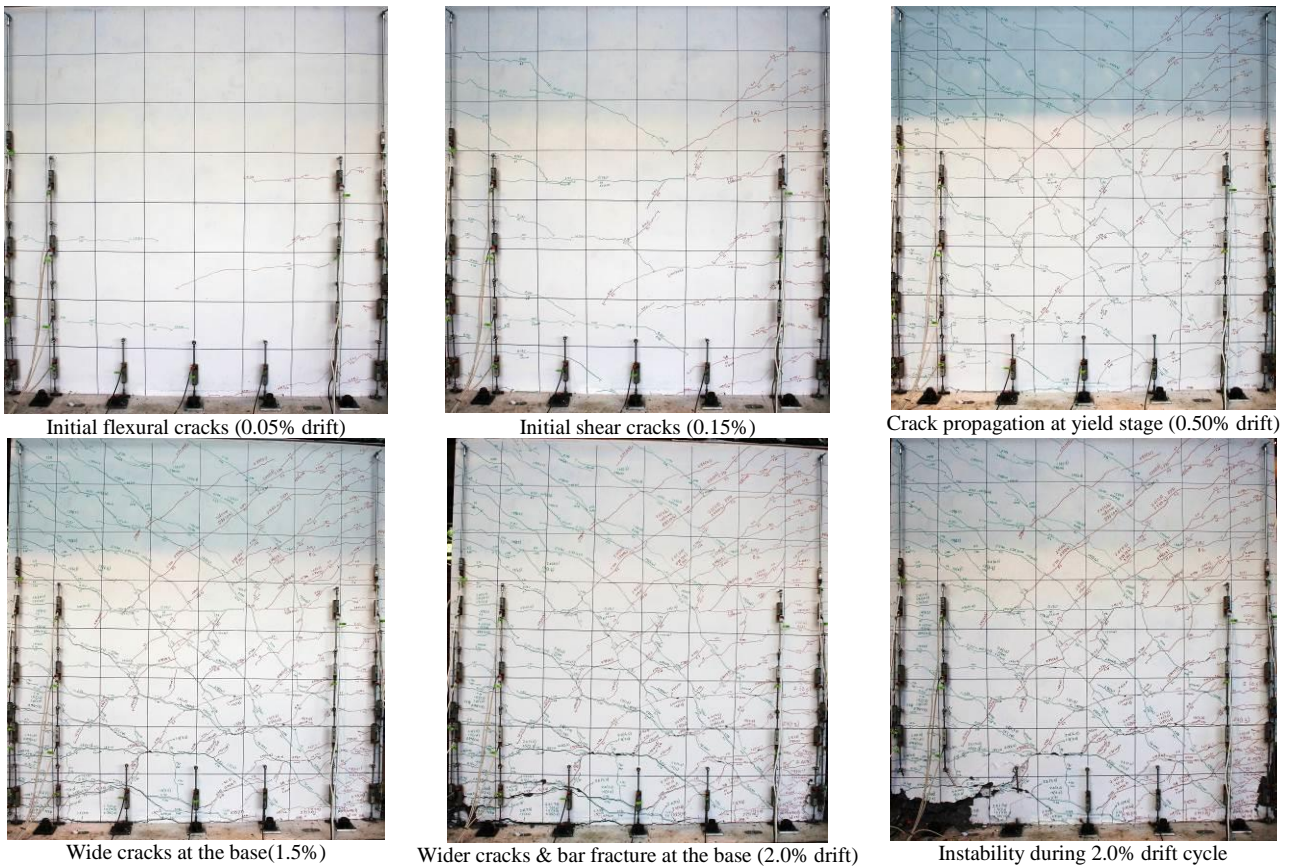
Figure 5. Crack pattern of Specimen RWB at different stages of loading - grid size 250x250 mm.

Specimen RWB was the benchmark specimen. Figure 5 displays the crack pattern of this specimen at different stages of loading. Figure 6 shows its lateral load versus top displacement response. The sequence of events resulting in the failure of the specimen is indicated in this figure.

Initial cracking occurred in this specimen at 0.05% drift level. As it can be seen in Figure 5, the cracks at this stage were all horizontal flexural cracks mostly located in the boundary zones. At 0.15% drift level, these horizontal cracks extended more with a diagonal orientation at the central region, and new cracks initiated up to a height of 1750 mm from the base of the specimen. The maximum crack width at this stage was 0.25 mm and the cracks were more distributed in the boundary regions but merged into a wider crack in the central panel region.

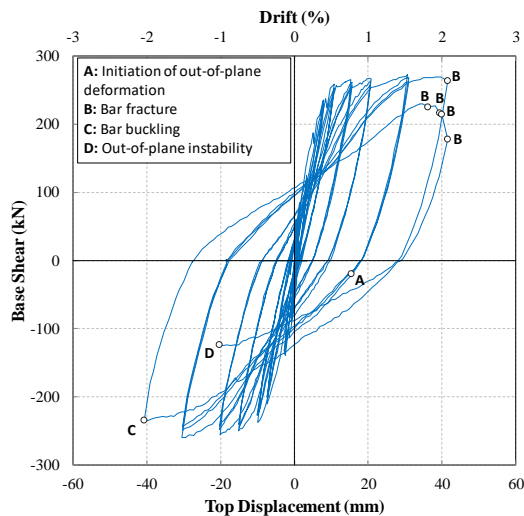
Figure 6. Lateral load vs. top displacement response of Specimen RWB.

While reaching the peak displacement of the first 2.0% drift cycle, a bar in the extreme tension region snapped at the base. The cracks widened within 600 mm from the base; the base crack width reached 7.0 mm. When the load was applied in the opposite direction, the out-of-plane deformations increased in the west boundary region and reached the maximum value of 17 mm at about zero displacement. This out-of-plane deformation did not recover completely at the peak displacement of -2.0% drift level and the following cycle started with about 6 mm residual out-of-plane deformation in the west boundary zone. At this stage bar buckling was observed at the base of the compression boundary region (Point C, Figure 6). Point C was decided based on visual appearance of bar buckling after the cover concrete was spalled. The exact point of initiation of bar buckling could not be detected, and it is likely that the bars might have started to buckle earlier. During the second cycle of 2.0% drift level, more bar fractures happened at the base of the west boundary region, and the specimen exhibited higher out-of-plane deformations when the load was reversed. Unlike the previous cycle, the out-of-plane deformation did not recover and increased steadily. At this stage, the strength degraded by about 50% (Figure 6) and the test was interrupted.

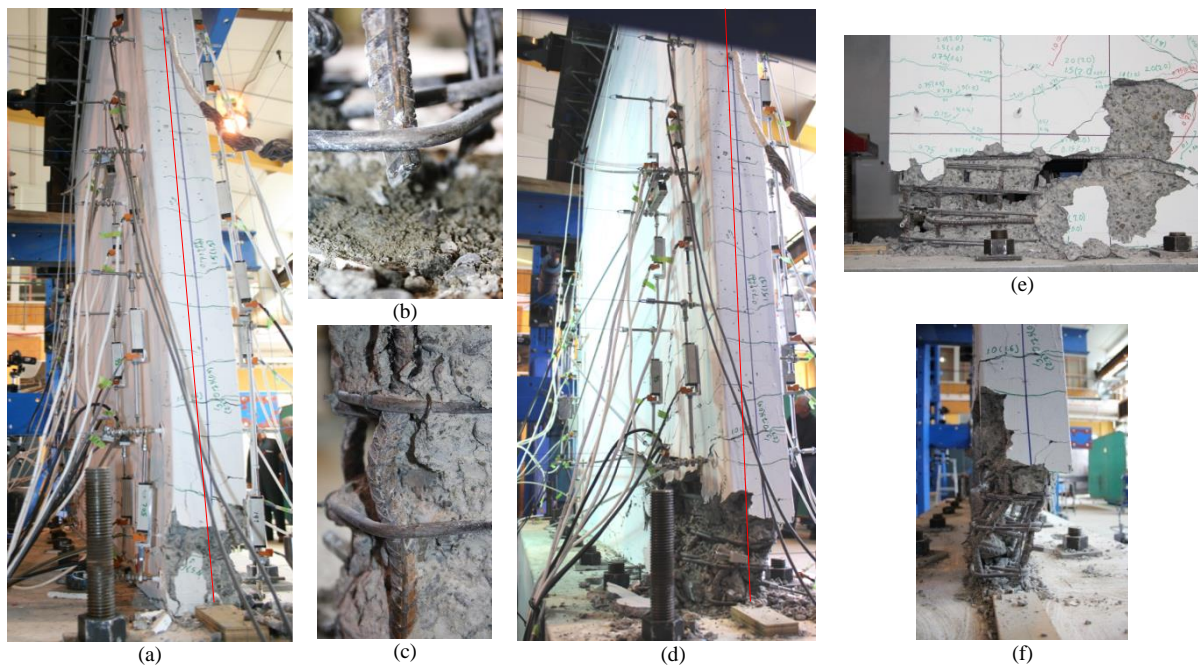
**Figure 7. Response of Specimen RWB: (a) out-of-plane deformation; (b) bar fracture; (c) bar buckling; (d) instability; (e&f) extent of concrete crushing.**

Figure 7 displays some of the observations at ultimate stages of the response of Specimen RWB. As can be seen in this figure, the bar fracture and bar buckling at the base resulted in concrete crushing in this region.

This concrete crushing along with the instability of the reinforcement under compression led to a laterally unstable cross-section, and as the specimen had exhibited out-of-plane deformation at earlier stages, it caused out-of-plane instability of the specimen.

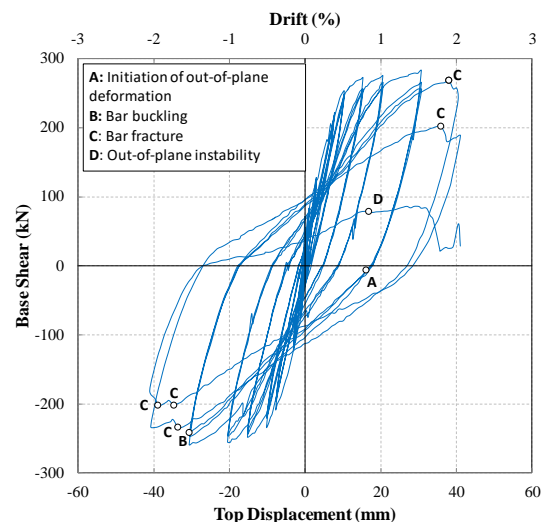
**Figure 8. Lateral load vs. top displacement response of Specimen RWT.**

in this boundary region. A relatively wide crack at the base (with 5.0 mm crack width), which remained wide open during unloading and even reloading in the opposite direction, was a sign of larger tensile strains at the base of the specimen. Out-of-plane deformations initiated in the east boundary zone, as well, during the first cycle of 1.5% drift level with maximum out-of-plane displacement of 6 mm. At this drift level, cover spalling was observed in both boundary zones. A buckled bar was observed in the east boundary zone during the third cycle of this drift level (Point B, Figure 8).

While reaching the peak displacement in the 1st cycle of 2.0% drift level, one bar fractured in the west boundary zone accompanied by a degradation observed in the load-displacement curve. The buckled bar in the east boundary straightened during the load reversal at -1.55% drift level. One bar also buckled in the west boundary zone, and one bar fractured in the east boundary at -1.8% drift, which resulted in another abrupt drop in the load-displacement curve. The fractured bar is the same bar that had buckled in the previous peak. Different instances of bar fracture are denoted as “C” in Figure 8, whereas only the initial bar buckling is shown in this

figure (Point B) as bar fracture was generally accompanied by bar buckling in the opposite boundary zone.

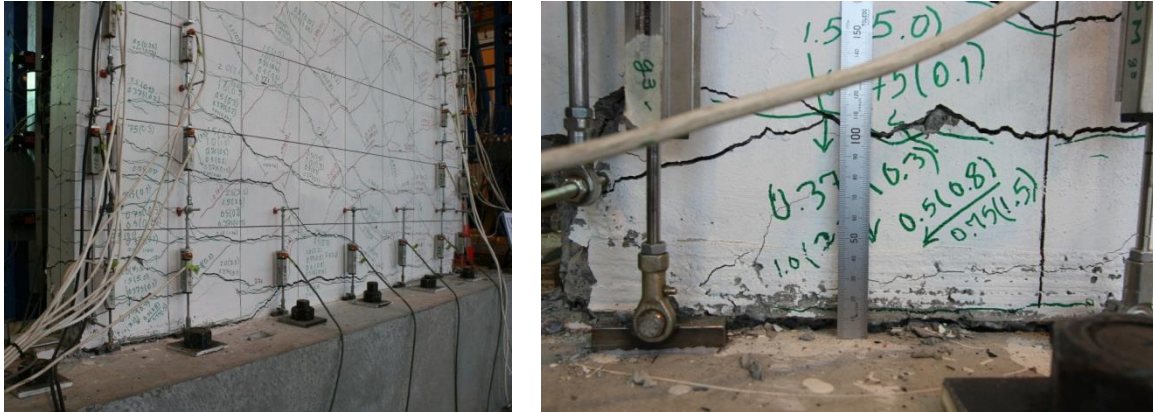
Figure 9. Wide cracks at +2.0% drift level – Specimen RWT.

The overall response of Specimen RWT was very similar to the one of Specimen RWB, and its failure initiated with out-of-plane deformation and included bar fracture and bar buckling at later stages of loading. However, the values of out-of-plane displacement were smaller in Specimen RWT compared to Specimen RWB when bar fracture had not come into effect in both specimens, which could be due to the slight increase in the wall thickness. Figure 9 and Figure 10 display the cracking, cover spalling, bar buckling and bar fracture observed in this test and Figure 11 shows the instability of this specimen.

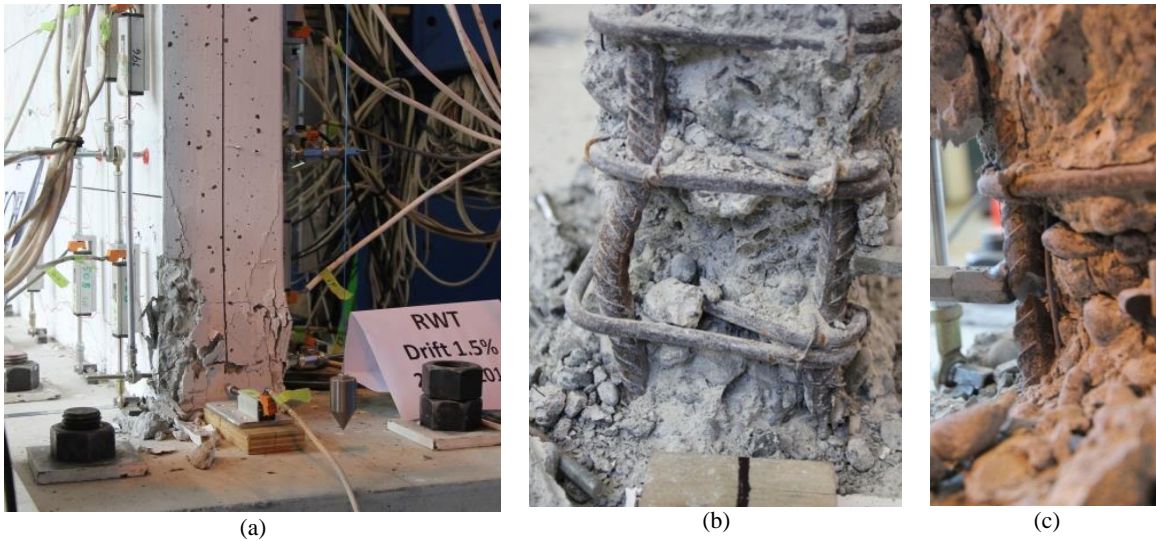
Figure 10. Development of local damage in Specimen RWT: (a) Cover spalling; (b) bar buckling; (c) bar fracture.

In addition to bar fracture, bar buckling was also observed during the 2.0% drift cycles in Specimens RWB and RWT although buckling resistance provisions of NZS3101:2006 (Table 5) were satisfied. The bar buckling mode of these specimens, shown in Figure 7d and Figure 10b, indicates that the effective buckling length is higher than the transverse

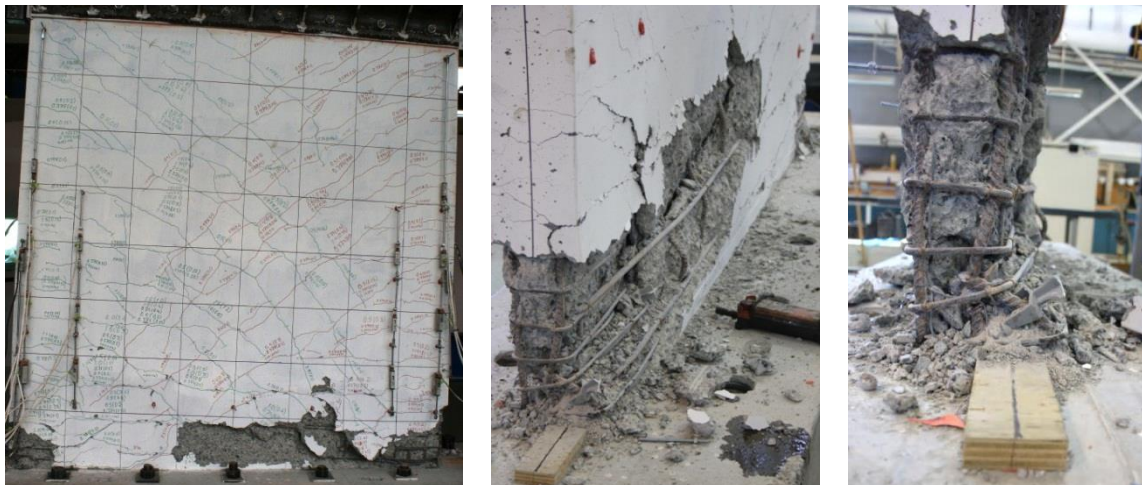
Figure 11. Instability of Specimen RWT.

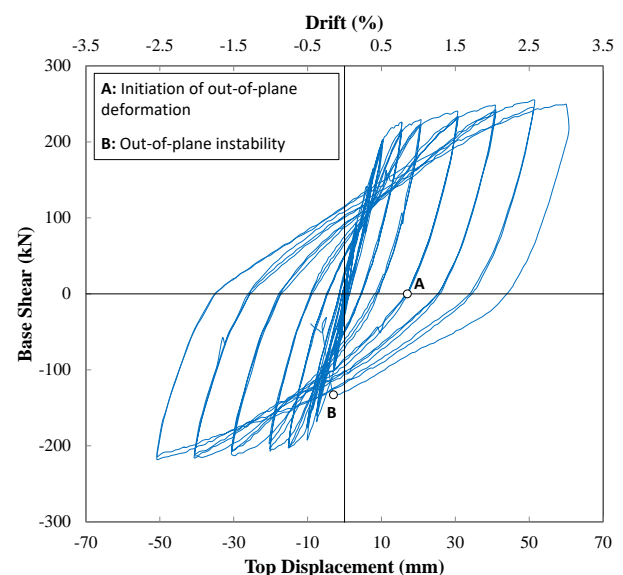
Figure 12. Lateral load vs. top displacement response of Specimen RWL.

Specimen RWL had a 20% reduction in length when compared to the benchmark RWB to investigate the effect of wall length on initiation and development of out-of-plane deformations. Therefore, this specimen had larger reinforcement ratios in the boundary regions and in the web to provide a flexural capacity close to the other specimens. The over-strength moment capacity of Specimens RWB and RWT was calculated to be 1522kNm and that of Specimen RWL was 1485kNm. Figure 12 displays the lateral load-top displacement response of the specimen. The failure pattern of the specimen was pure out-of-plane instability and neither bar fracture nor bar buckling was observed in the test. The out-of-plane deformation initiated at Point A when the specimen was unloaded from 1.5% drift and was starting to reload in the opposite direction. The out-of-plane deformation recovered completely as the specimen was reloaded in the opposite direction. This out-of-plane displacement recovery happened at early stages of loading. During 2.5% drift cycles, the out-of-plane deformation did not recover completely, and the specimen started to exhibit residual out-of-plane displacement. The residual out-of-plane displacement increased with the number of cycles and the specimen became unstable at Point B where the abrupt strength degradation was observed.

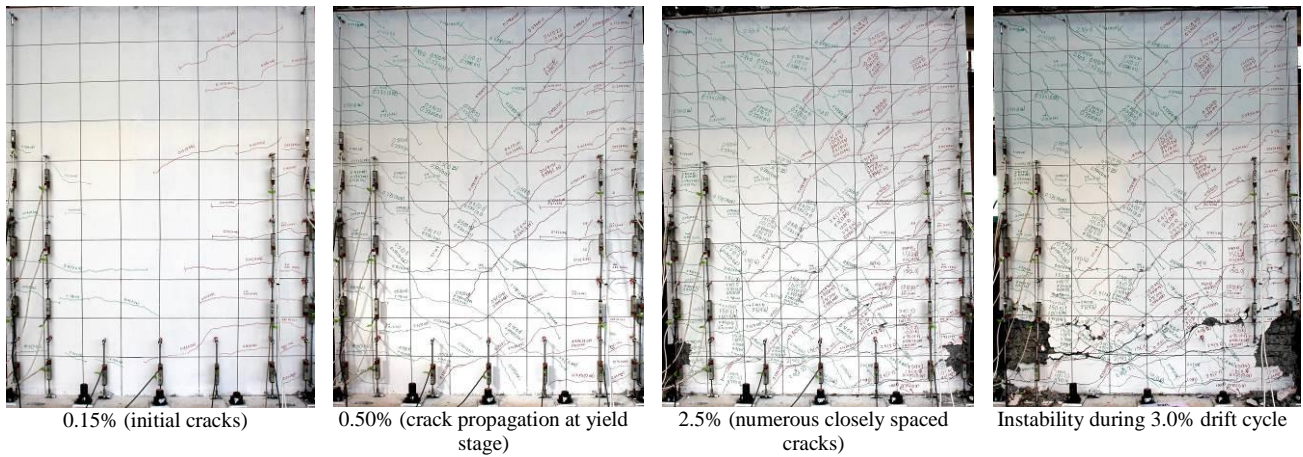
Figure 13. Crack pattern of Specimen RWL at different drift levels - grid size 200x200 mm.

Figure 13 displays the crack pattern of the specimen at different stages of loading. The grid size was 200x200 mm for this specimen. The specimen did not exhibit any cracking at 0.05% drift cycle. The first cracking happened at 0.06% drift during the 0.15% drift cycle at about 550 mm from the base. As it can be seen in Figure 13, the flexural cracks were distributed along the whole height of the specimen during the 0.15% drift cycle. The crack width was almost equal throughout the wall at this stage and was about 0.04 mm. The number of horizontal cracks increased significantly at 0.38% drift level. These cracks were observed mostly along the boundary regions. A considerable number of diagonal cracks were observed throughout the panel at this drift level, as well. The distribution of crack width was almost uniform all over the specimen which can be attributed to the fact that the specimen represented the plastic hinge region of a four-storey wall. The cracks became wider and increased in number at 0.5% drift level. During the first cycle of 0.75% drift, a wide crack (1 mm) developed at the base and extended up to 1150 mm along the wall length (70% of the wall length). Another wide crack was observed at about 200 mm from the base in the boundary region which did not extend more than 600 mm along the wall length. According to the lateral load-top displacement response of the specimen, this is the stage where overall yielding of the specimen happened. During the 1.0% drift cycles, the width of horizontal cracks in the boundary region increased considerably within 600 mm from the base and the width of diagonal central region cracks increased within 1000 mm from the base. Cover spalling was observed at the extreme compression end of the specimen during the 1<sup>st</sup> cycle of 1.0% drift.

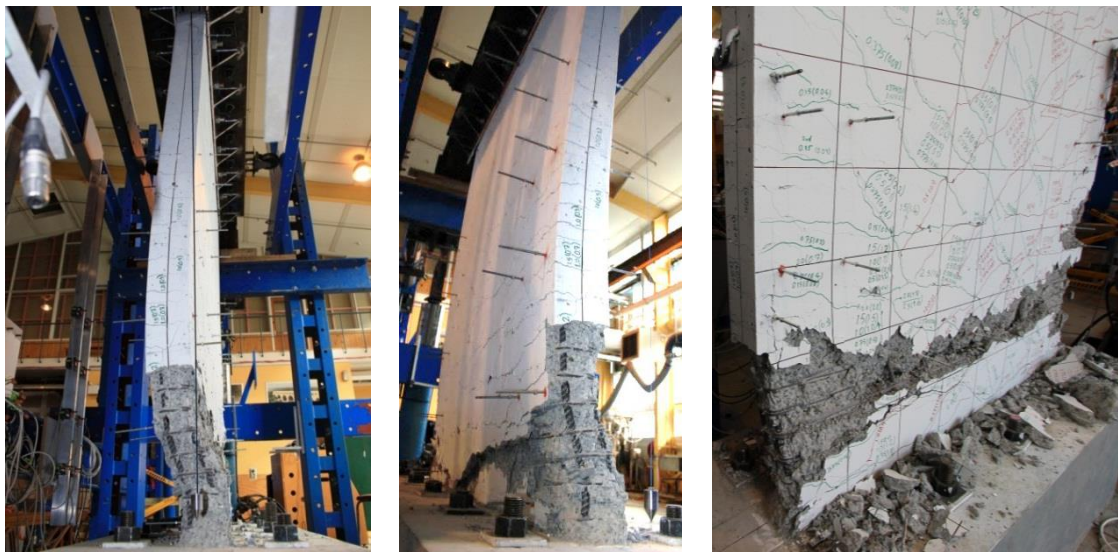
Figure 14. Out-of-plane instability of Specimen RWL.

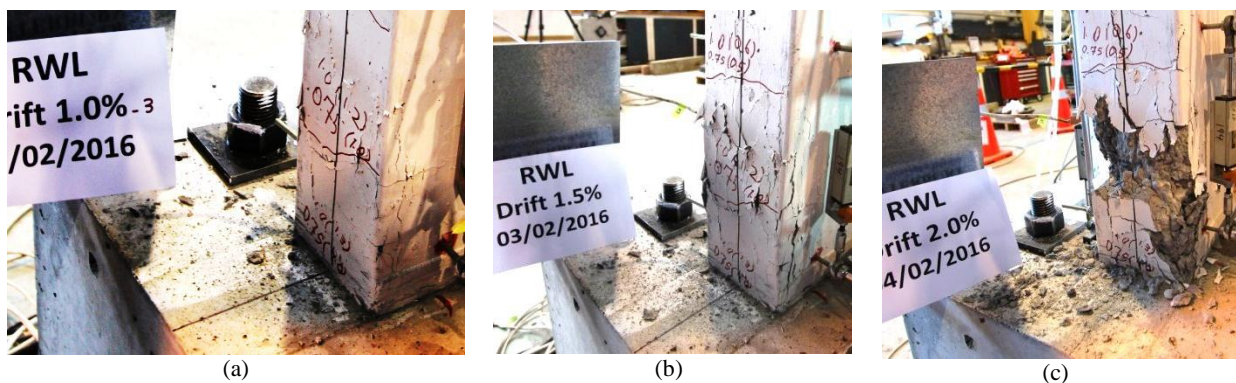
Figure 15. Development of cover spalling for Specimen RWL: (a) 1.0% drift; (b) 1.5% drift; (c) 2.0% drift.

In literature [21, 22], asymmetric spalling of concrete cover has been postulated to be one of the factors contributing to out-of-plane deformation of rectangular walls under cyclic loading. In this section, the effect of cover spalling on development of out-of-plane deformation is investigated. Figure 15 shows the initiation and development of cover spalling observed in the east boundary region of Specimen RWL. As can be seen in this figure, although 1.5% and 2.0% drift levels correspond to initiation and increase of out-of-plane deformations, the cover concrete had spalled off quite symmetrically at these stages. Also, considering the very limited area of spalled cover concrete compared to the length

of boundary regions, its asymmetric spalling would not have a noticeable effect on initiation and development of out-of-plane deformation. Furthermore, the onset of out-of-plane deformation is generally associated with unloading from a peak displacement level. At this stage, the cracks are wide open and the response of the section is mainly dependent on the reinforcement. Therefore, any asymmetric response of concrete would not be influential on the evolution of out-of-plane deformation. However, the excessive amount of out-of-plane deformation can result in formation of asymmetric cover spalling, which will understandably occur at the elevation with maximum out-of-plane deformation.
