LOW DAMAGE SEISMIC SOLUTIONS FOR NON-STRUCTURAL DRYWALL PARTITIONS

Abstract. Non-structural drywall partitions are the most common partitions used in buildings. They are usually bounded by either a structural frame or by two floor slabs, which makes them prone to damage by imposed inter-storey deformations. Usually the loss of serviceability occurs at very low drift levels. Typically, drywalls can either be steel framed or timber framed. As part of a research investigation into the development of low damage solutions for non-structural vertical elements, experimental and numerical studies have been carried out. This paper will present the inherent low seismic performance of drywall designed and constructed as per typical practice and proposed low damage drywall solution. Moreover, studying this poor performance, a low damage solution for drywall partitions, capable of reaching high level of drift without loss of serviceability, is developed based on refinements of existing drywall detailing. An overview of the connection details and of the results of the experimental campaign is herein reported for both the current practice drywall solution and for the proposed low damage drywall

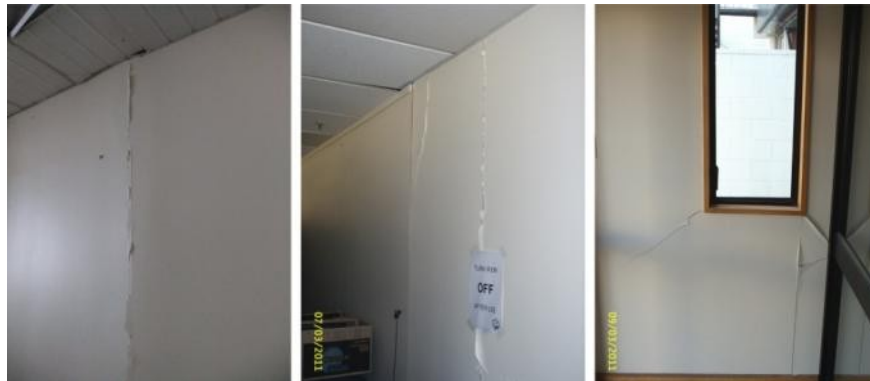
Figure 1. Typical drywall partition damage in buildings observed after 22nd February 2011 Christchurch earthquake in New Zealand.

Non-structural elements have repeatedly shown to be the most vulnerable elements in a building during an earthquake over the years. For newly designed buildings that are capable of undergoing moderate-to-severe earthquakes with no or low structural damage, the vulnerability of the non-structural elements potentially holds a high economical burden after an earthquake. Recently, Christchurch has been struck by an unusual sequence of earthquakes from September 2010 till September 2012. The total number of earthquakes above the magnitude 3.0, 4.0, 5.0 and 6.0 are reported as 4423, 958, 82, 9 respectively (EQC/GNS, 2012) with the most intensive one being February 22, 2011 (Magnitude 6.2, depth 5 km). One of the most common observations was that during the sequence of strong aftershocks (Magnitude 5+), many if not most of the modern buildings suffered moderate to extensive damage of the drywalls that needed repeatedly extensive repair or complete replacement, which is a severe economical burden for putting the building back to serviceable condition for reoccupation. In addition, the costs associated with the loss of the non-structural components approximately constitutes 62% for offices, 70% for hotels, 48% for hospitals (Taghavi and Miranda 2003). Some examples of the damage associated with the seismic events in Christchurch are shown in Figure 1.

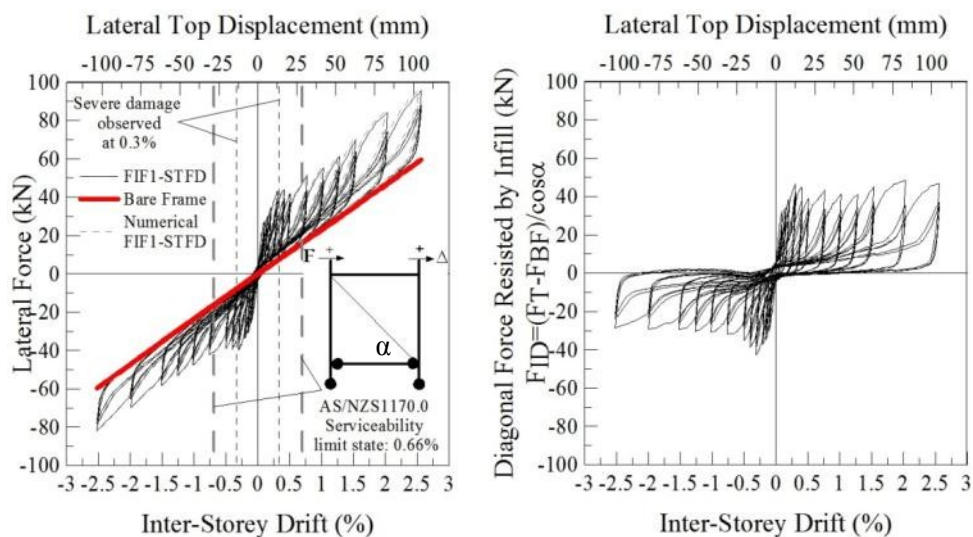
Figure 5. Hysteresis curve and corresponding diagonal force acting on the drywall for as built steel framed drywall and observed damage at the end of test: Interface damage due to rocking type of behaviour observed on the linings (FIF1-STFD)

Under the imposed displacements, the specimen lost its serviceability at 0.3% inter-storey drift by the formation of a vertical cracking at the lining interfaces. According to the New Zealand code (AS/NZS1170.0, 2002), this limit for new design would be predicted to occur at 0.66% drift, thus representing a remarkable and unconservative overestimation of performance (Figure 5). The specimen suffered significant interface damage between the linings starting at 0.3% drift till the end of the test at 2.5% drift level (Figure 5). The main damage was concentrated along the vertical lining interfaces. The results were used to calibrate the diagonal strut model to be used in the upcoming analyses. The numerical and experimental comparison of the hysteresis curves are shown in Figure 5. For simplicity the drywall is modelled as a single strut acting in both compression and tension. However, it can also be modelled as two separate compression only struts extending from both diagonal directions. The strut was modelled using Wayne Stewart Degrading Stiffness Hysteresis without a gap in Ruaumoko 2D (Carr, 2013).

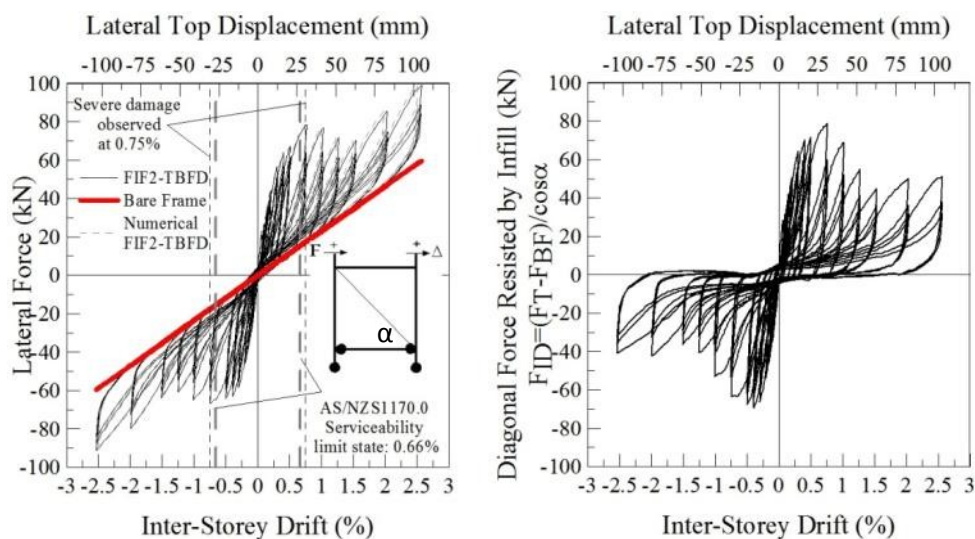
Figure 6. Hysteresis curve and corresponding diagonal force acting on the drywall for as built timber framed drywall and observed damage at the end of test: Corner damage due to profound strut effect (FIF2-TBFD)

timber studs, the underlying framing had a more monolithic construct. Therefore, there was a more significant strut effect, which changed the global behaviour and the failure mode. The specimen remained serviceable until 0.75% drift level. At 0.75% drift, the anchors used to fix the timber framing to the lower beam sheared. For more details, refer to Tasligedik et al 2012. This level of drift was slightly higher than, but overall comparable with the value (0.66%) recommended for design in the NZS1170.0, suggesting that the NZ code limit state values might have been better calibrated on timber framed drywalls (Figure 6). However, the wall was affecting the structural behaviour more than its steel framed counterpart and this interference was brittle rather than ductile, unlike steel framed drywall. The profound strut effect also manifested itself by corner damage at the drywall as it can be seen in Figure 6. The behaviour was modelled using Wayne Stewart Degrading Stiffness Hysteresis without a gap in Ruaumoko 2D (Carr, 2013).

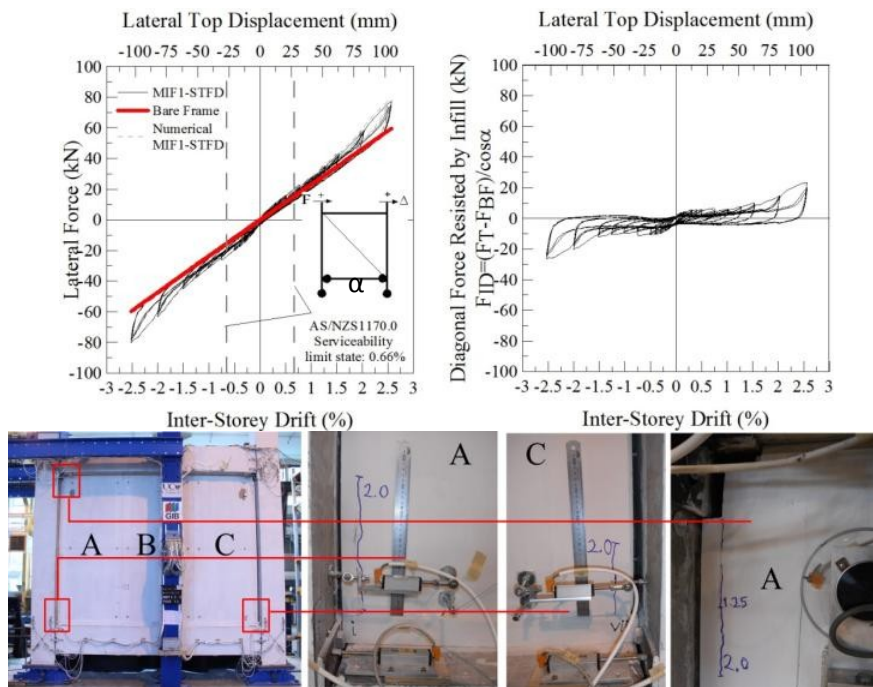
Figure 9. Hysteresis curve and corresponding diagonal force acting on the drywall for low damage steel framed drywall and observed damage at the end of test: Minor plaster crack (MIF1-STFD)

The same displacement history was applied to the specimen. The external gap closed around 1.2% drift and the internal gaps closed around 1.5% drift. However, no damage was imposed on the specimen until 2.0% drift level. From 2.0% onwards, minor plaster cracks occurred at the external lining finishes (Aluminium L-trim plaster). Force displacement hysteresis and observed damage at the end of the test are shown in Figure 9. In the hysteresis, it can easily be seen that the global behaviour approached to that of the bare frame. In other words, the interaction between the structural frame and the non-structural wall was minimized. The experimental results were compared with numerical model in Ruaumoko 2D, based on the use of a Wayne Stewart Degrading Stiffness Hysteresis, as per the specimen-FIF1-STFD, with the addition of a gap (Carr, 2013). The extent of the gap in the strut model was calculated as the projection of the total horizontal drift-based gap of 40 mm into the diagonal direction.

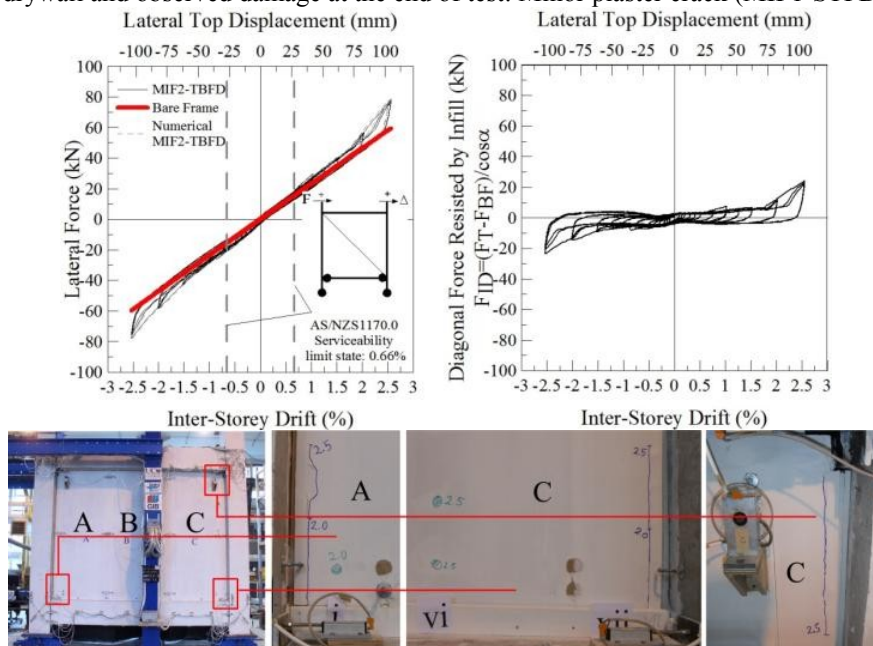
Figure 10. Hysteresis curve and corresponding diagonal force acting on the drywall for low damage timber framed drywall and observed damage at the end of test: Minor plaster crack (MIF2-TBFD)

This specimen behaved in the same way as MIF1-STFD. The gaps around the linings closed at around 1.5% drift and starting from 2.0%, only the aluminium L-trim plasters cracked, which is a very minor damage. Apart from those, the wall was completely intact. The behaviour was very close to that of the bare frame as it was in MIF1-STFD. The specimen was modelled the same way as FIF1-TBFD with the addition of gap at Wayne Stewart Degrading Stiffness Model. The total gap of 40 mm was projected to the diagonal direction. The results are shown in Figure 10.

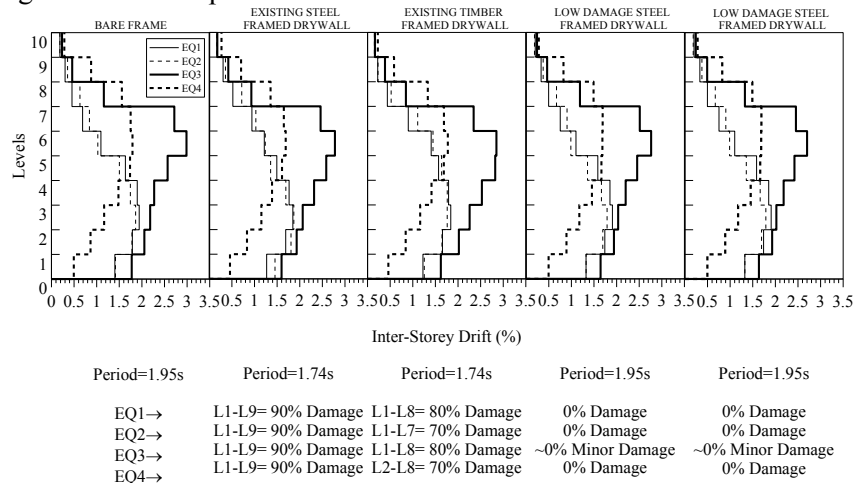
Figure 12. Numerically computed inter-storey drifts, periods and damaged partition percentages

The results of the analyses are shown in Figure 12. As it can be seen, the existing drywall partitions interact with the structural system and cause a slight change in the period of the structure (10% lower). On the other hand, due to the low interaction achieved in the low damage systems, the period of the structure remains the same as per the bare frame. Provided sufficient allowance is given in the design of the gap in the low damage drywall solution, the designer would thus not be required to account for any structural-non structural (partitions) system interaction in the numerical model. Moreover, the widespread damage of the traditional drywalls can be easily observed. At least 80% of the total drywalls would be expected to lose their serviceability within this building under the given earthquake records. On the other hand, with the implemented low damage solution, the percentage of damaged partitions can be lowered down drastically (up to 0% for these specific analyses), anticipating significant savings in terms of repair costs and downtime in a real life scenario.
