Spatial Correlations of Underground Pipeline Damage in Christchurch

Correlations with liquefaction-induced ground surface deformations and CPT-based liquefaction vulnerability index parameters

April 2019

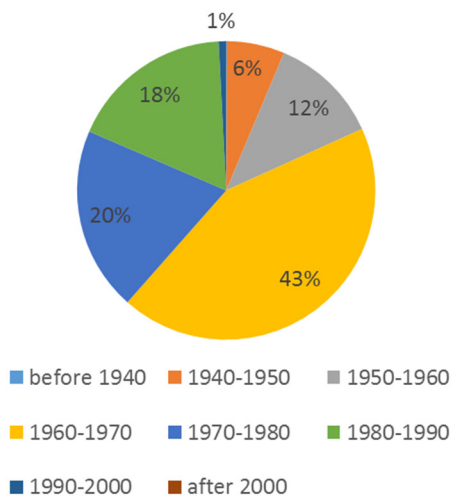
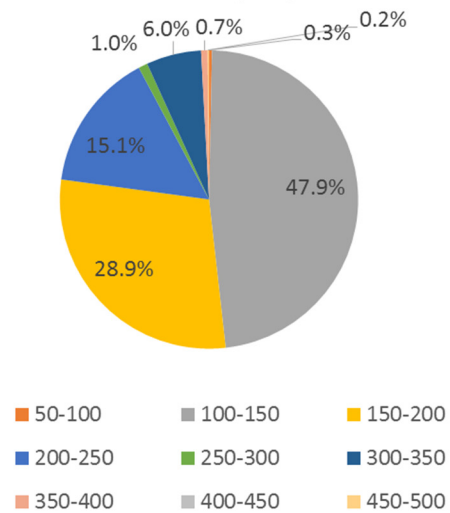
AC Pipeline Percentage of Length by Year of Installation

AC Pipeline Percentage of Length by Diameter (mm)

Figure 2-1 Percentage of AC pipeline length by year of installation, and by diameter in the Christchurch water supply system.

AC pipes were mainly introduced in the system in the 1960s (Figure 2-1a) and their production ceased in New Zealand in 1986 (Water New Zealand, 2017). They had been the primary pipe material installed in Christchurch in the decade following World War II, and, as shown in Table 2-1 they comprised the largest category of pipes in the Christchurch water supply system by the time the 22 February 2011 earthquake took place. AC pipes have diameters ranging from 100mm to 200mm (Figure 2-1b) and are typically connected with rubber ring coupling joints. The oldest AC pipes in the system were manufactured as a mixture of asbestos fibres, clay filler and cement, and have significant wall thickness, whereas the newer ones were a mixture of asbestos fibres and cement and have smaller wall thickness. Because of the decreased wall thickness, newer AC pipes are more deteriorated due to internal corrosion so, in some cases, they are weaker than the older AC pipes in the system.

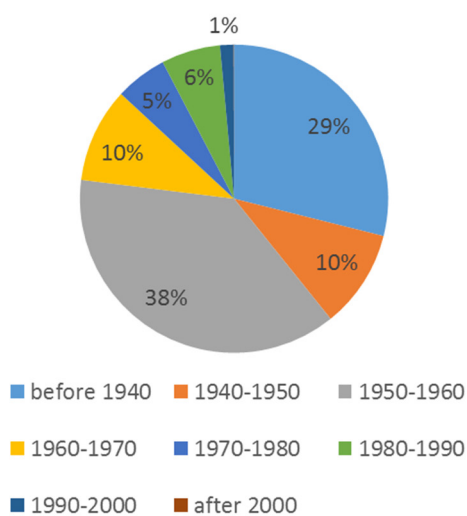
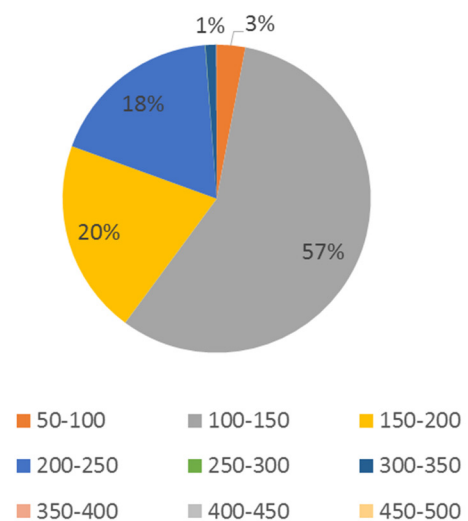
CI Pipeline Percentage of Length by Year of Installation

CI Pipeline Percentage of Length by Diameter (mm)

Figure 2-2 Percentage of CI pipeline length by year of installation, and by diameter in the Christchurch water supply system.

CI pipes are among the oldest pipes in the Christchurch water supply system, dating to the 1890s (Figure 2-2a). Installation of these pipes stopped in the 1990s when PVC became the main pipe material for new installations in the water supply system (Figure 2-3a). The majority of CI pipes have diameters ranging from 100mm to 200mm (Figure 2-2b), and typically have rubber ring, lead wool or poured lead bell and spigot joints.

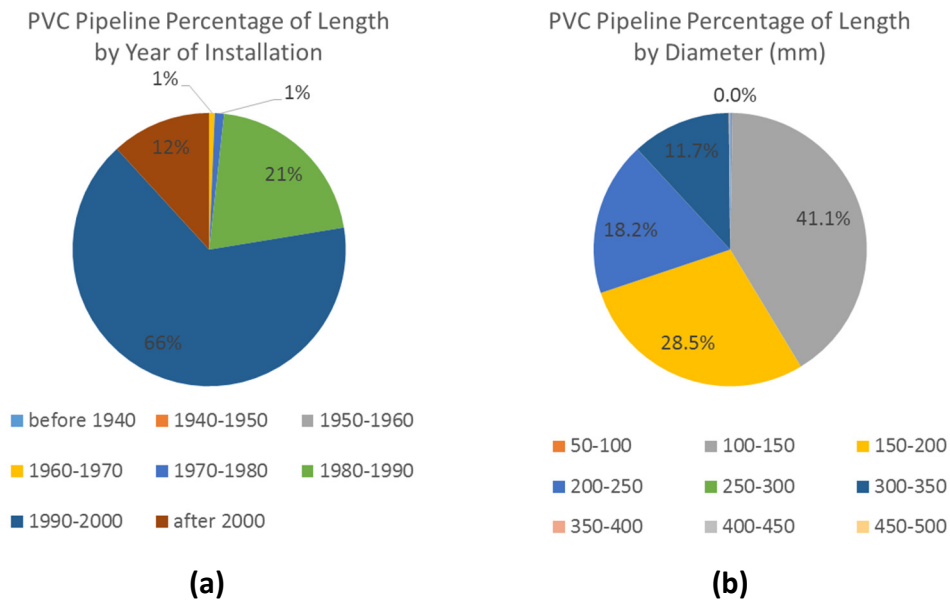
Figure 2-3 Percentage of PVC pipeline length by year of installation, and by diameter in the Christchurch water supply system.

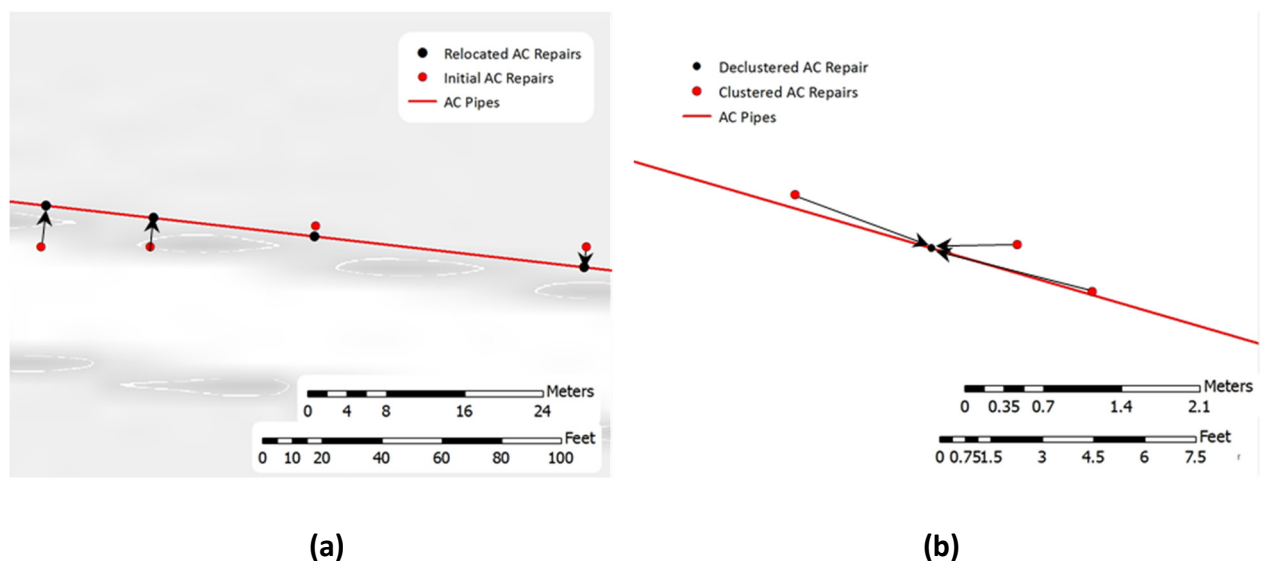
Figure 3-1 Examples of: a) repair inaccurate location in the geospatial data set, b) repair clustering and inaccurate location in the geospatial data set.

As briefly described in Section 0, the water distribution network repairs were reviewed and corrected for misplacement and clustering of pipe repair records. Several repair data were georeferenced far from their actual locations in the field. Repair data were not always linked to their respective pipe segments, resulting in mislocated geospatial repair data that were not located on the appropriate damaged pipelines. Moreover, several repairs in the GIS shapefile were clustered in several locations, indicating that the same repair was recorded multiple times. Figure 3-1(a) and Figure 3-1(b) illustrate two characteristic examples of repair relocation and de-clustering, respectively, for the AC repair dataset.

The actual location of a repair was determined by using the unique pipe identifier to relocate each repair to its respective damaged pipe segment. During de-clustering, repairs located within a 2m radius from each other were de-clustered by merging them into one single repair data point.

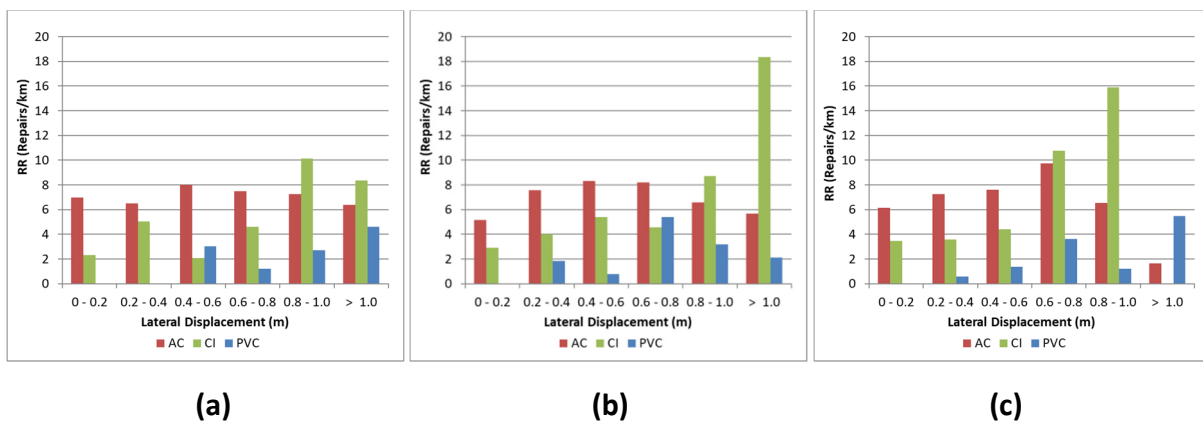
Figure 3-3 Histograms of AC, CI, PVC: RR vs liquefaction-related lateral ground surface displacement derived from a) unfiltered LiDAR data, b) filtered LiDAR data, and c) satellite imagery data, within the geographical extent of the SAT Zone.

In addition to the comparison of liquefaction-related lateral displacements derived from unfiltered LiDAR, filtered LiDAR, and satellite imagery shown in Figure 2-13 and discussed in Section 2.6.2, a comparative study was also performed on the basis of RR correlations with lateral displacements derived from unfiltered and filtered LiDAR and satellite imagery over the geographical extent of the SAT Zone which contains all three types of data sets. The results are presented in Figure 3-3 for the three major pipe types in the water supply system, i.e., AC, CI and PVC pipes. Similar trends in RR vs lateral displacement are shown for AC pipes among all three types of data sets, whereas there are some distinctive differences for CI and PVC pipes. Overall, filtered LiDAR and satellite imagery seem to provide stronger correlations of RR with lateral displacement than unfiltered LiDAR data sets, with reasonably increasing trends of RR towards larger values of lateral displacement. It is noted that none of the RR trends shown in Figure 3-3 has an intercept at zero or very small lateral displacements, indicating that pipeline damage is also controlled by other ground surface deformation mechanisms such as liquefaction-related settlement and transient ground surface deformations due to seismic ground shaking.

The liquefaction-related filtered LiDAR lateral displacements were used in this study to investigate correlations of pipeline damage with liquefaction-induced lateral movements because of the noise in the unfiltered LiDAR data set and the stronger RR correlations with lateral displacement using filtered LiDAR and satellite imagery. As indicated previously, the satellite imagery covers a significantly smaller extent of the Christchurch area, thus restraining subsequent analyses to a much smaller geographic extent.

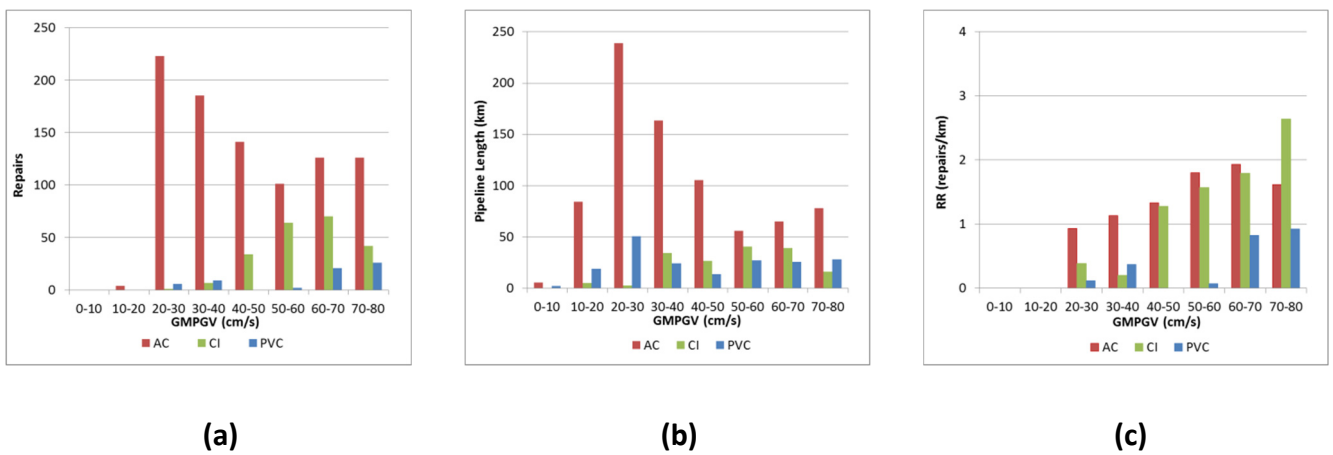
Figure 3-4 Histograms of AC, CI, PVC within the TOT zone: a) Repairs vs GMPGV, b) Pipeline length vs GMPGV, c) RR vs GMPGV.

Figure 3-4 to 3-6 show histograms of repairs, pipeline length and RR for the three major pipe types in the water supply system (i.e., AC, CI and PVC pipes) vs GMPGV using the geographical extents of the TOT Zone, the NOLIQ Zone and the LIQ zone. Comparison of the distributions of repairs in Figure 3-4a, 3-5a and 3-6a with respect to GMPGV indicates that the majority of repairs (more than an order of magnitude of the total number of repairs) is located within the LIQ zone even though, as shown in Figures 3-4b, 3-5b and 3-6b, pipelines are approximately equally distributed between the LIQ and NOLIQ zones.

The results in Figures 3-4c, 3-5c and 3-6c of RR vs GMPGV show that the highest RR values are related to pipeline damage within the LIQ zone, whereas the maximum RRs in the areas not affected by liquefaction (NOLIQ zone) are slightly higher than 1 repair/km.

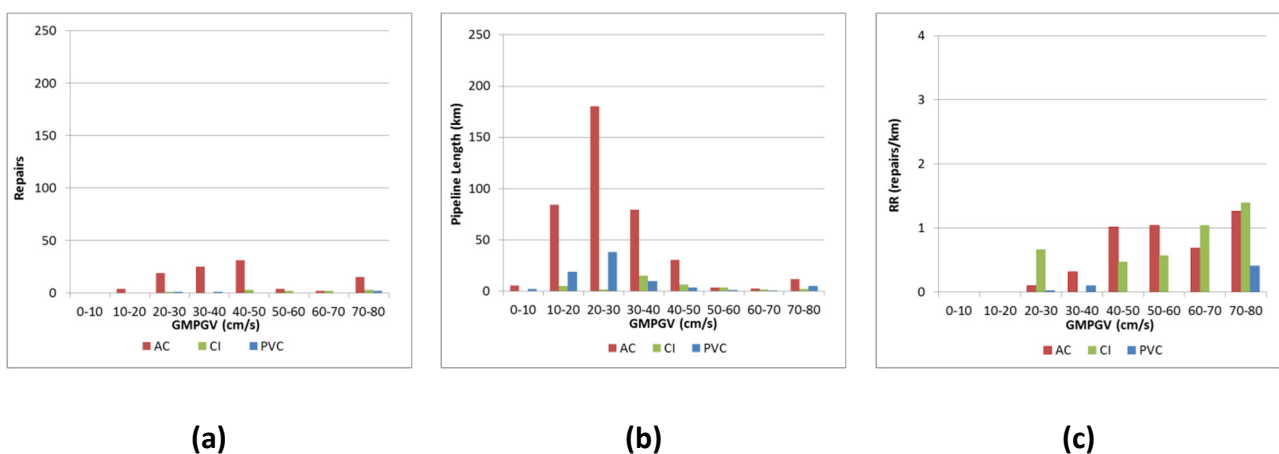
Figure 3-5 Histograms of AC, CI, PVC within the NOLIQ zone: a) Repairs vs GMPGV, b) Pipeline length vs GMPGV, c) RR vs GMPGV.

It is noted that the increasing trends of RR with respect to GMPGV in Figure 3-5c for AC and CI pipelines in the NOLIQ zones are in very good agreement with the correlations of RR vs GMPGV developed by Bouziou (2015).

It is noted that the contours for AC pipes in Figure 3-13 are not zero at the (0,0) intercept. As shown in Figure 3-5a, a large number of AC repairs is associated with GMPGV values between 20cm/s and 40cm/s. These GMPGV values and AC repairs are mainly identified outside the LIQ zone (see Figure 3-5). Moreover, as shown in Figure 3-5c, GMPGV values between 20cm/s and 40cm/s are associated with high RR levels for AC pipelines. These AC repairs are not associated with liquefaction-induced lateral displacement and settlement. Nevertheless, they fall within the TOT Zone and, thus, are included in the correlation shown in Figure 3-13. It appears, therefore, that GMPGV contributes to AC pipeline damage when the lateral displacement and settlement shown in Figure 3-13a are negligible.

Pipeline damage (i.e., pipe repairs in this study) attributed to seismic wave effects, or TGD, was estimated by RR vs GMPGV correlations developed by Bouziou (2015). These correlations are for pipeline repairs outside the LIQ Zone after the 22 February 2011 earthquake and are in close agreement with the RR correlations for the NOLIQ zone shown in Figure 3-5c.

Based on the very low levels of RR_{TGD} with respect to GMPGV shown in Figure 3-5c for PVC pipelines in the NOLIQ zone, it was assumed that $RR = RR_{Add-Liq}$ for PVC pipelines. That is, the additional amount of pipeline damage for PVC pipelines due to liquefaction effects is equivalent to the pipeline damage that was actually recorded.

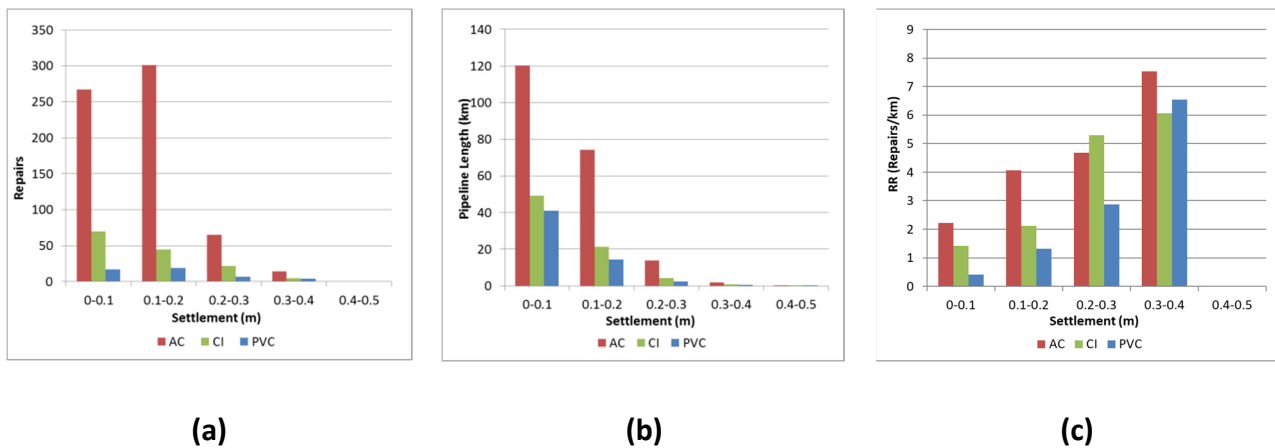
Figure 3-7 Histograms of AC, CI, PVC within the TOT zone: a) Repairs vs Settlement, b) Pipeline length vs Settlement, c) RR vs Settlement.

Figures 3-7 to 3-9 show histograms of repairs, pipeline length and RR for the three major pipe types in the water supply system (i.e., AC, CI and PVC pipes) vs settlement using the geographical extents of the TOT Zone, the NOLIQ Zone and the LIQ zone.

As shown in Figure 3-7 to 3-9, most of the pipeline repairs and most of AC, CI and PVC pipelines are located within the LIQ Zone. Figure 3-9c demonstrates that RR values greater than zero are related to very small to negligible settlement, indicating that other effects such as liquefaction-induced lateral ground strain and ground shaking have also contributed to pipeline damage within the LIQ Zone. As previously discussed, pipelines within the LIQ

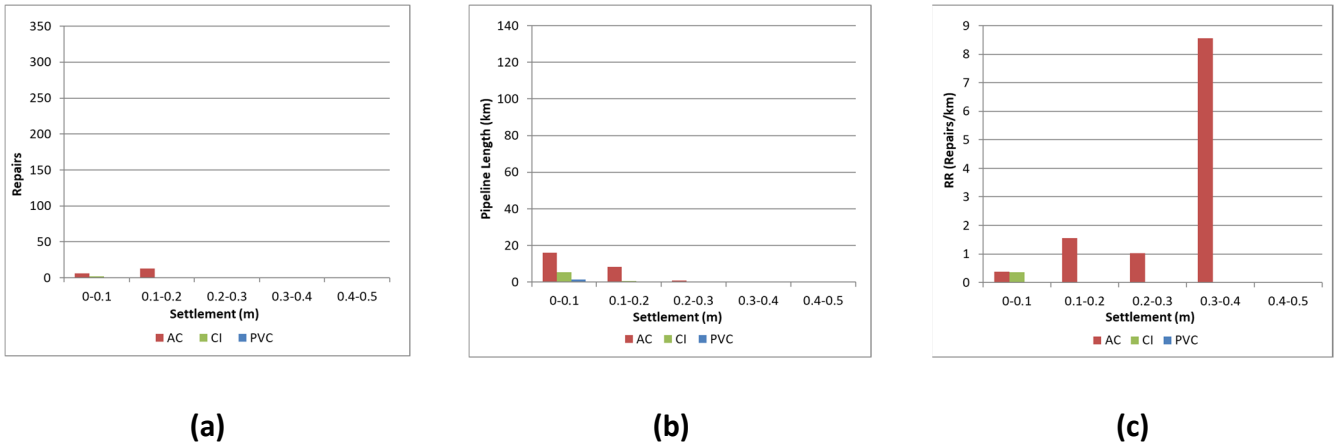
Figure 3-8 Histograms of AC, CI, PVC within the NOLIQ zone: a) Repairs vs Settlement, b) Pipeline length vs Settlement, c) RR vs Settlement.

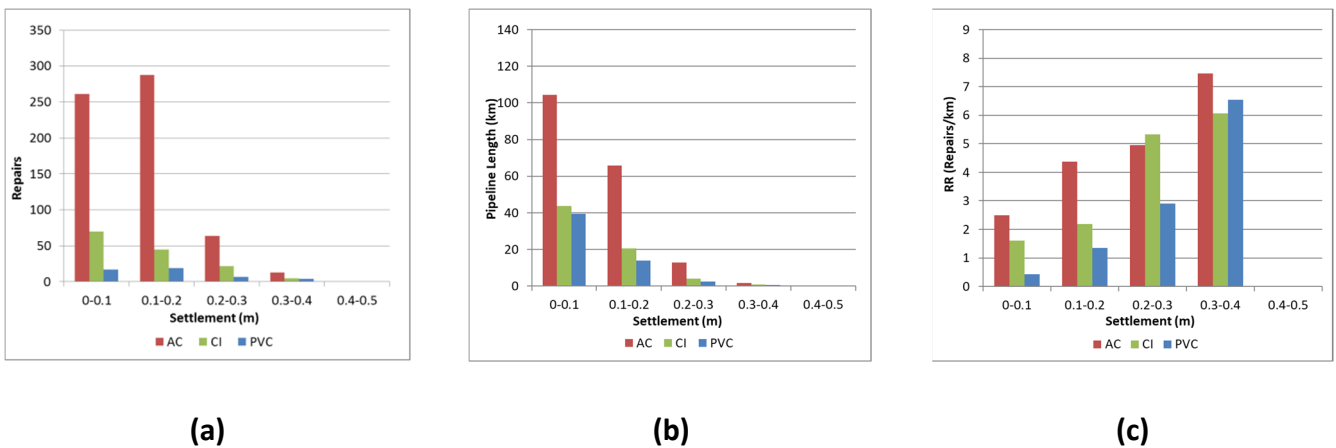
Figure 3-9 Histograms of AC, CI, PVC within the LIQ zone: a) Repairs vs Settlement, b) Pipeline length vs Settlement, c) RR vs Settlement.

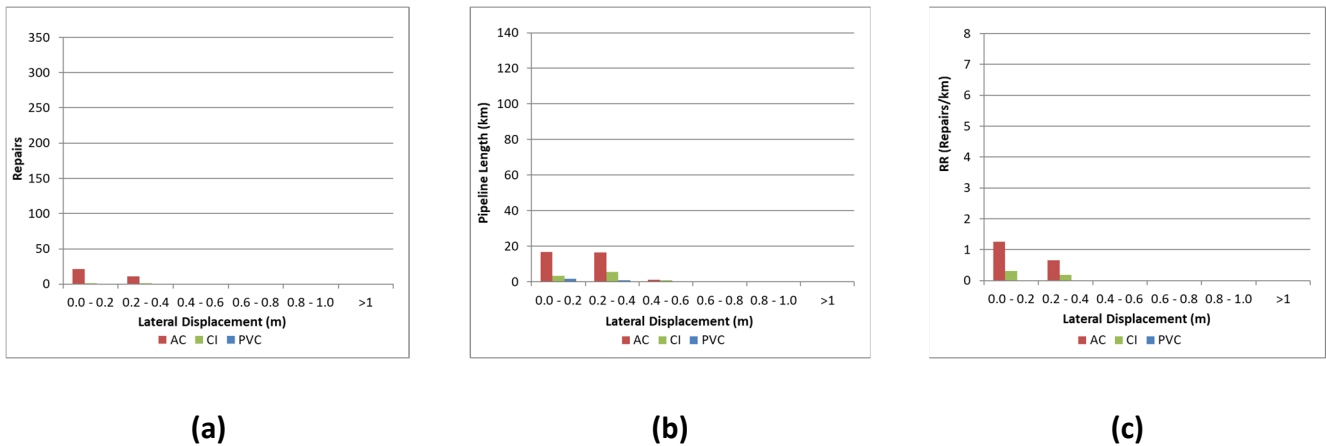
Figure 3-11 Histograms of AC, CI, and PVC pipelines within the NOLIQ zone for: a) repairs, b) pipeline length, c) repair rate vs lateral displacement.

Figure 3-10 through 3-12 show histograms of repairs, pipeline length and RR for the three major pipe types in the water supply system (i.e. AC, CI and PVC pipes) vs lateral displacement using the geographical extents of the TOT Zone, the NOLIQ Zone and the LIQ zone. As previously discussed, lateral displacements were derived from filtered LiDAR datasets collected before and after the 22 February 2011 earthquake and were corrected for tectonic movement to reflect lateral displacement caused by liquefaction effects. Similar to the liquefaction-related settlement, liquefaction-related lateral displacement may have also taken place during the 22 February 2011 earthquake in the NOLIQ Zone without any surface manifestation and may have also contributed to pipeline damage in the wider TOT Zone.

As shown in Figure 3-10 through Figure 3-12 most of the pipe repairs and most of AC, CI and PVC pipes are located within the TOT zone, and the highest RR values are related to damage within the LIQ zone. RR values as high as 2 repairs/km in Figure 3-12c are observed at very small to negligible lateral displacement, indicating that pipeline damage was caused by some combination of liquefaction-induced settlement and ground shaking.

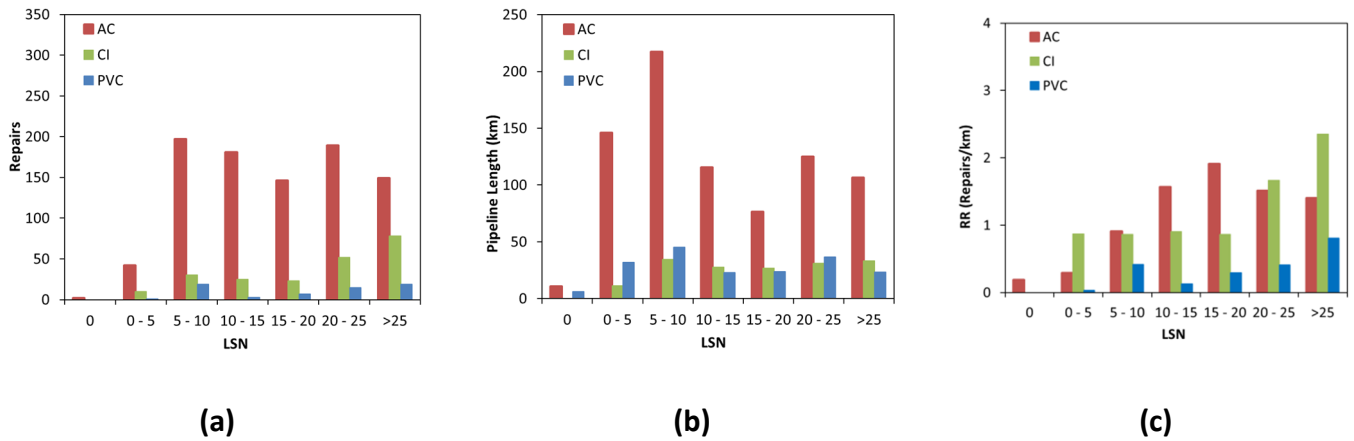
Figure 3-14 Histograms of: a) Repairs, b) Pipeline Length, and c) RR vs LSN (50th percentile), for AC, CI, PVC within the TOT zone.

The distribution of repairs, pipeline length and RR with respect to the 50th and 75th values of LSN for AC, CI and PVC pipelines is shown in Figure 3-14 and Figure 3-15. Overall, AC pipelines are more vulnerable with respect to any level of LSN than CI pipelines, and CI pipelines in most cases are more vulnerable with respect to LSN than PVC pipelines. The histograms of RR with respect to the 75th percentile LSN values provide stronger increasing trends than the histograms of RR with respect to the 50th percentile LSN values.

It is noted that the pipeline RRs shown in Figure 3-14 and Figure 3-15 are greater than zero at LSN=0. Similar to RR correlations with the liquefaction-induced ground displacements

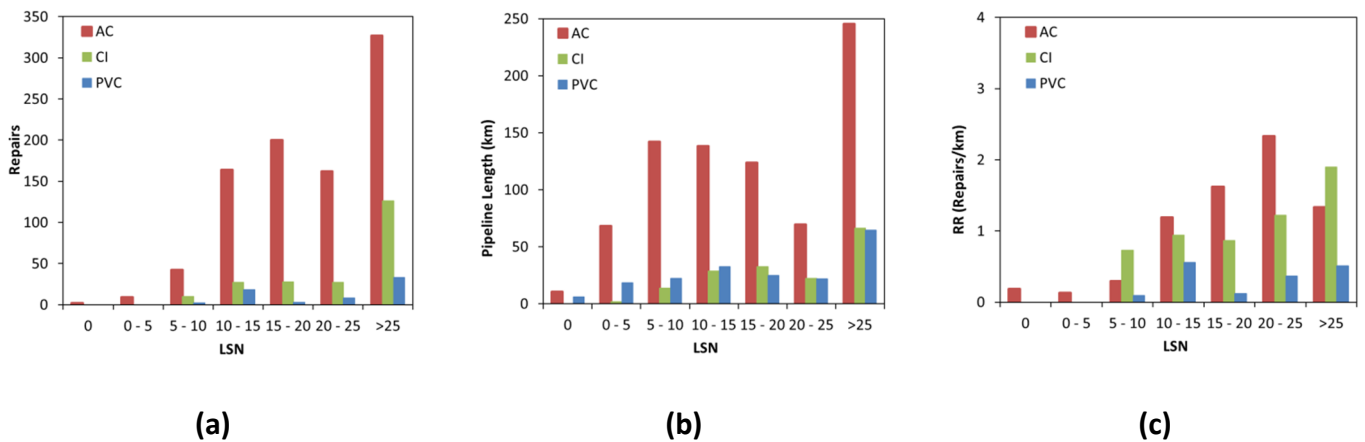
Figure 3-15 Histograms of: a) Repairs, b) Pipeline Length, and c) RR vs LSN (75th percentile), for AC, CI, PVC within the TOT zone.

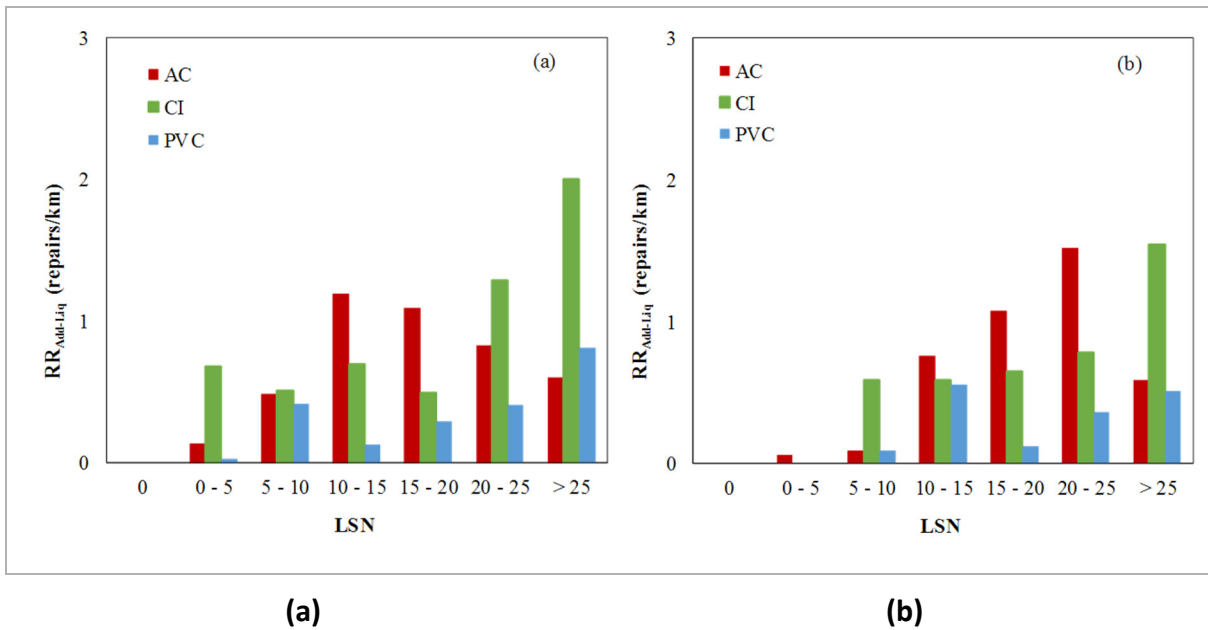
Figure 4-2 Histograms of RR_{Add-Liq} vs LSN within the TOT Zone for: a) AC, CI and PVC pipelines using the 50th percentile, and b) AC, CI and PVC pipelines using the 75th percentile.

Correlations of $RR_{\text{Add-Liq}}$ with respect to the 50th and 75th LSN values for AC, CI and PVC pipelines are presented in Figure 4-2. The histograms of $RR_{\text{Add-Liq}}$ presented in Figure 4-2 are smaller than the RR shown in Figures 3-14 and 3-15. The $RR_{\text{Add-Liq}}$ correlations are close to zero at an LSN value of zero (i.e., when the predicted liquefaction vulnerability is zero, then $RR_{\text{Add-Liq}}$ should be zero).

The results also show that AC pipelines are more susceptible to liquefaction-related effects than CI pipelines, and CI pipes are more susceptible to liquefaction-related effects than PVC pipes.

The histograms of $RR_{\text{Add-Liq}}$ with respect to the 75th percentile LSN values provide stronger increasing trends than the histograms of $RR_{\text{Add-Liq}}$ with respect to the 50th percentile LSN values. The correlation of pipeline damage with the 75th percentile LSN values therefore produces a better-defined trend of increasing $RR_{\text{Add-Liq}}$ vs LSN. Indicative, smoothed trend lines have been visually fitted to the 75th percentile LSN histograms and are shown in Figure 4-3. These are indicative lines only to depict the shape of the $RR_{\text{Add-Liq}}$ vs LSN functions. Further work is necessary to more robustly fit $RR_{\text{Add-Liq}}$ vs LSN functions to the data.

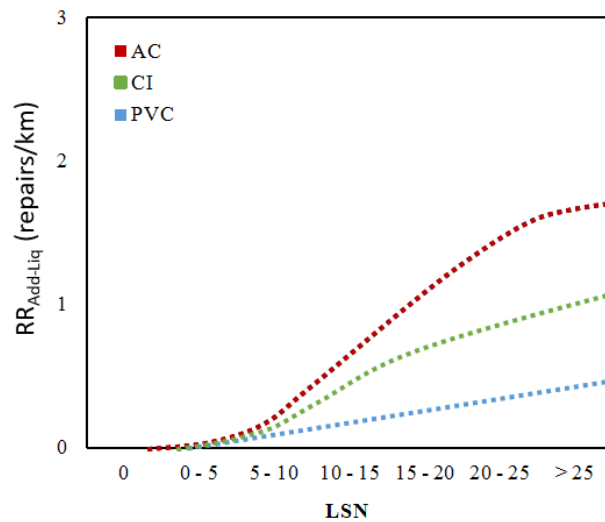
Figure 4-3 Indicative RR_{Add-Liq} vs LSN functions for AC, CI and PVC pipelines based on 75th percentile calculated LSN values.

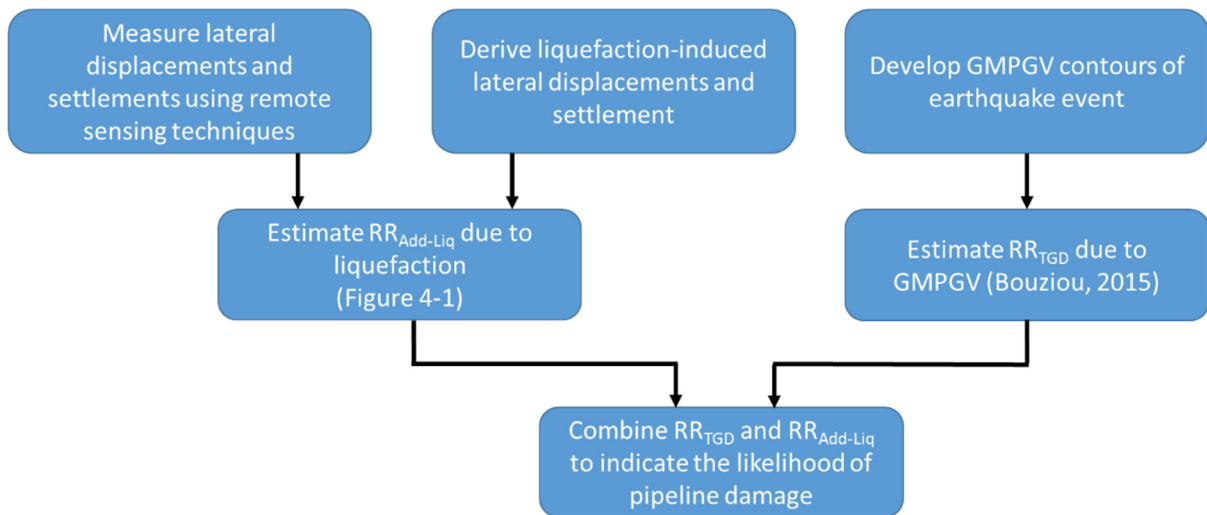
Figure 5-2 Flow chart of suggested framework for assessing the likelihood of pipeline damage for post-earthquake event situations.

In addition to pre-event risk assessment and planning, the findings of this work can also be applied after an earthquake to improve emergency response and recovery. Using the framework in Figure 5-2 pipeline damage can be rapidly estimated using remote sensing technologies that provide information about the distribution of ground surface movements. This information guides the detailed damage assessment process and restoration of the pipeline network to enhance emergency repairs and support community recovery. The methodology can be incorporated into regional response and recovery operations.
