# PANEL CONNECTION DETAILS IN EXISTING NEW ZEALAND PRECAST CONCRETE BUILDINGS

## ABSTRACT

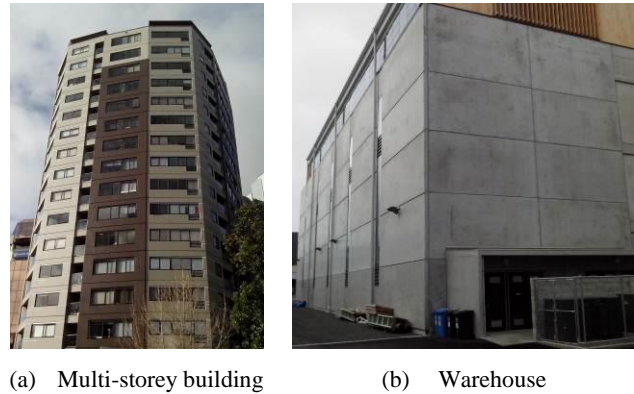
**Figure 3: Examples of precast concrete panels in New Zealand.**
